Inspection Report

Safe@Home Inspections, LLC

Date: 1/1/2024	Time:	Report ID: 20190801-Sample-Office
Property:	Customer: Professional Investor

Executive Summary

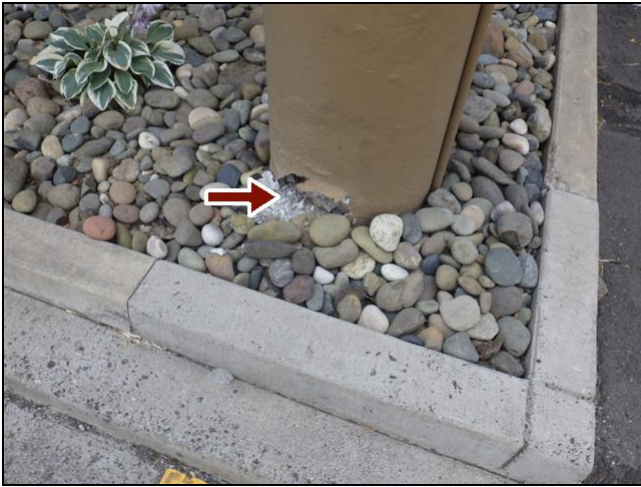
B. Item 4 (Picture)

(3) Minor damage was noted on two columns (east and west ends) that have spalled concrete and exposed rebar. This will lead to further degradation of the column base in time. Recommend repairs now by a licensed and qualified contractor.

Estimate: \$250 - \$500

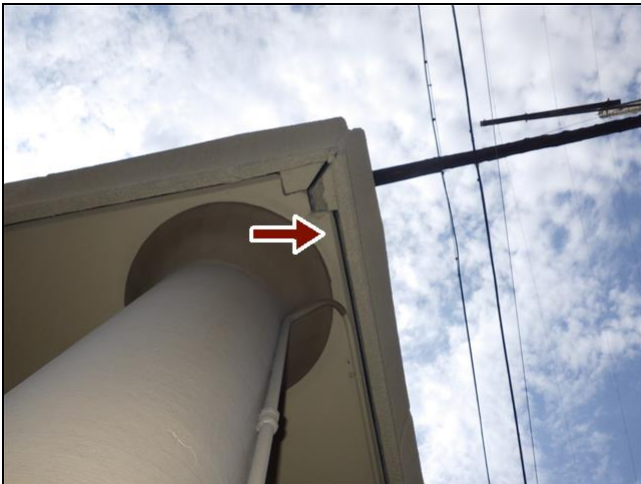
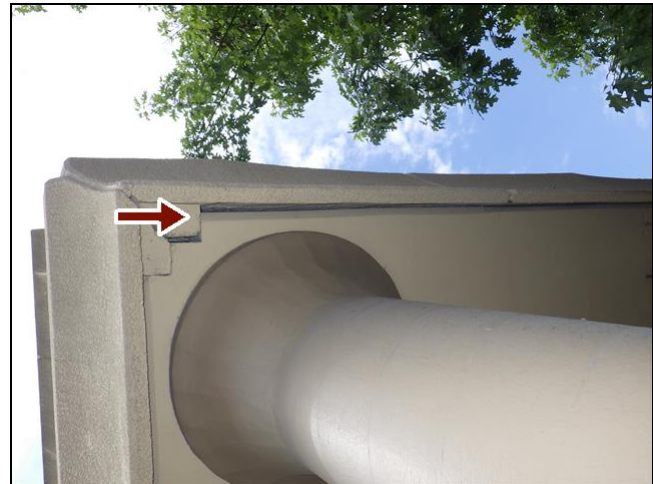
(2) Two panels appear to be out of plumb. One on the northwest corner, west-facing panel, and one on the northeast corner, north-facing panel, show separation from the top of the beam to which they bear. Recommend evaluation by a structural engineer to determine how significant a concern this is.

Estimate: Detailed quotation required.

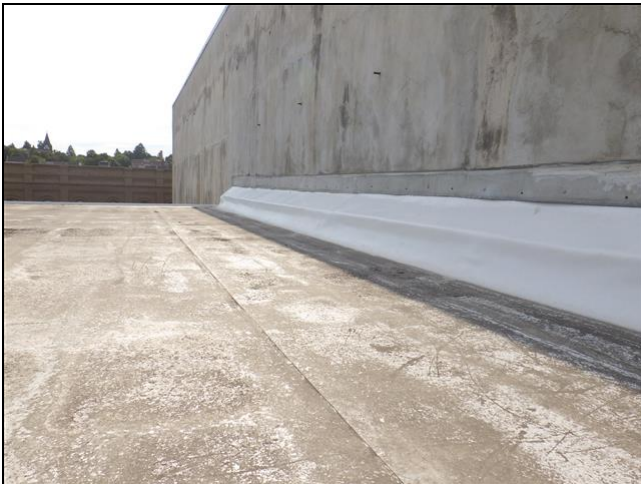
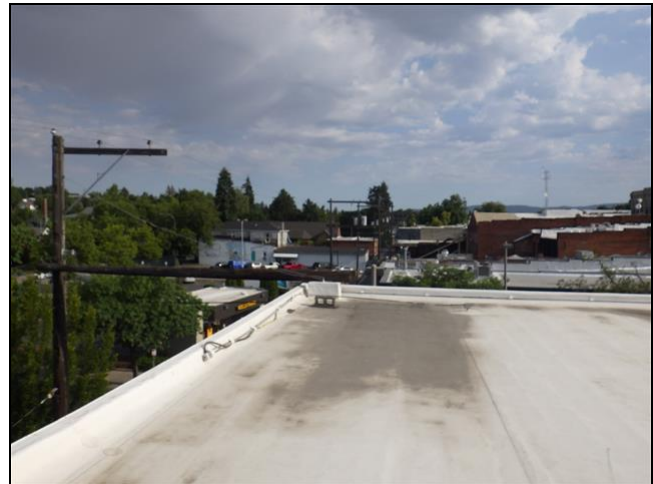
(2) The roof does not appear to be properly sloped for drainage as is evident from the residual pooling marks. This is not feasible for correction until the roof is replaced.

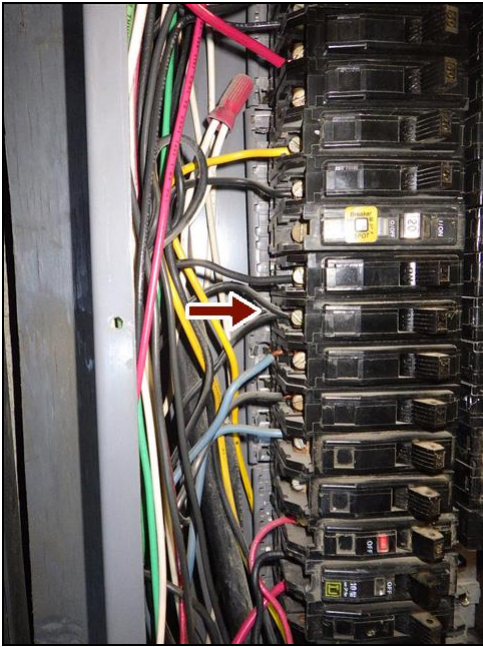
B. Item 6 (Picture)

(5) One double tap is present in Panel A. Recommend correction by a licensed and qualified electrical contractor.

Estimate: \$101 - \$250

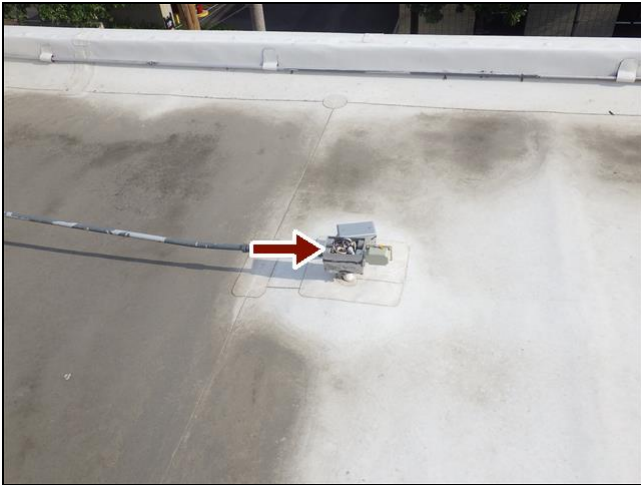
C. Item 1 (Picture)

(2) One junction box on the roof is missing a cover plate. Recommend correction.

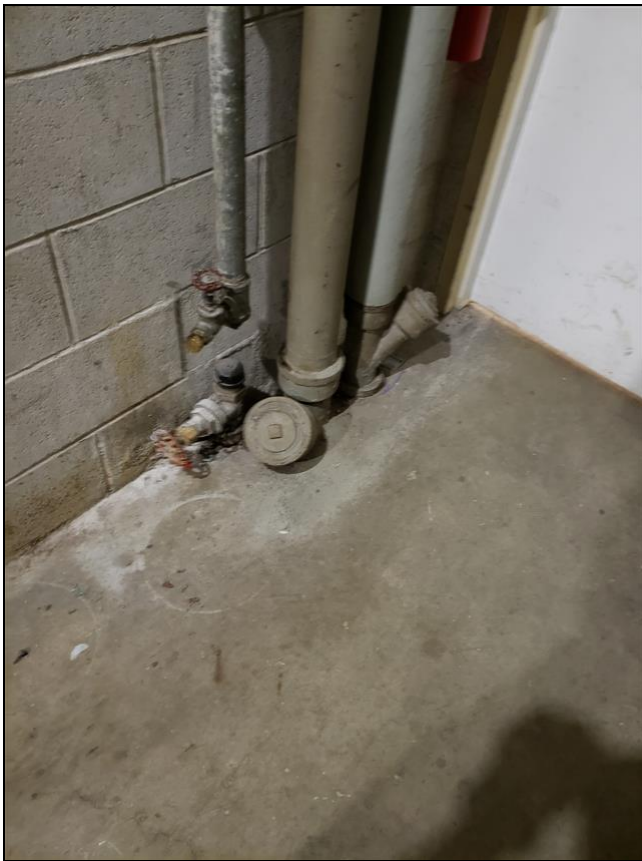
C. Item 1 (Picture)

(3) The building has one or more of the following: horizontal cast iron piping which may be deteriorated; clay tile piping or Orangeburg piping connecting the house to the utility sewer system or onsite sewer system. Thus, THE FOLLOWING SHOULD BE DONE: Have a licensed and qualified plumbing contractor video-scan the the main sewer line from the home to the street or the onsite sewage system to check for blockages or hidden damage BEFORE YOU CLOSE.

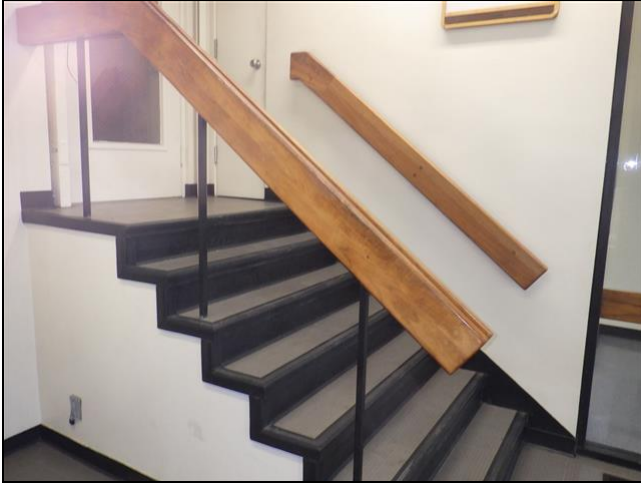
A. Item 1 (Picture)

There were two stairwells present. The first was located on the west side of the building. This stairwell appears to meet current safety standards except where the handrails terminate. Instead of terminating to the wall, they are open. The second stairwell leads to the drug store upper floor. This stairwell lacks proper baluster spacing for the guard rails. Recommend installing to prevent falls.

Estimate: \$501 - \$1000

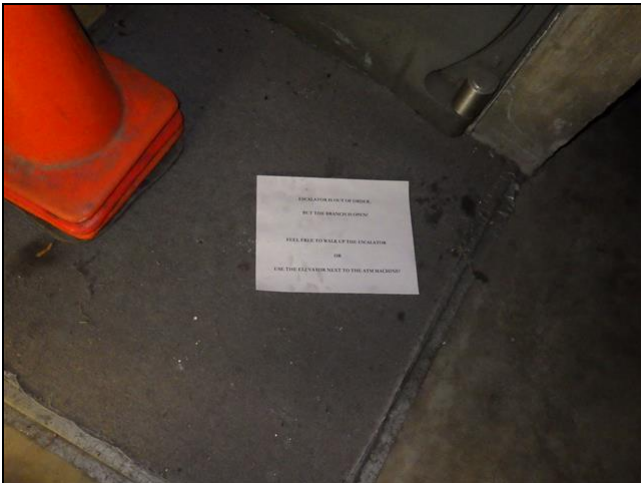
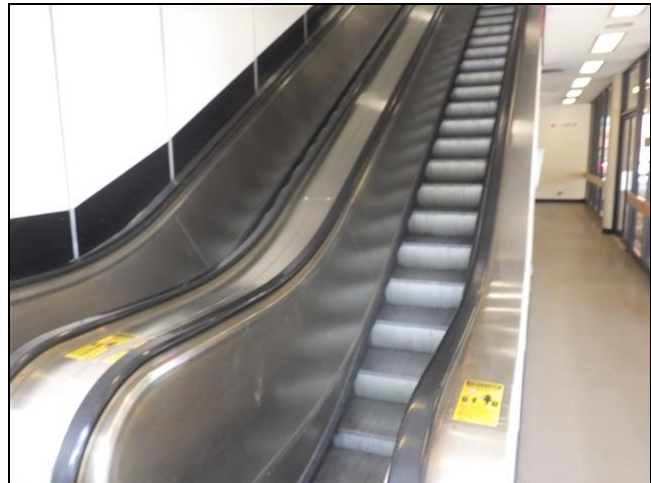
The escalators are located on the east side of the building. They appear original to the building. Based on available signage, their reliability is suspect. Recommend full servicing and evaluation to determine the feasibility of continuing their use, their status relative to modern safety requirements, and prospects for replacement.

Estimate: Detailed quotation required.

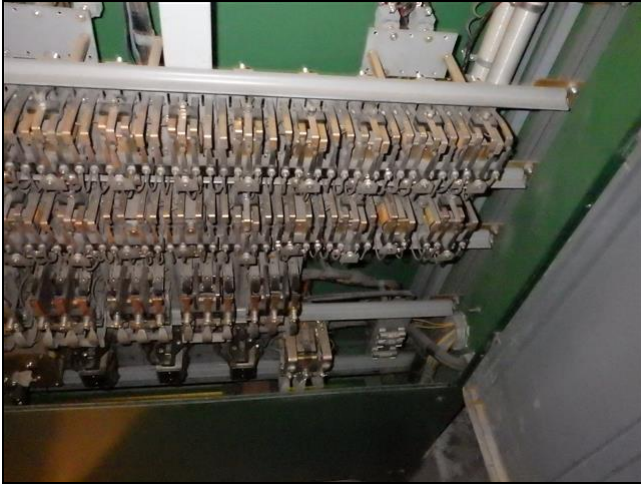
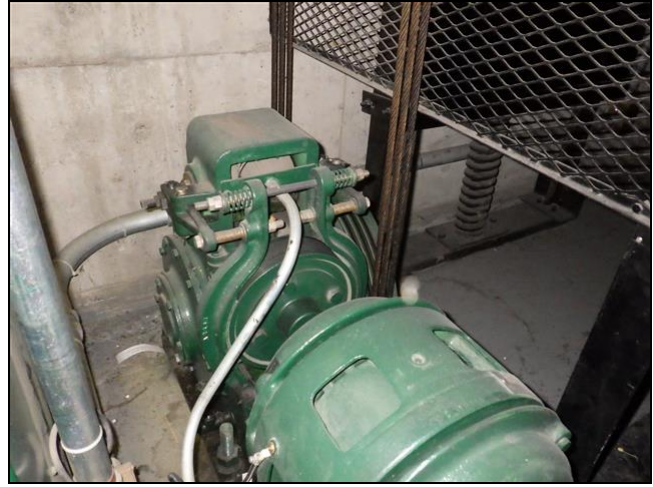
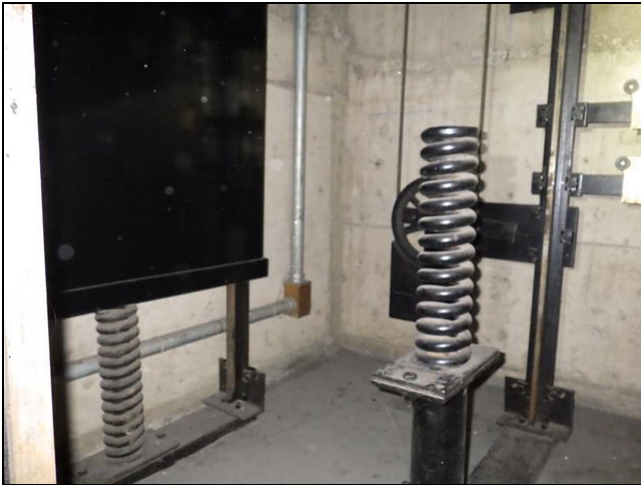
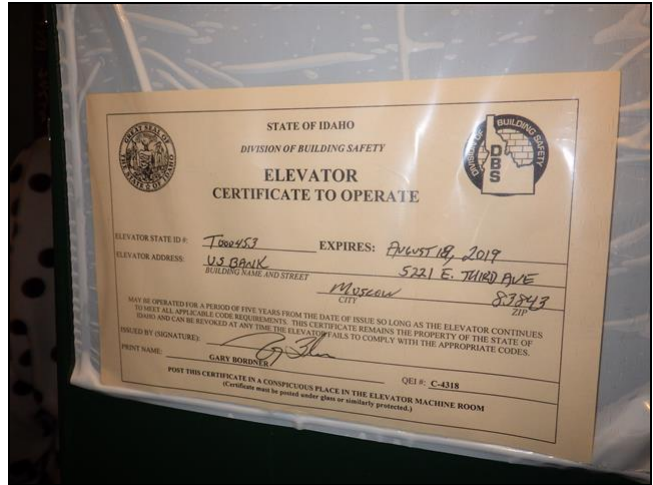
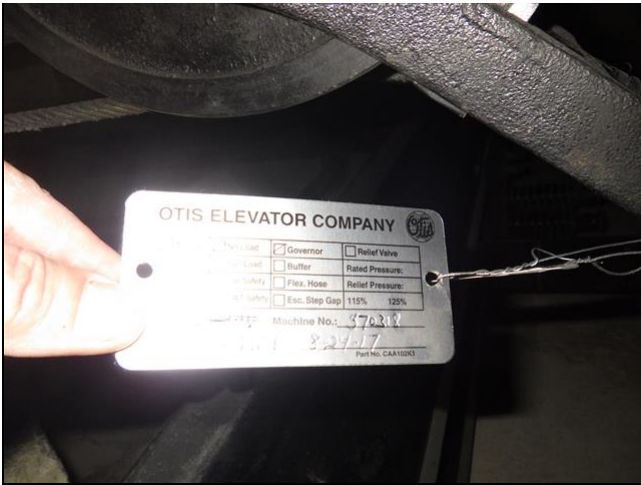
The elevator is an older model that uses electrical-mechanical relays for the controls. The motor and relays are located in a basement pit below the elevator itself. Inspections appear current but will expire soon. I recommend contacting the servicing company to re-certify the elevator and to assess the potential for adding an additional stop.

Estimate: Detailed quotation required.

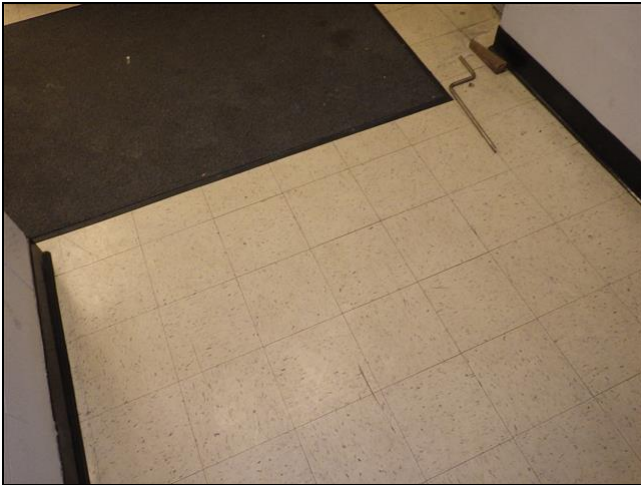
A. Item 1 (Picture)

(1) The ceiling was constructed as a drop ceiling with acoustic panels. Given the vintage of the building, there is a reasonable chance that the panels are asbestos containing. Recommend testing. In general, the ceiling tiles were in better than average condition.

(2) Walls were gypsum board with paint or wallpaper. Two points of water intrusion were noted but these appear to be old damage.

(3) There are several styles of flooring tile that are likely asbestos containing. The EPA recommendation is to cover them with other flooring materials. Major remodels may require abatement.

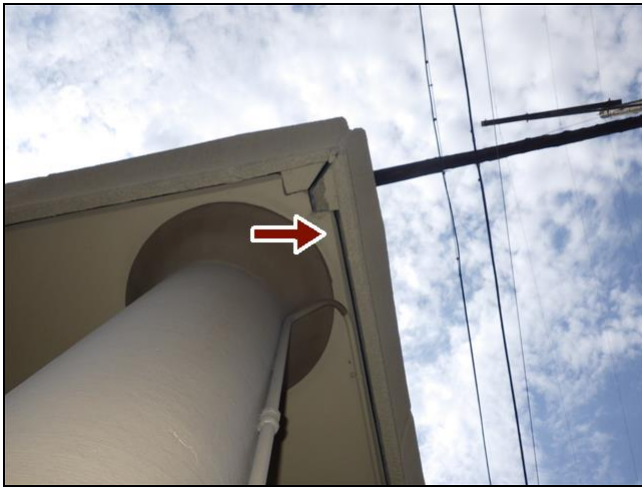
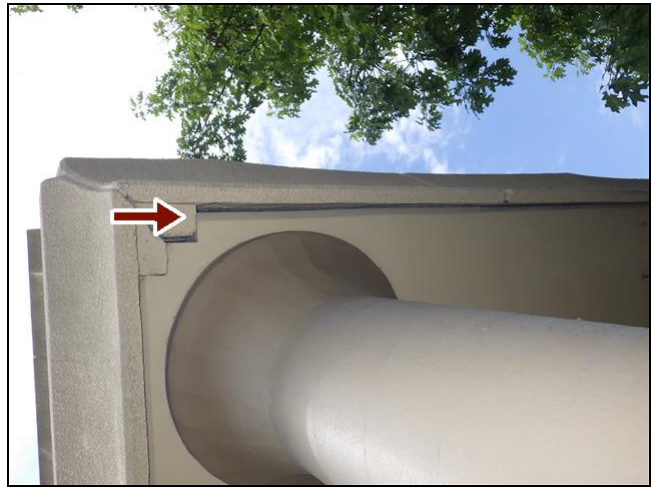
(2) Two panels appear to be out of plumb. One on the northwest corner, west-facing panel, and one on the northeast corner, north-facing panel, show separation from the top of the beam to which they bear. Recommend evaluation by a structural engineer to determine how significant a concern this is.

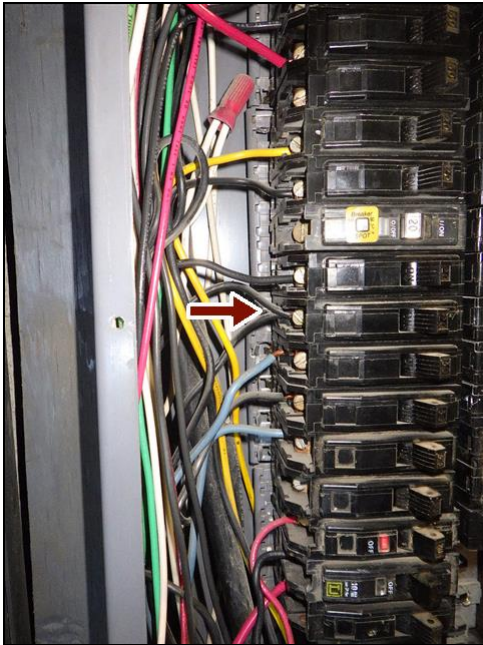
B. Item 6 (Picture)

(5) One double tap is present in Panel A. Recommend correction by a licensed and qualified electrical contractor.

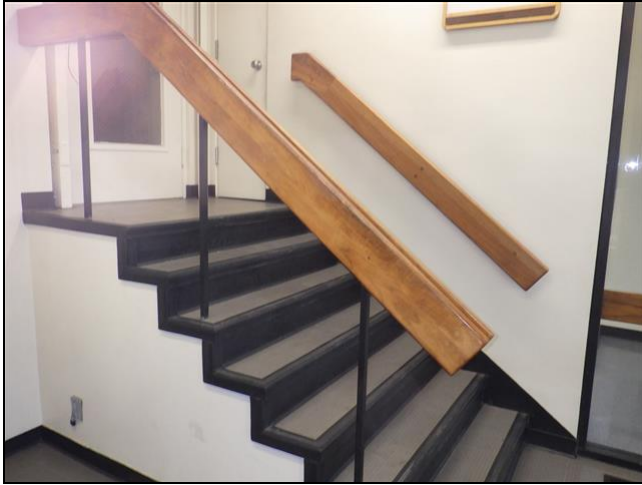
A. Item 1 (Picture)

There were two stairwells present. The first was located on the west side of the building. This stairwell appears to meet current safety standards except where the handrails terminate. Instead of terminating to the wall, they are open. The second stairwell leads to the drug store upper floor. This stairwell lacks proper baluster spacing for the guard rails. Recommend installing to prevent falls.

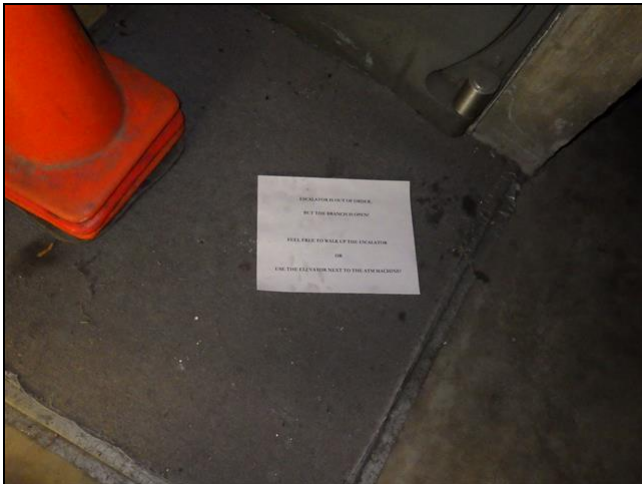
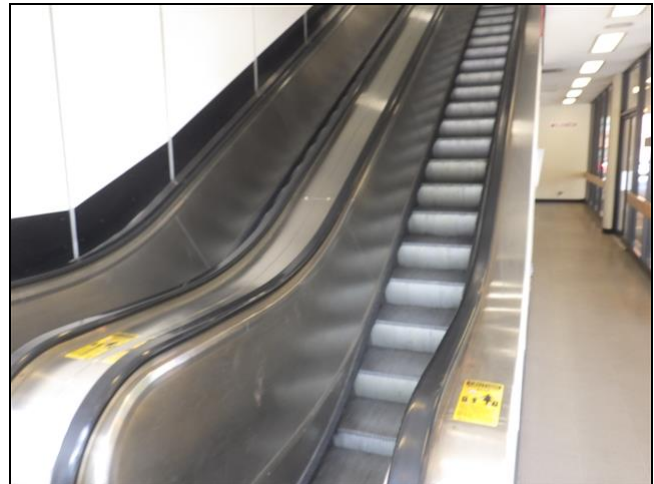
The escalators are located on the east side of the building. They appear original to the building. Based on available signage, their reliability is suspect. Recommend full servicing and evaluation to determine the feasibility of continuing their use, their status relative to modern safety requirements, and prospects for replacement.

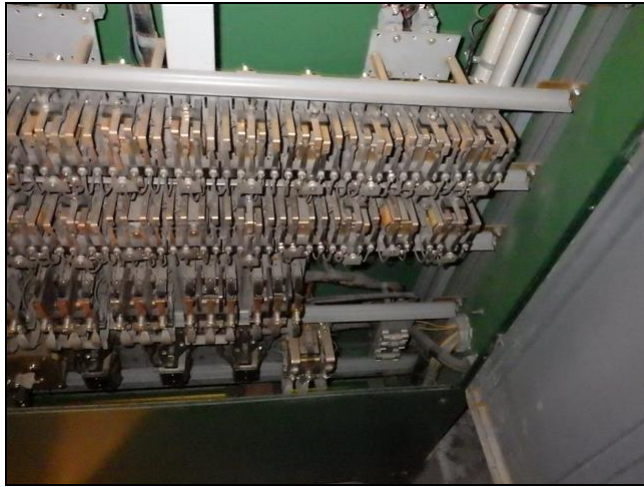
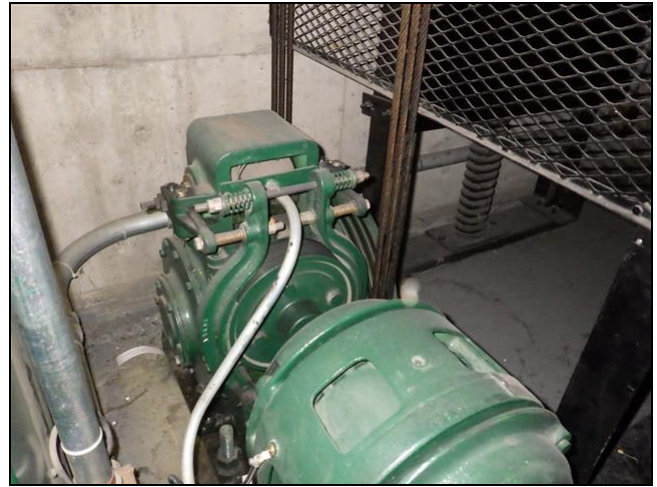
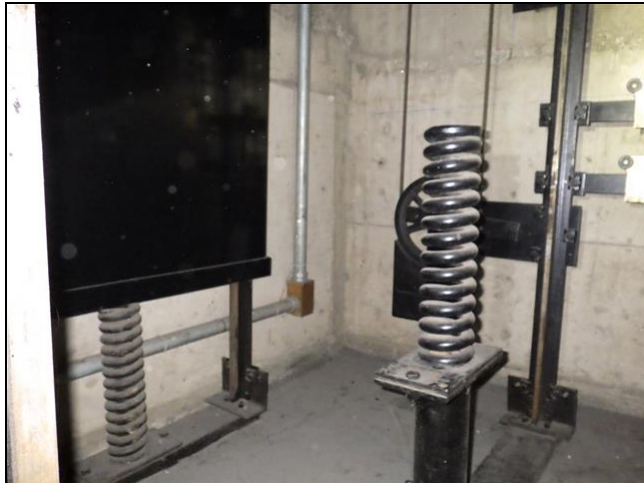
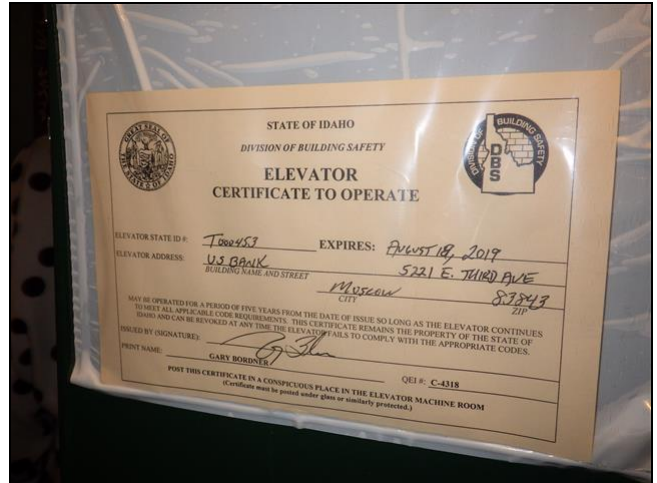
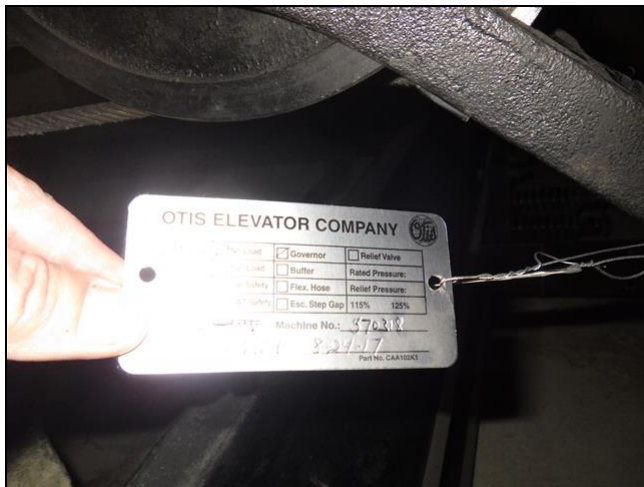
The elevator is an older model that uses electrical-mechanical relays for the controls. The motor and relays are located in a basement pit below the elevator itself. Inspections appear current but will expire soon. I recommend contacting the servicing company to re-certify the elevator and to assess the potential for adding an additional stop.

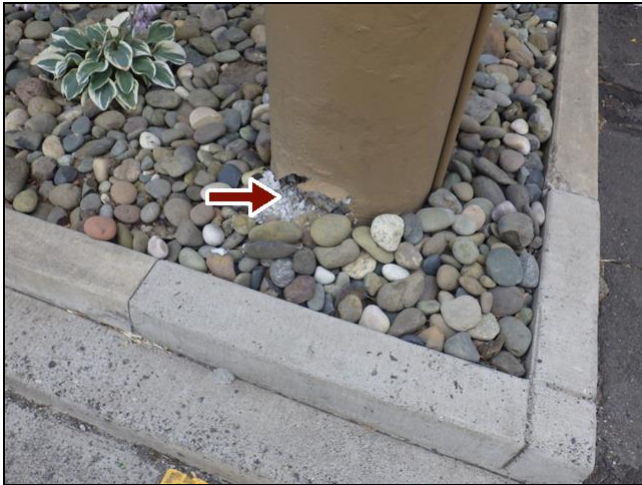
B. Item 4 (Picture)

(3) Minor damage was noted on two columns (east and west ends) that have spalled concrete and exposed rebar. This will lead to further degradation of the column base in time. Recommend repairs now by a licensed and qualified contractor.
