Inspection Report

Professional Investor

Safe@Home Inspections, LLC

**Paul Duffau, WA Lic#215 MT #HI0454
308 2nd Street
Asotin, WA 99402
208-596-1489**

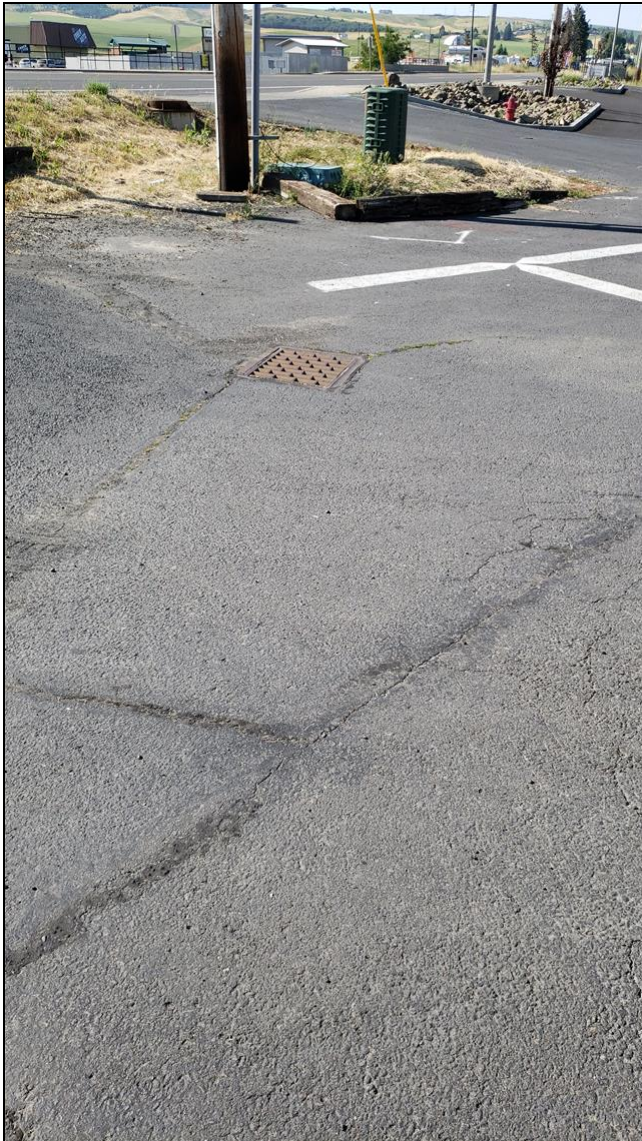
C. Item 1 (Picture)

(2) The front drain is slightly uphill from the building sharply limiting the effectiveness of the storm water drainage. This appears to leading to degradation of the asphalt parking lot and, due to location, possible degradation of the foundation of the front addition. Recommend repair by a licensed and qualified paving contractor.

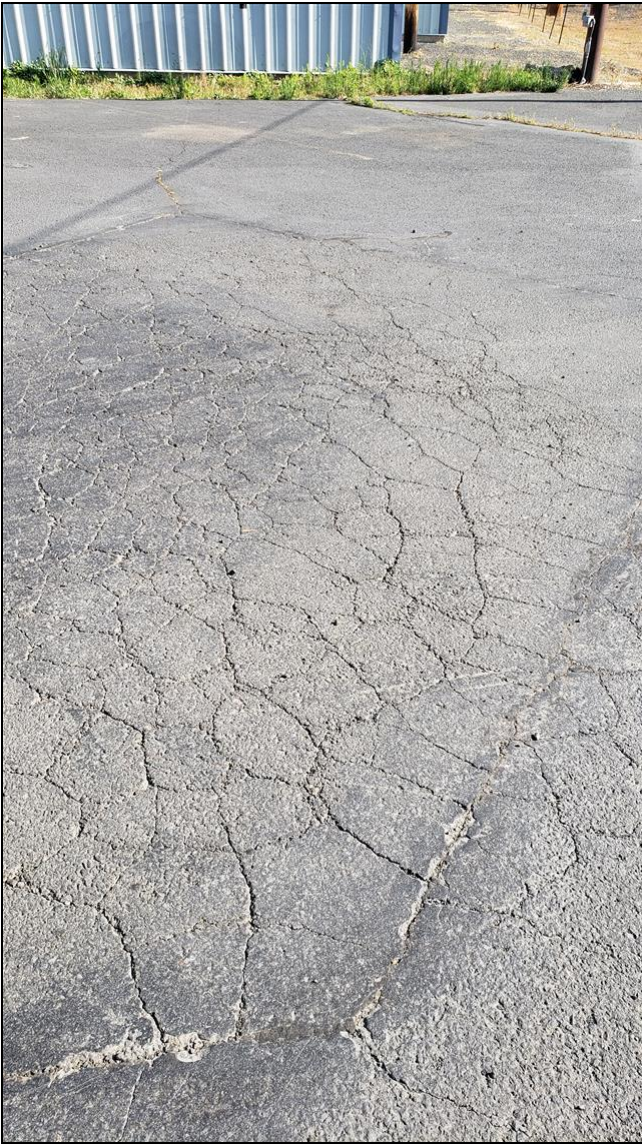
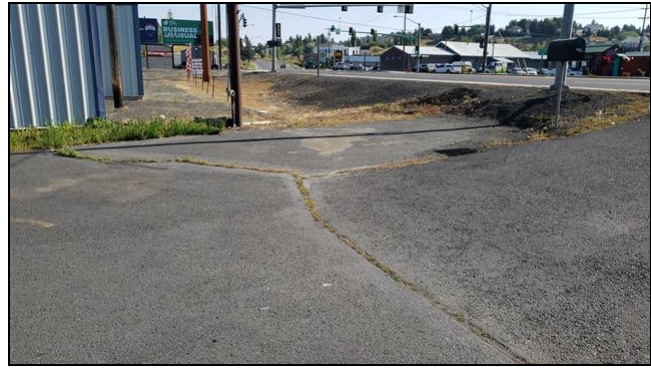
(2) The parking lots and drives are in very poor condition with extensive surface cracking, evidence of pumping that suggest the subgrade compaction is damaged, and evidence of previous repairs now failing. Striping is nearly non-existent in the front lot. Repairs are necessary on an immediate basis to limit further damage.

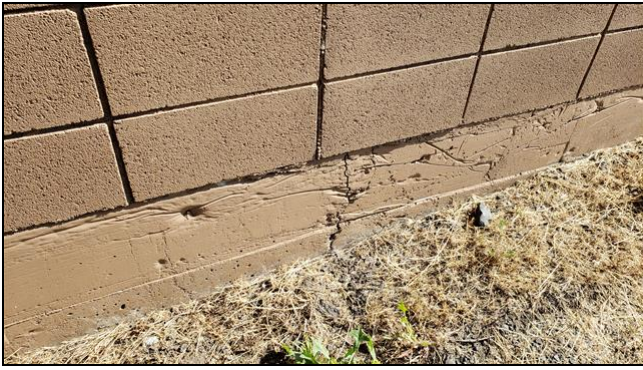
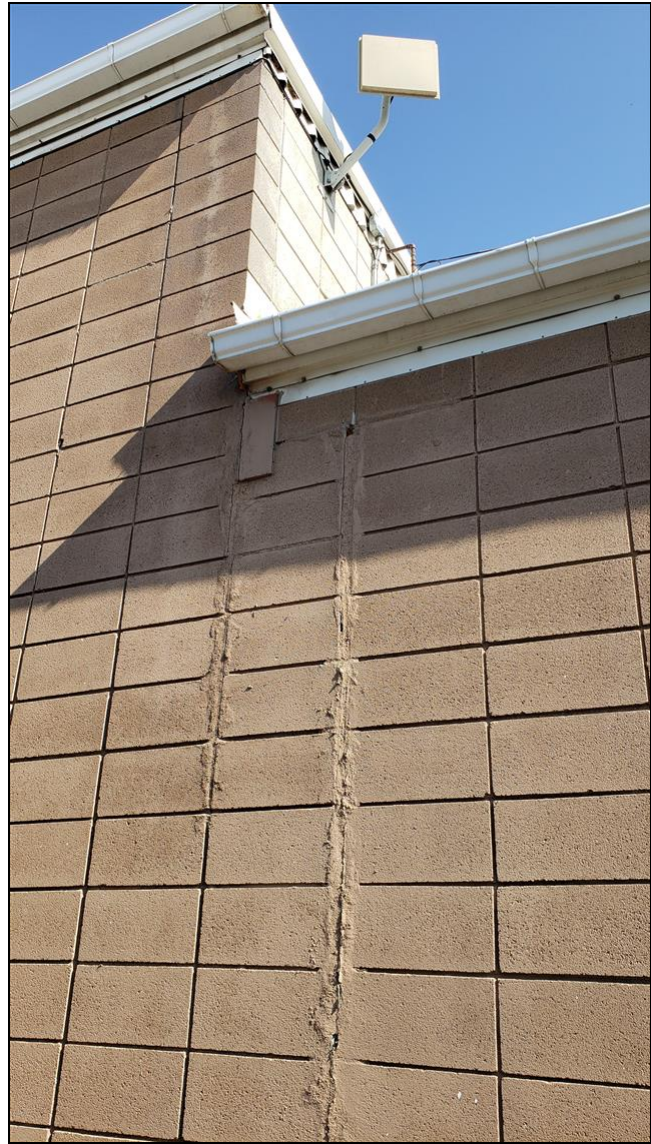
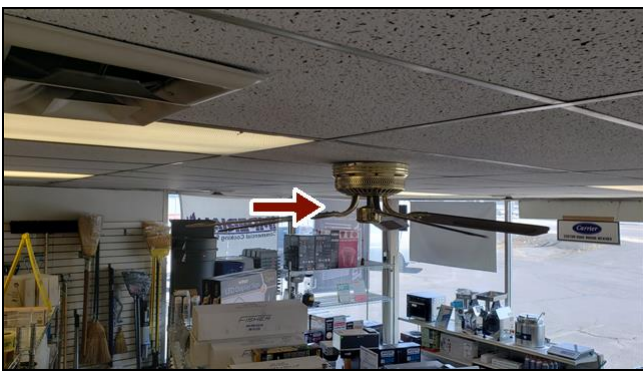
(2) A structural crack in the foundation wall at left side was observed. This crack translates up the masonry wall and shows differential hinging movement. The crack is large enough or has sufficient differential movement to be a concern. The corner of the addition slab opposite the crack has settled. Recommend evaluation by a structural engineer to fully determine the scope of the issues. All recommendations made by the engineer should be completed by a licensed and qualified contractor.

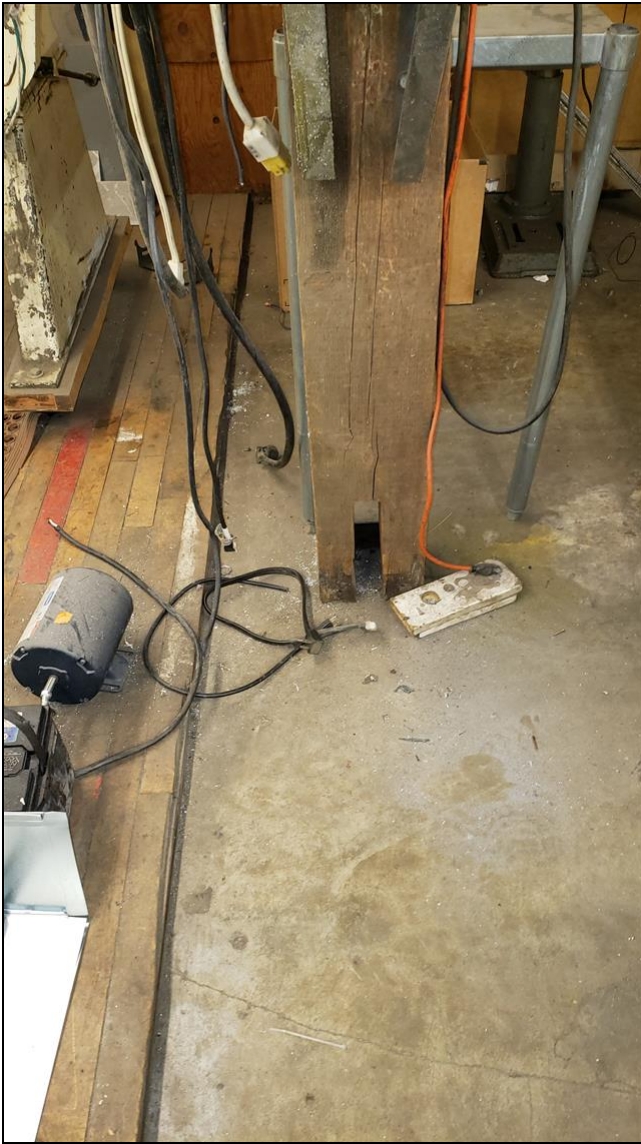
C. Item 1 (Picture)

(1) It appears that the sub-structure framing for the loft/mezzanine appears to be constructed of columns that were recycled from another building.

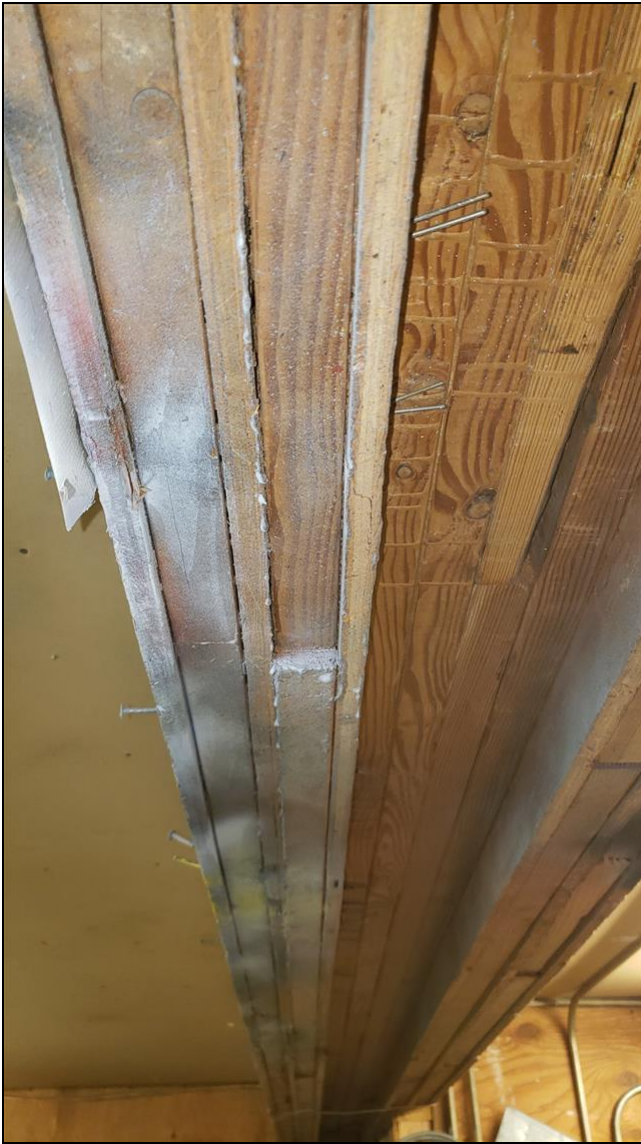
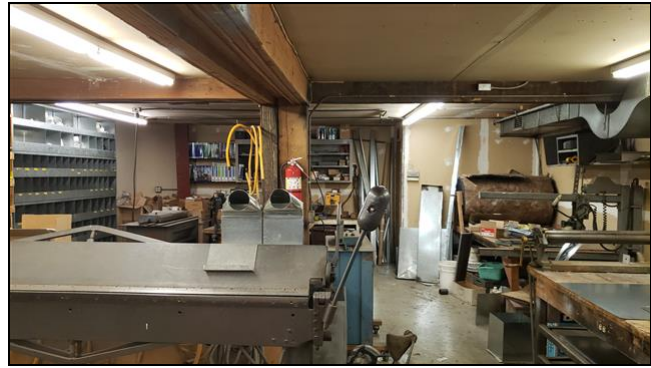
(2) Beam structures were improperly constructed laminate systems. They lack columns under splices and are significantly sagging. Recommend evaluation

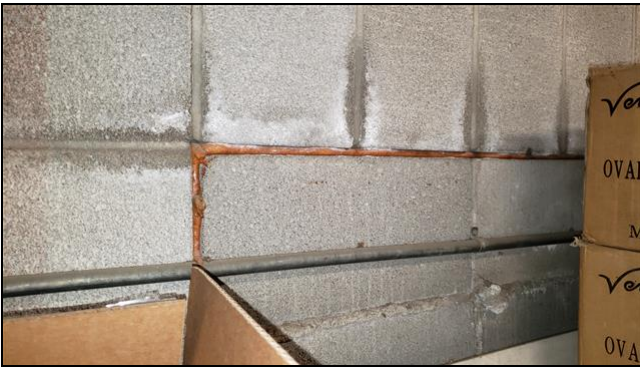
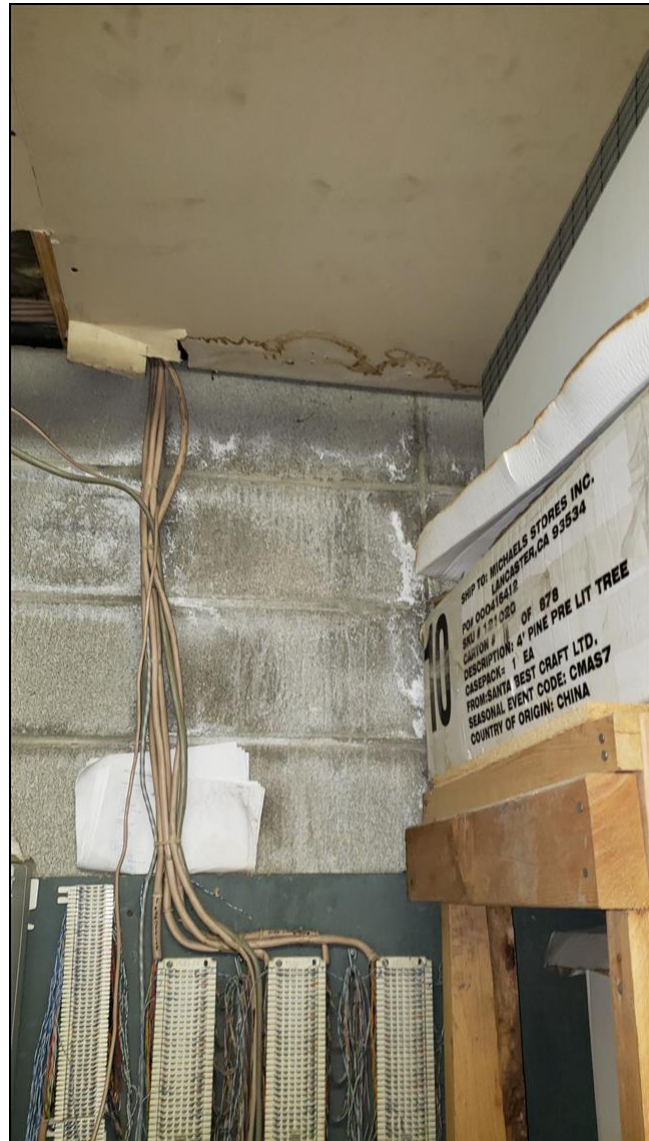
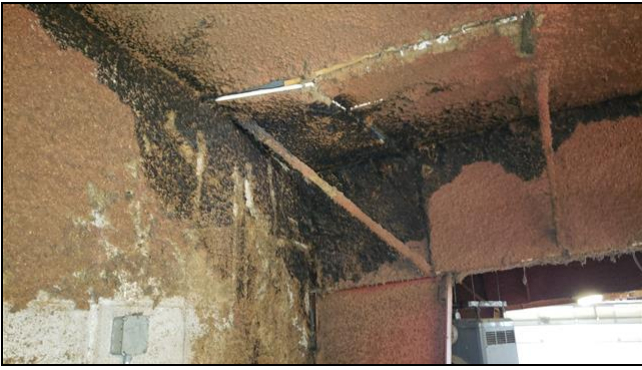
(2) There was extensive water intrusion at the masonry walls evident by the efflorescence on the wall and the detachment of spray applied insulation. In one location, it appears that this intrusion may have triggered fungal growth. Recommend correction of intrusion and evaluation of the suspected fungal growth.

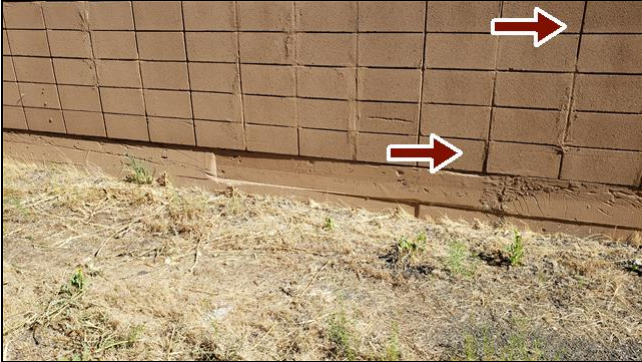
E. Item 4 (Picture)

(3) Mortar for the masonry work is deteriorating in several areas. Recommend repair.

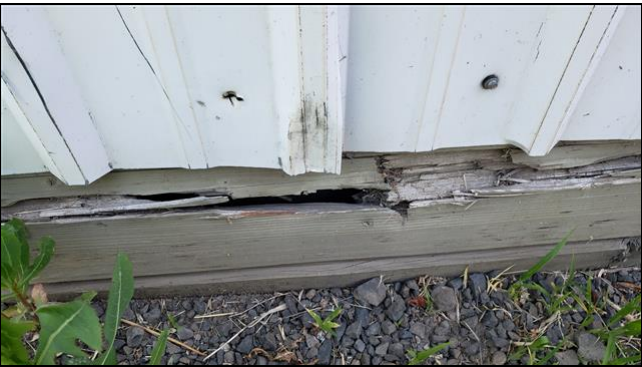
F. Item 1 (Picture)

(2) Wood rot noted on the skirting at the base of the pole barn. Recommend replacement of all damaged wood with sound materials.

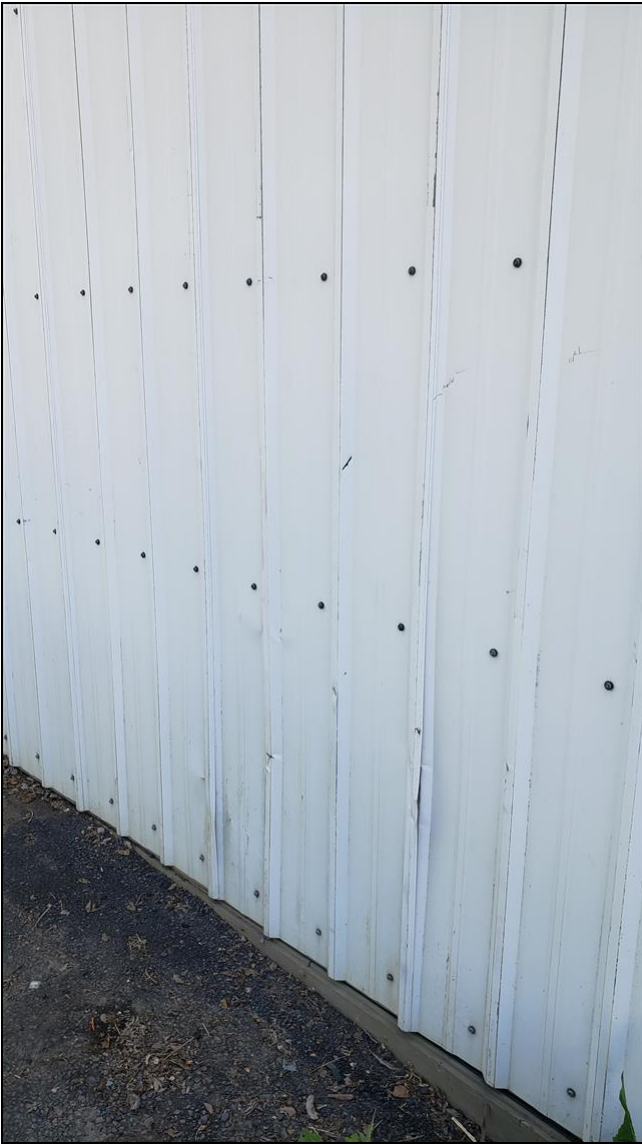
F. Item 2 (Picture)

(3) The siding had loose, protruding or missing fasteners at the rear addition visible at the time of the inspection. Minor dents and holes present. This condition should be corrected to avoid wind damage and/or damage from moisture intrusion.

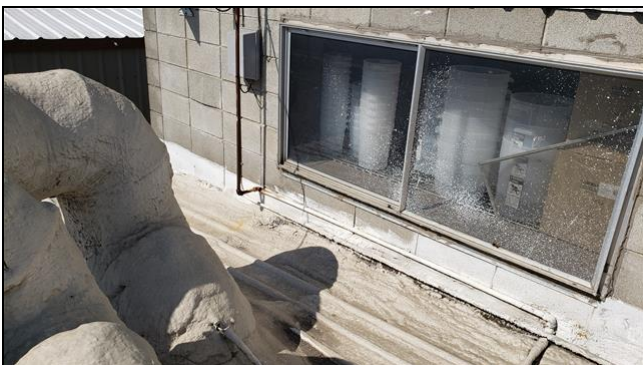
H. Item 1 (Picture)

(2) The upper windows were poorly installed without flashing and are due for replacement.

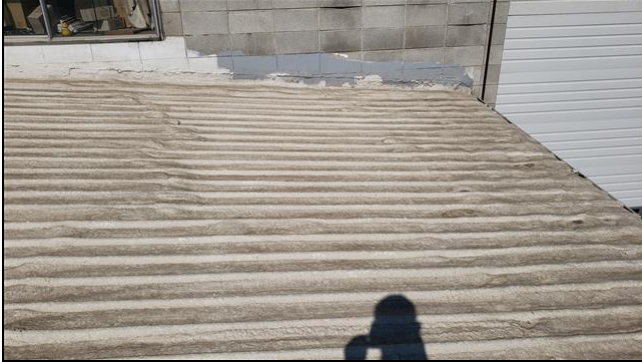
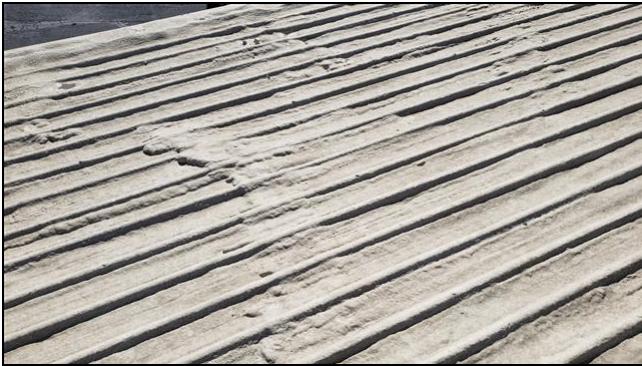
(1) The roof covering was a lapped metal panel system with exposed screws or nails for fasteners. The typical lifespan of these panels is 30-60 years depending on the quality of the initial material, the quality of the installer, the quality of maintenance, and environmental conditions. A spray-applied insulation product has been placed on the roofing panels with an additional elastomeric coating painted on.

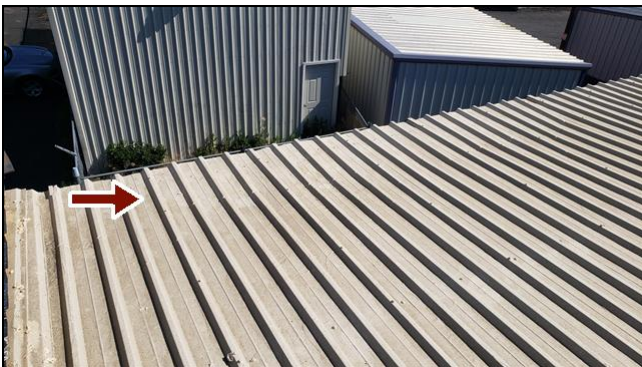
J. Item 4 (Picture)

(2) The roofing covering materials are approaching the end of their service life. Some areas are in worse condition than others. Materials in several areas show mechanical damage. While the roof may have some serviceable life left and does not appear to be currently leaking, an evaluation is needed to determine what repairs can be completed at this time and how much longer the roof will last. That evaluation should include the costs associated with any necessary repairs, as well as estimates of remaining service life of the materials. All work should be completed by a licensed and competent roofing contractor.

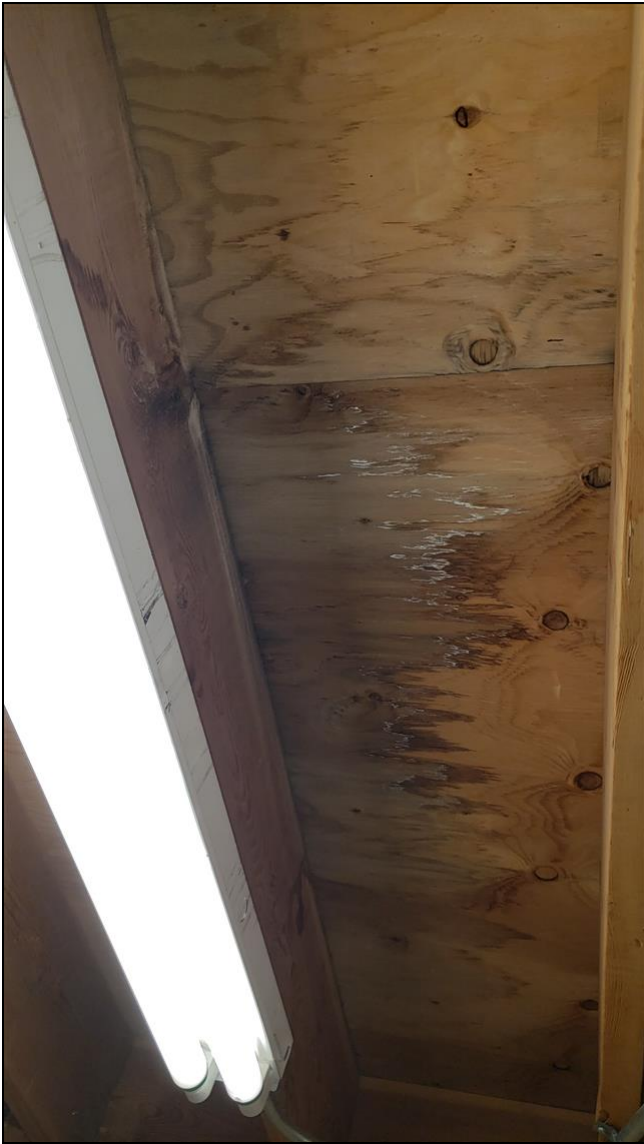
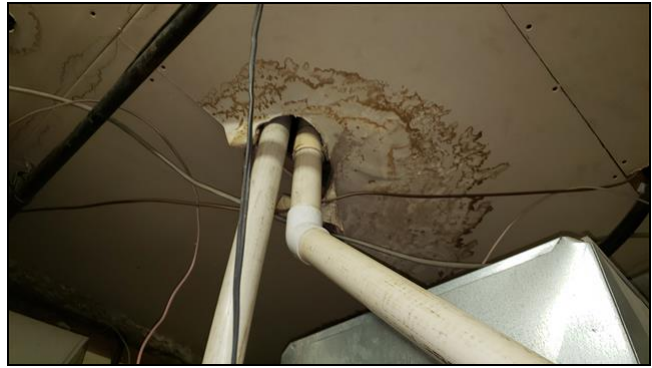
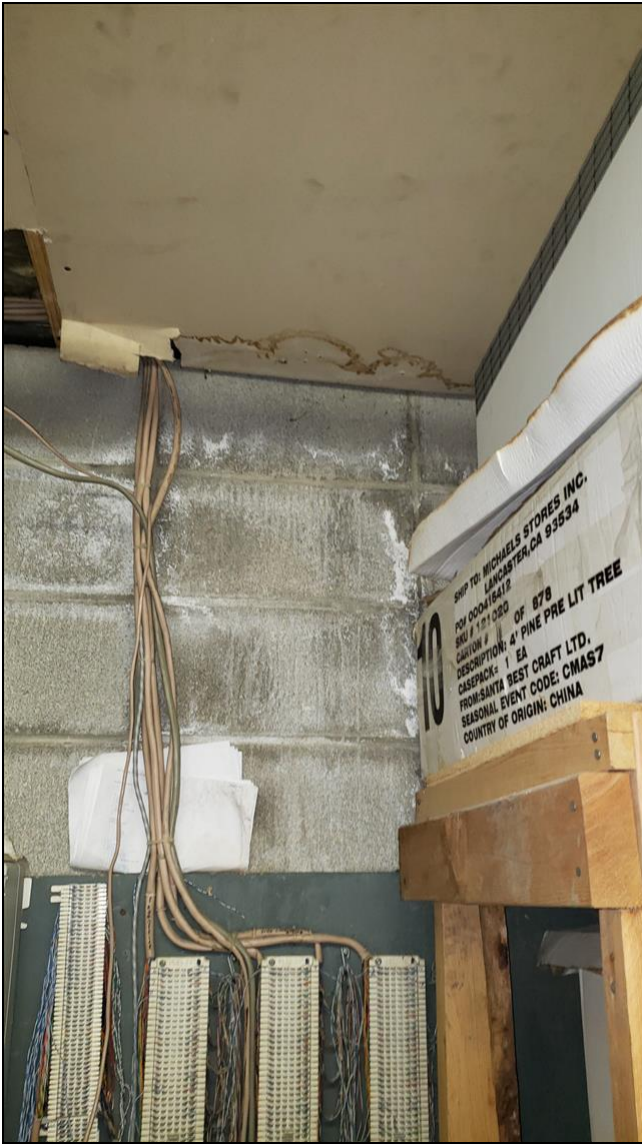
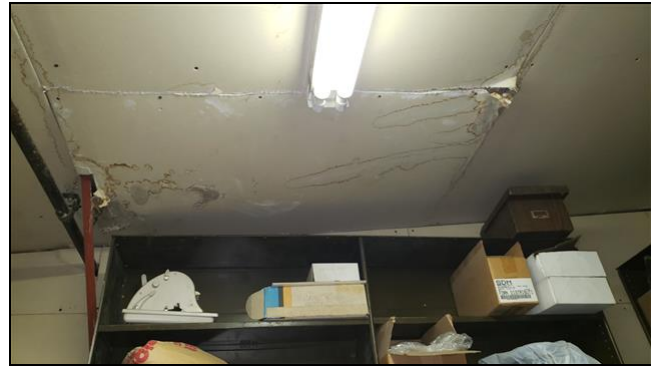
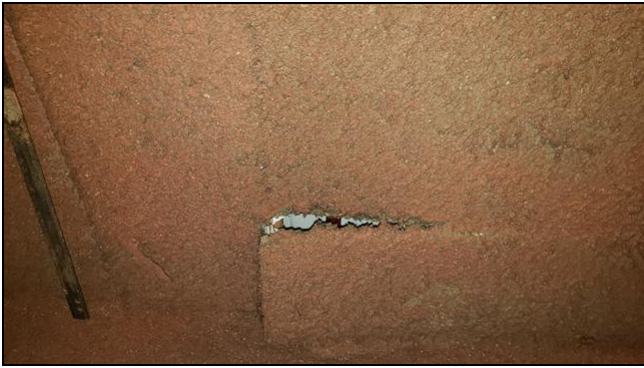
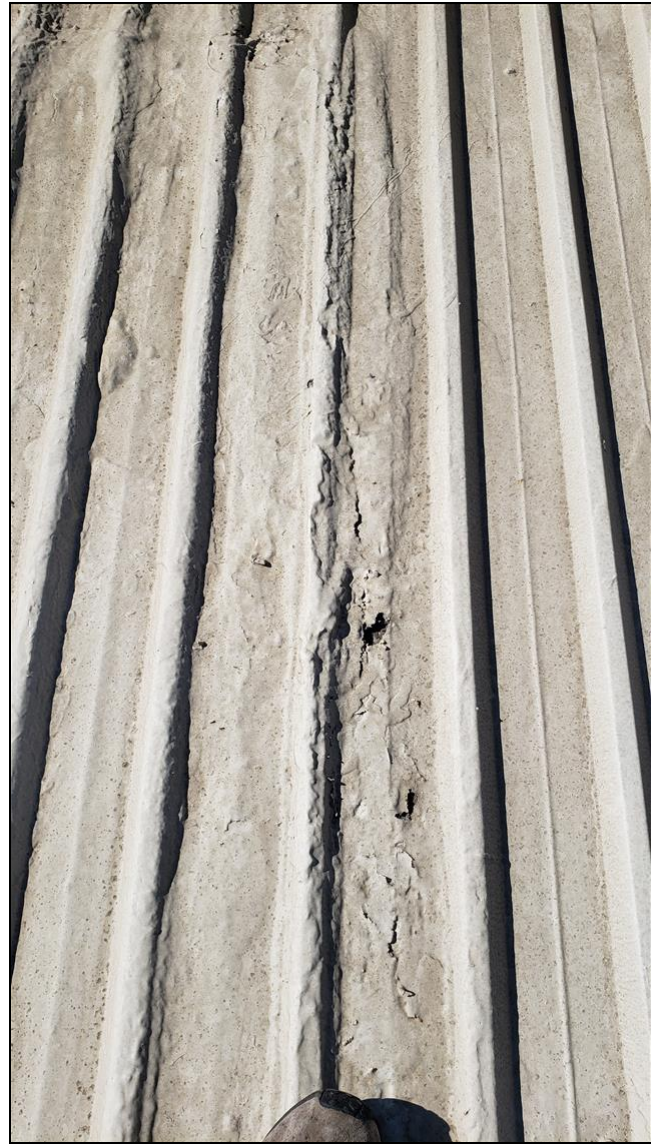
(3) Extensive leaking of the roof noted as evident by the multitude of stains inside the structure. Deterioration of the roofing coatings noted in multiple areas.

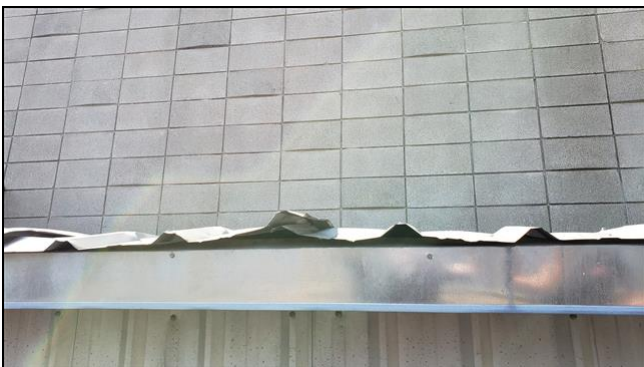
J. Item 11 (Picture)

(5) Loose, protruding or missing fasteners visible by movement noted at the time of the inspection. This condition should be corrected to avoid wind damage and/or damage from moisture intrusion. This condition will be challenging to correct with the coatings present. Recommend repair by a licensed and qualified roofing contractor.

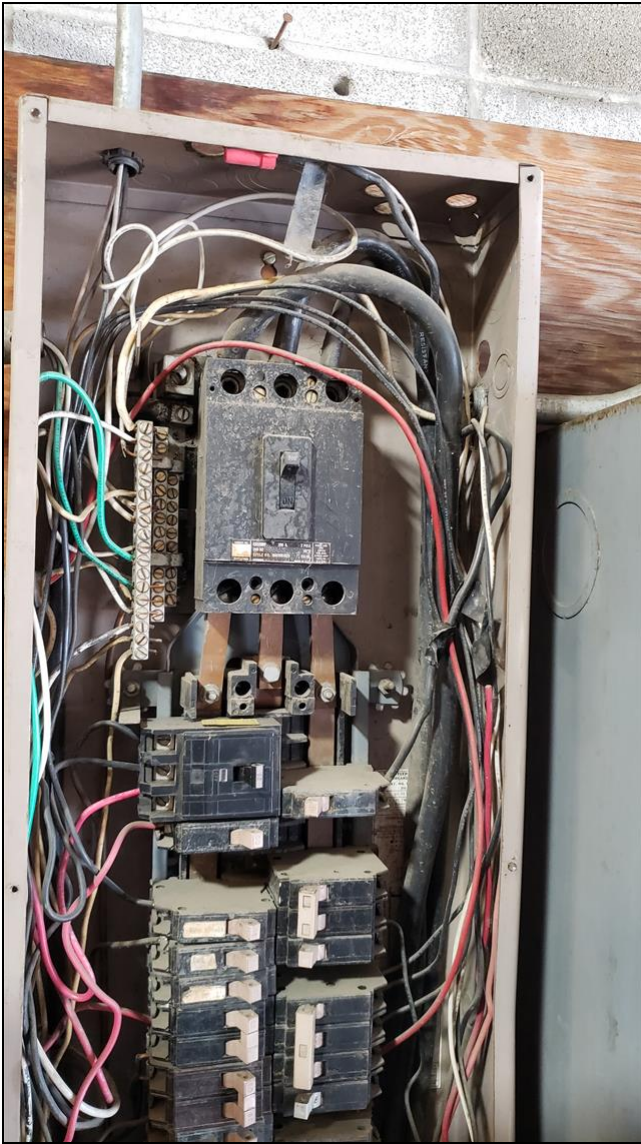
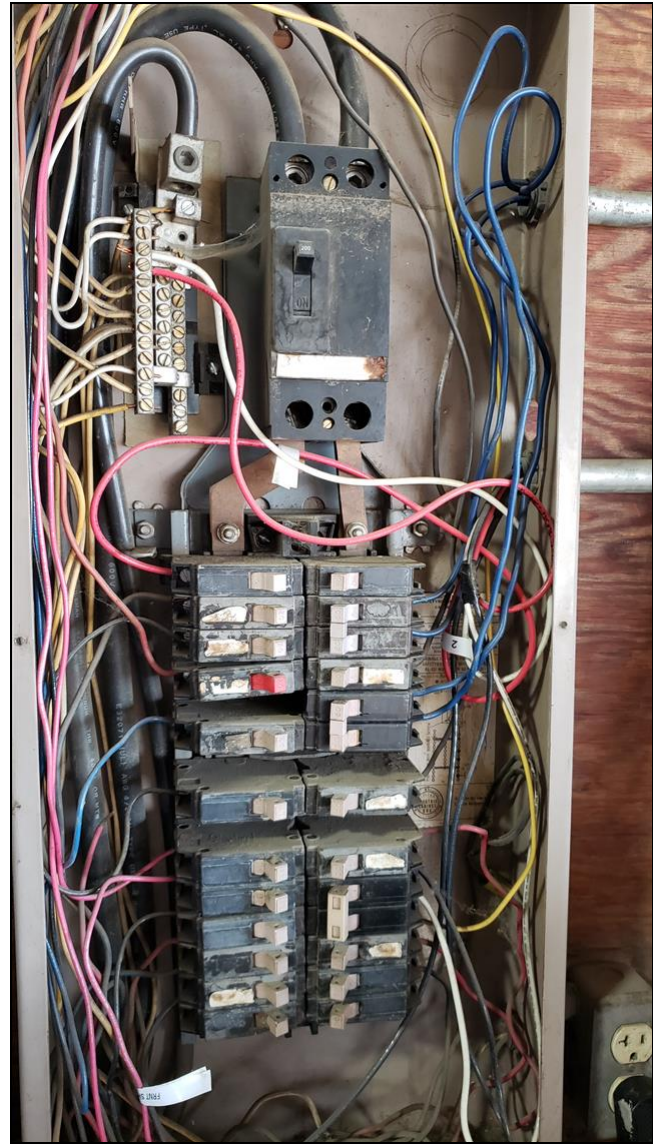
(1) Electrical power ran from the interior transfer box to a pair of Cutler-Hammer electric panels that appear original located in the garage portion of the building. One panel was rated at 200amp with 120/240/480 capacity. The second panel was rated at 200amps and 120/240v.

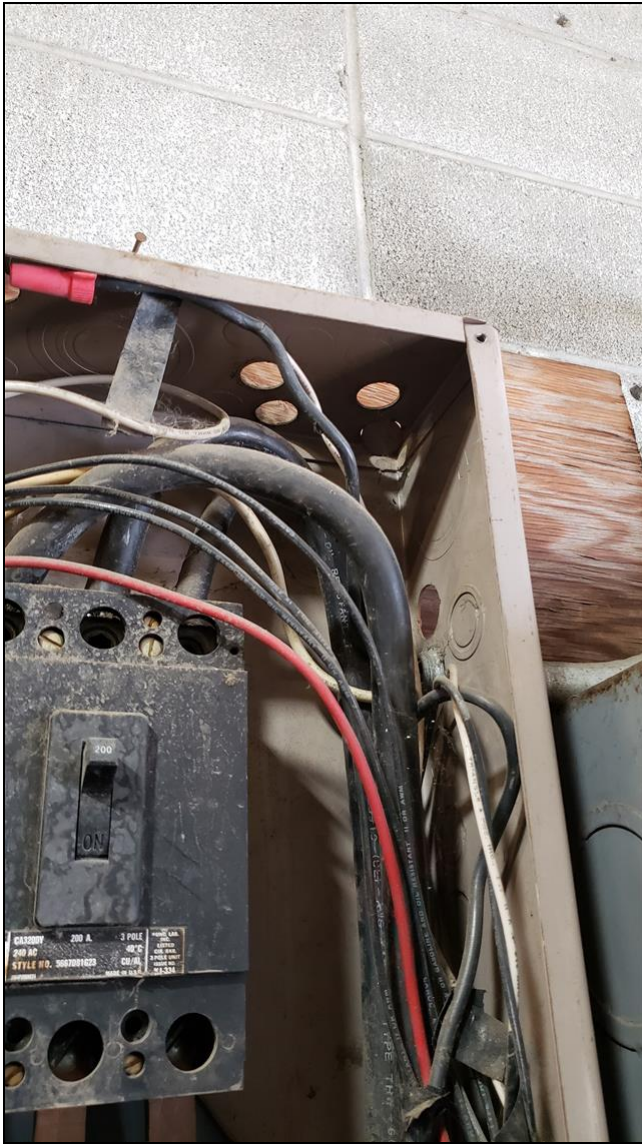
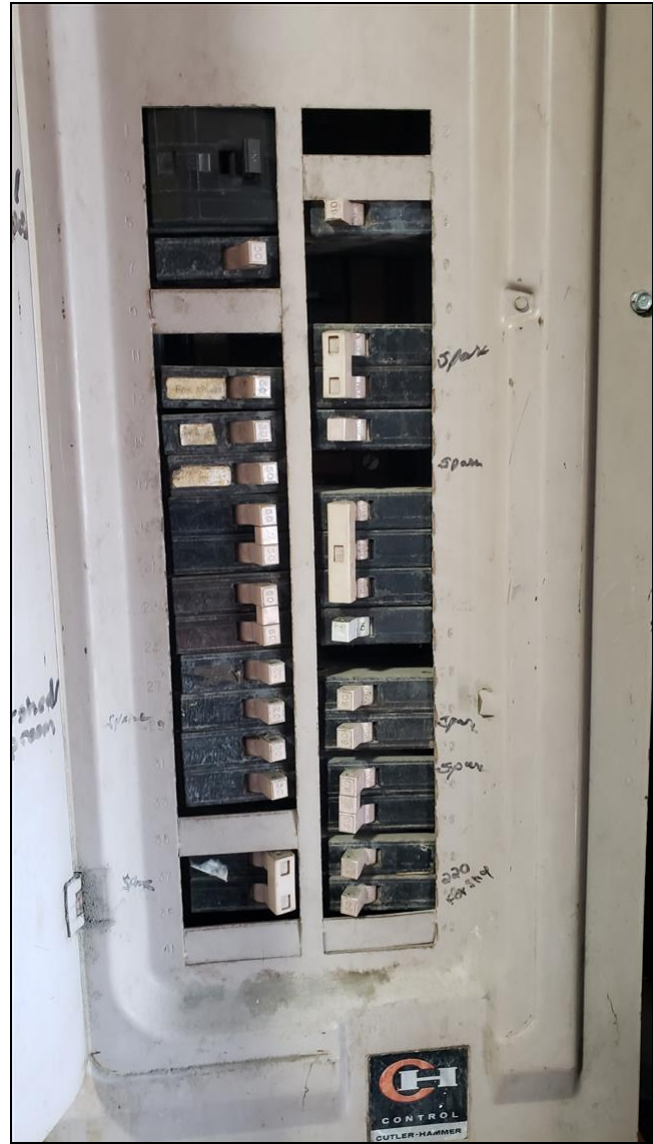
(3) Unfilled holes or knockouts in the main electrical service panel may allow persons to come into contact with energized electrical components. This condition is a potential shock/electrocution hazard and should be corrected by a licensed and qualified electrical contractor.

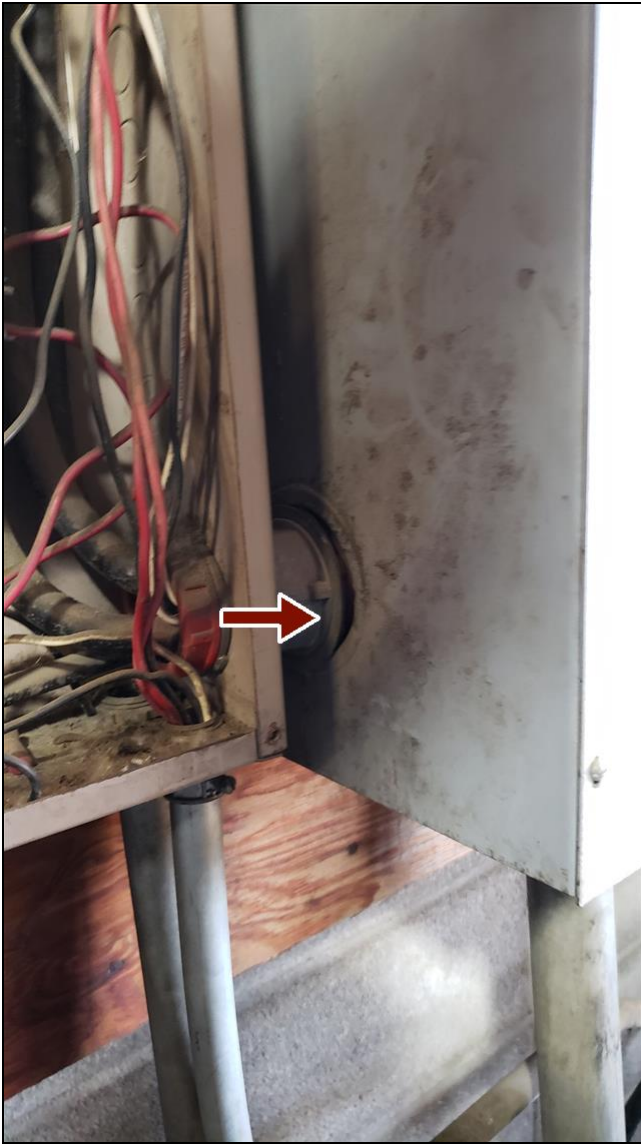
A. Item 5 (Picture)

(5) The two conduits for the service feeds to the panels from the transfer box are open. Recommend repair.

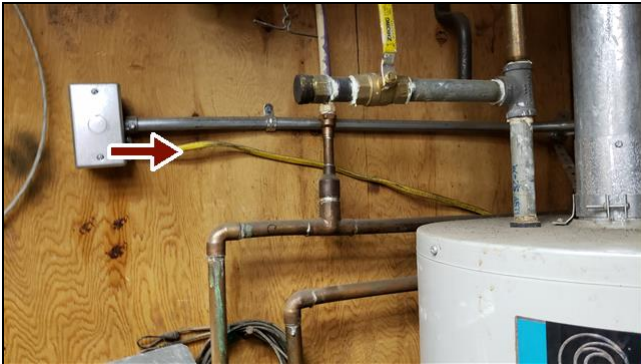
B. Item 1 (Picture)

- (1) Missing covers noted on junction boxes, switches, or receptacles in multiple locations. This is a potential shock hazard. Recommend having a competent handyman/homeowner install covers in all locations where necessary. Not every location may be noted within the report due to access issues.
- (2) The wiring in several areas appears to have been installed by a person unfamiliar with good electrical practices. Wiring is exposed to damage and the junction boxes are missing bushings. Recommend evaluation by a licensed and qualified electrical contractor.

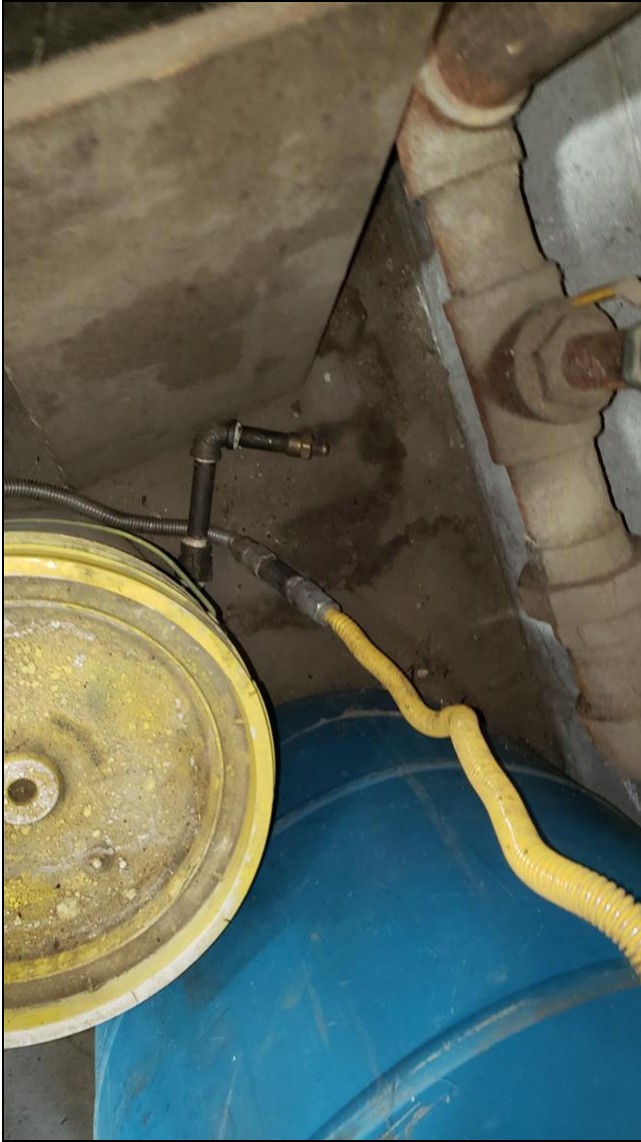
B. Item 1 (Picture)

Several gas pipes were not capped though turned off. This is a safety hazard if the knob gets bumped as gas could be released into the building. Recommend capping.

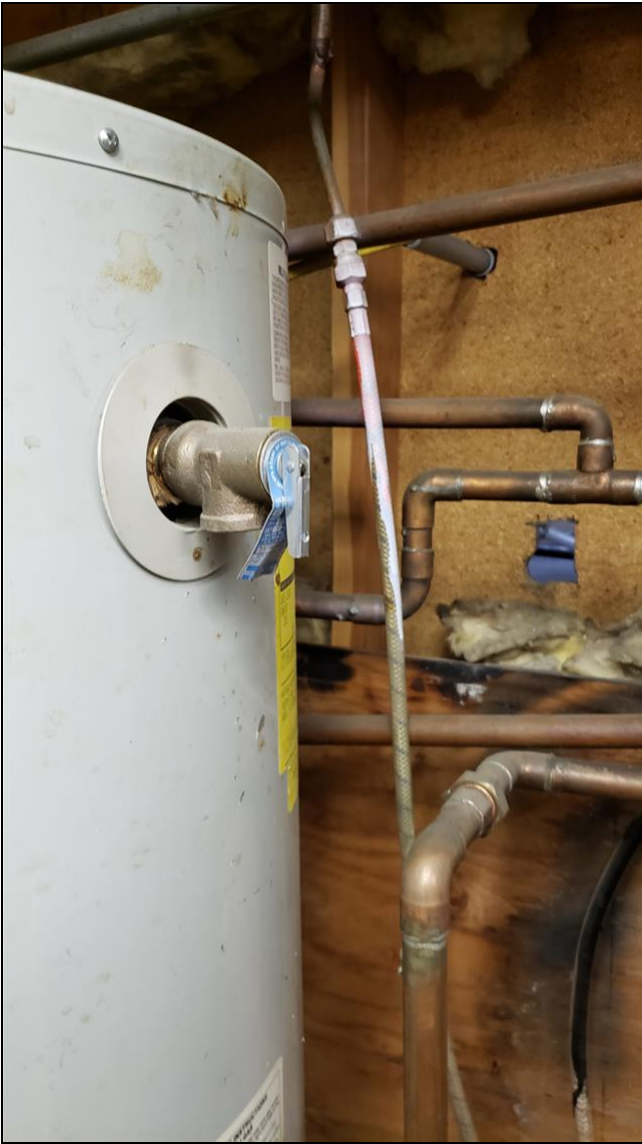
E. Item 1 (Picture)

The TPR valve on water heater needs a proper extension to extend within 6 inches of floor or other approved location visible to occupants. I recommend repair by a licensed and qualified plumbing contractor.

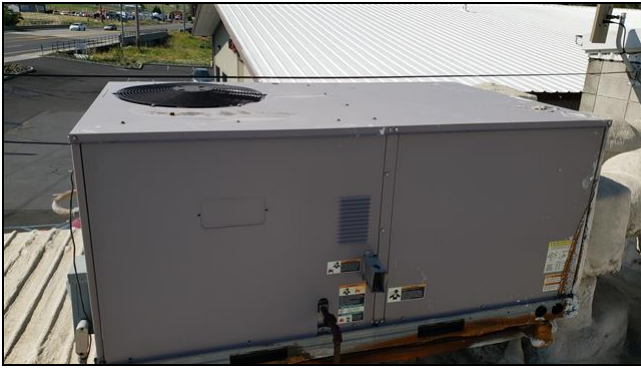
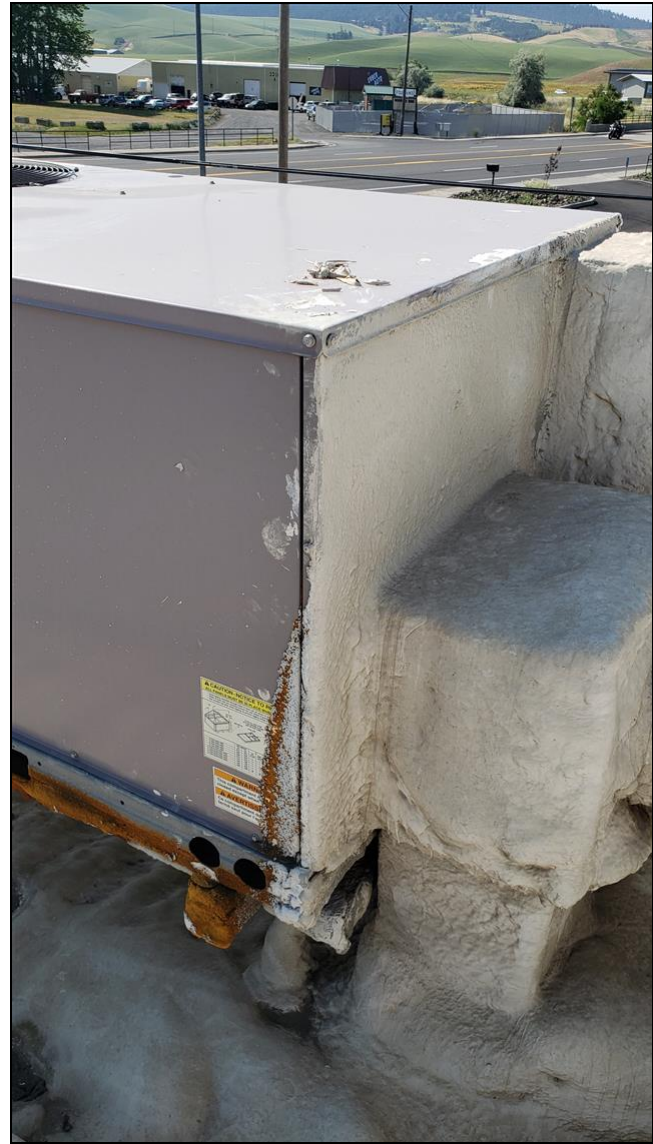
There was a single roof-top unitary system present. The data tag was covered in spray applied insulation. It appears to a Carrier unit that is approximately 20 years old.

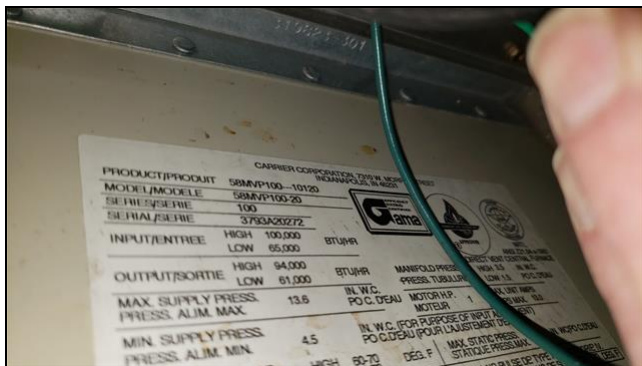
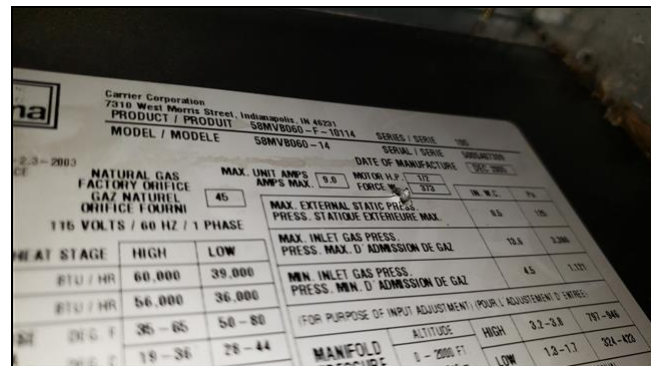
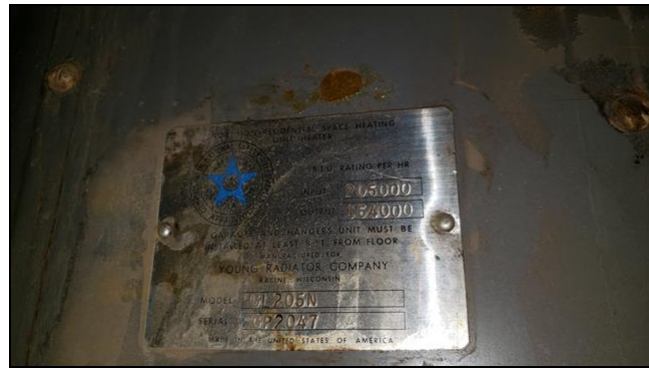
(1) This building has three high-efficiency gas-fired condensing furnaces. These furnaces are typically 90% to 98.5% efficient (AFUE). The combustion chambers are sealed, and the heat extracted from the burnt gases causes water vapor to return to a liquid state. These furnaces discharge water to a condensate pump or drain when operating. Two furnace were Carrier systems located in the loft area. These were 18 and 30 years old and rated at 100,000 and 60,000 BTUs respectively. One furnace was a Lennox system that is 24 years old and rated at 75,000BTUs.

There was one ceiling mounted induced draft furnace present. This was manufactured by Young Radiator Company and rated at 205,000 BTUs.

(2) Two condensing furnaces are 20+ years old which is substantially beyond a normal service life (15-20 years per the NAHB). The ceiling mounted furnace appears to older than 20 years. They are overdue for replacement. Recommend doing so now.

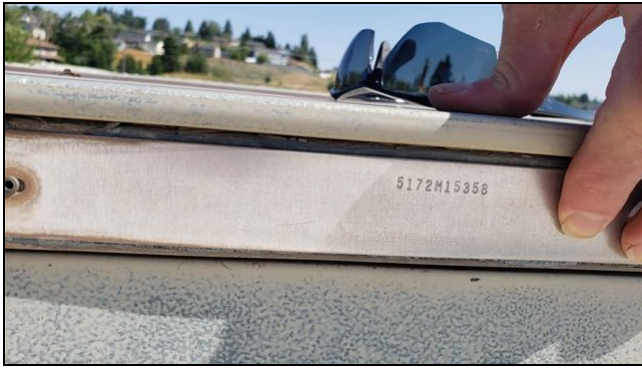
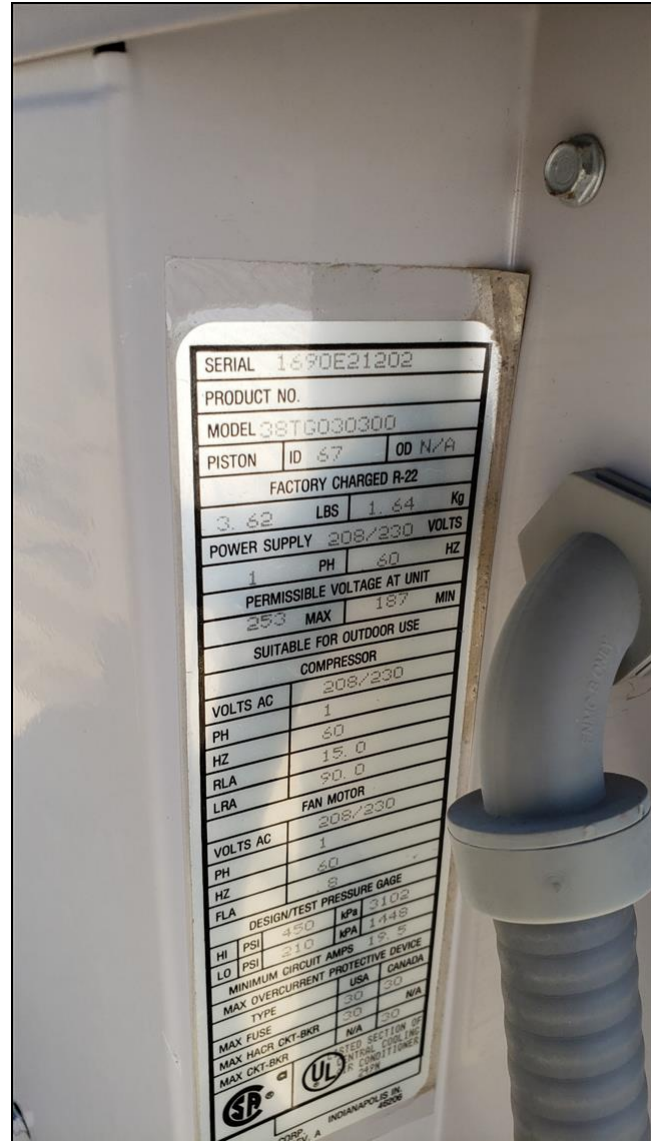
One system was a Lennox which was 50 years old. The second was a Carrier that was more than 30 years old.

(5) Both air conditioners exceed a normal service life. Recommend replacement.

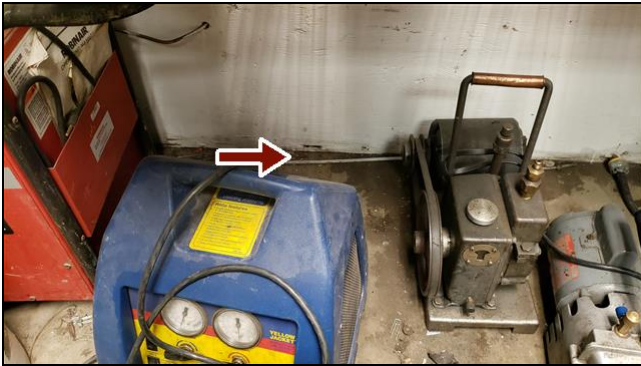
B. Item 1 (Picture)

(2) Water damage noted at the base of the walls in the utility room with the water heater.

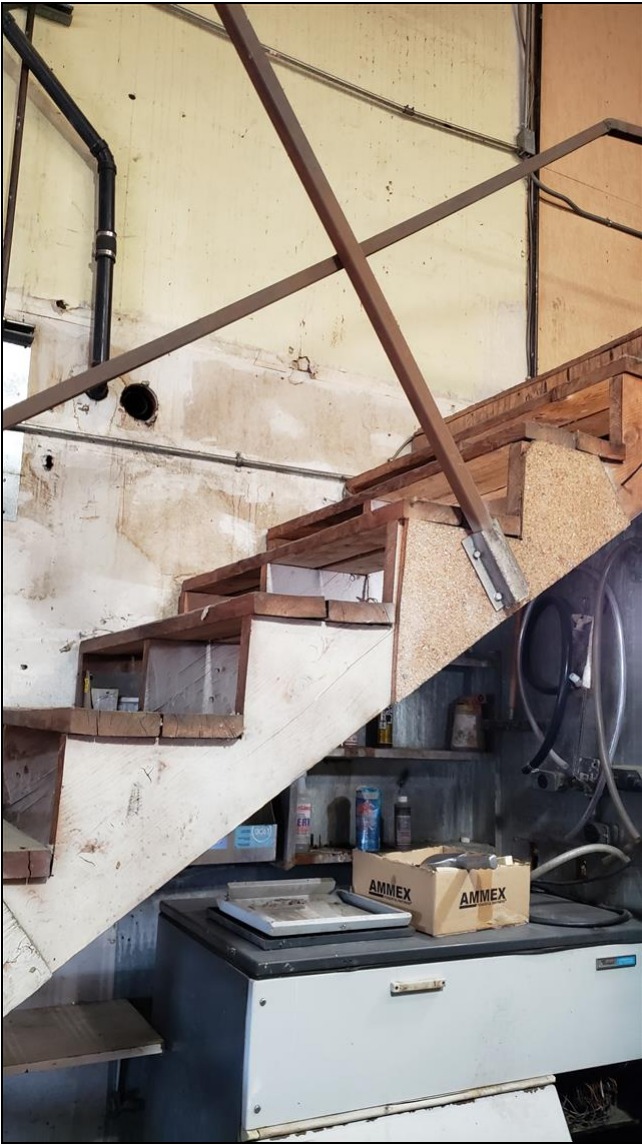
E. Item 1 (Picture)

(1) The handrails and guardrails had baluster spacings larger than 4 3/8". This can permit a small child to get their head stuck or fall through. Recommend correction when feasible.
