Inspection Report

Professional Investor

Safe@Home Inspections, LLC

**Paul Duffau, WA Lic#215 MT #HI0454
308 2nd Street
Asotin, WA 99402
208-596-1489**

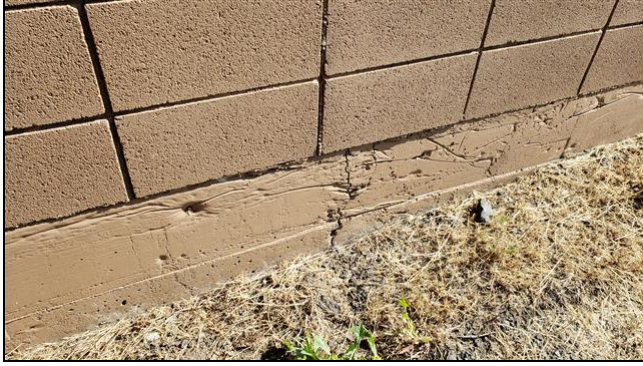
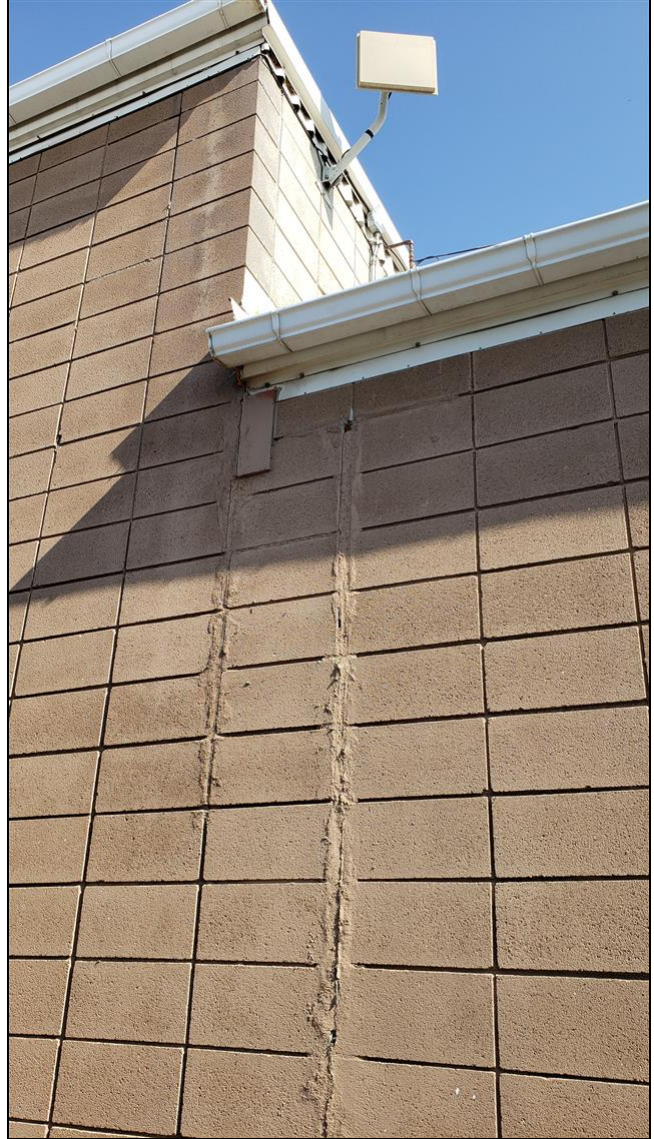
concern. The corner of the addition slab opposite the crack has settled. Recommend evaluation by a structural engineer to fully determine the scope of the issues. All recommendations made by the engineer should be completed by a licensed and qualified contractor.

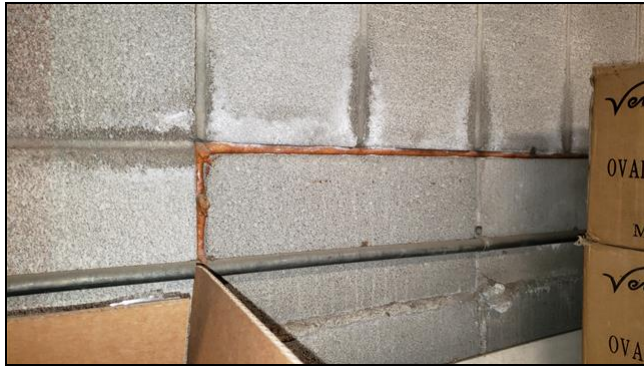
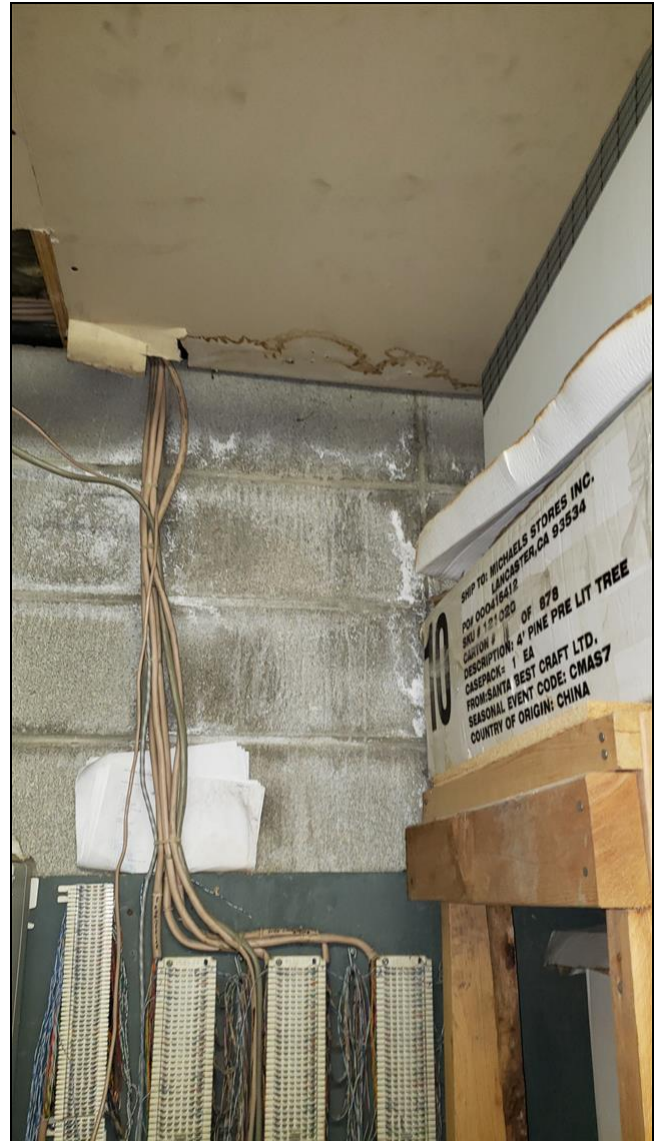
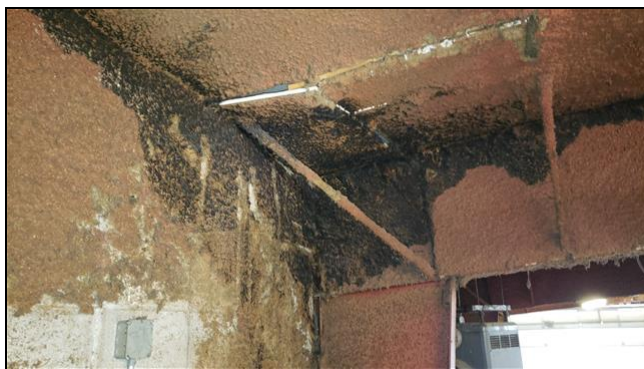
(2) There was extensive water intrusion at the masonry walls evident by the efflorescence on the wall and the detachment of spray applied insulation. In one location, it appears that this intrusion may have triggered fungal growth. Recommend correction of intrusion and evaluation of the suspected fungal growth.

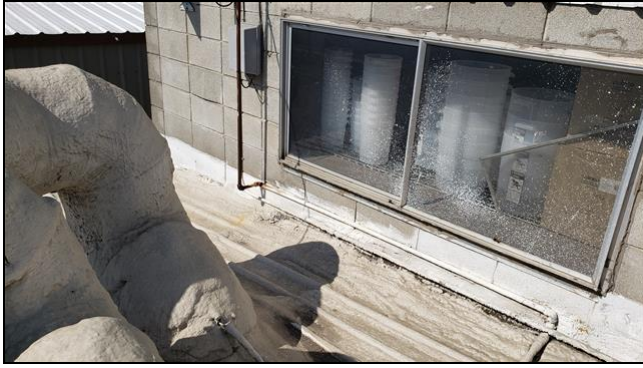
H. Item 1 (Picture)

(2) The upper windows were poorly installed without flashing and are due for replacement.

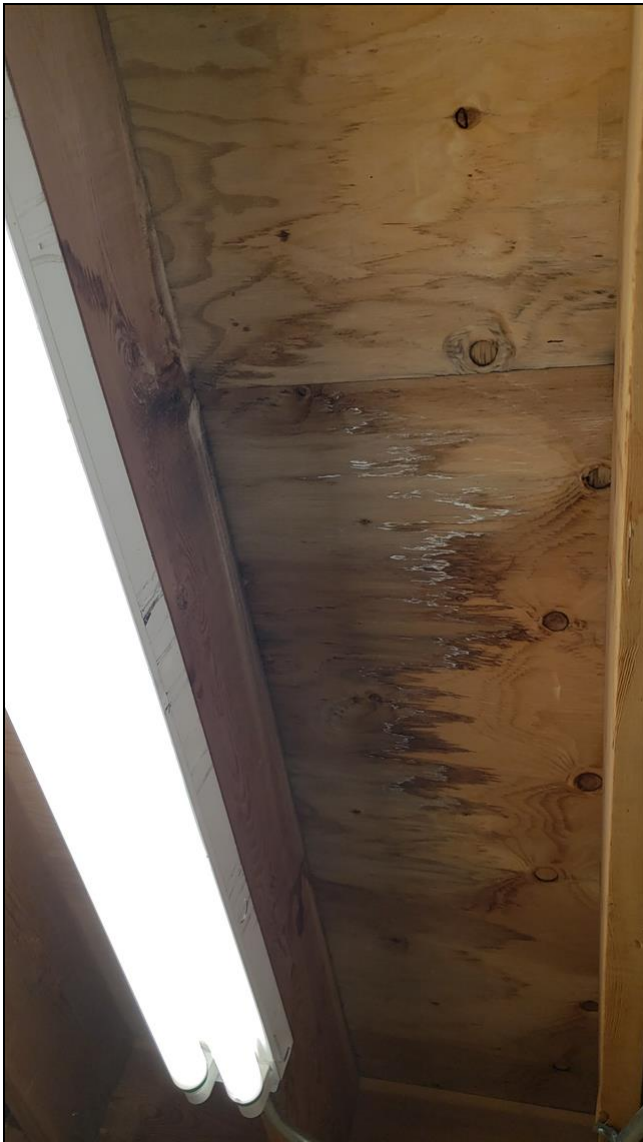
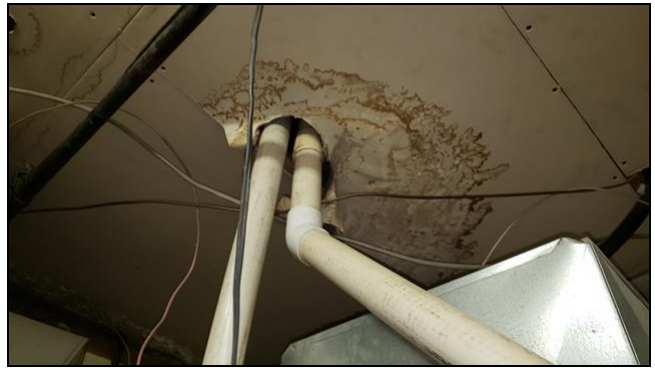
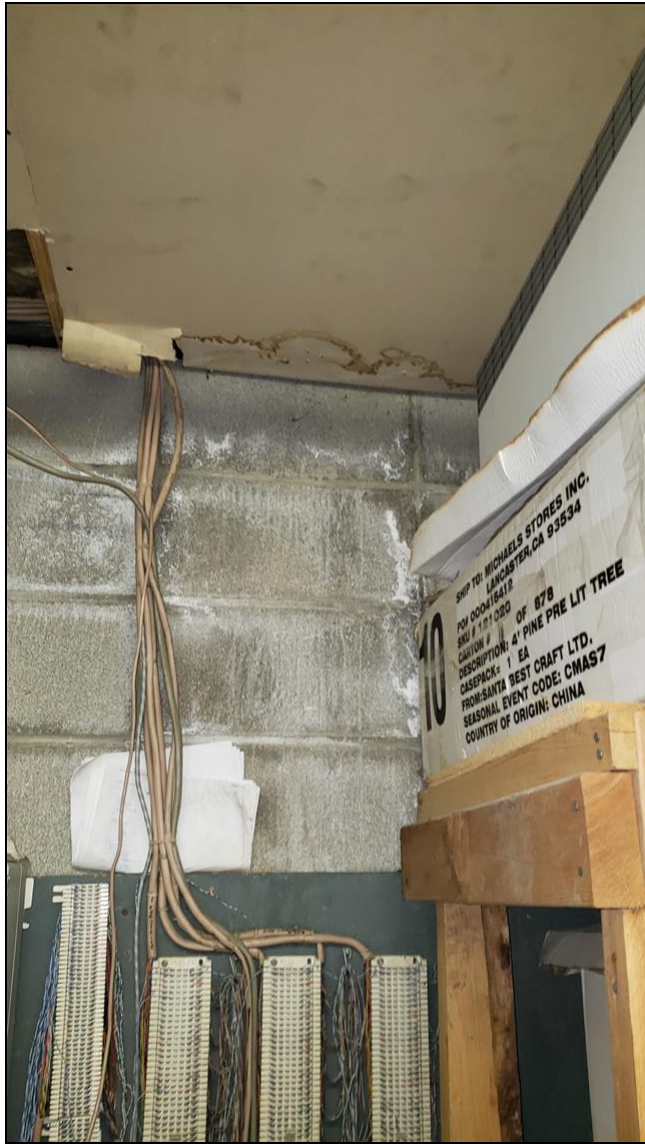
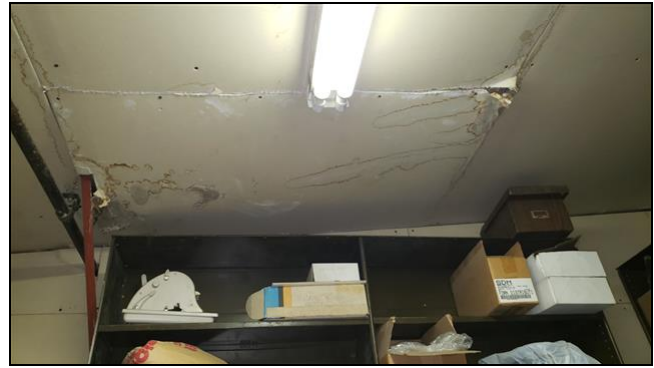
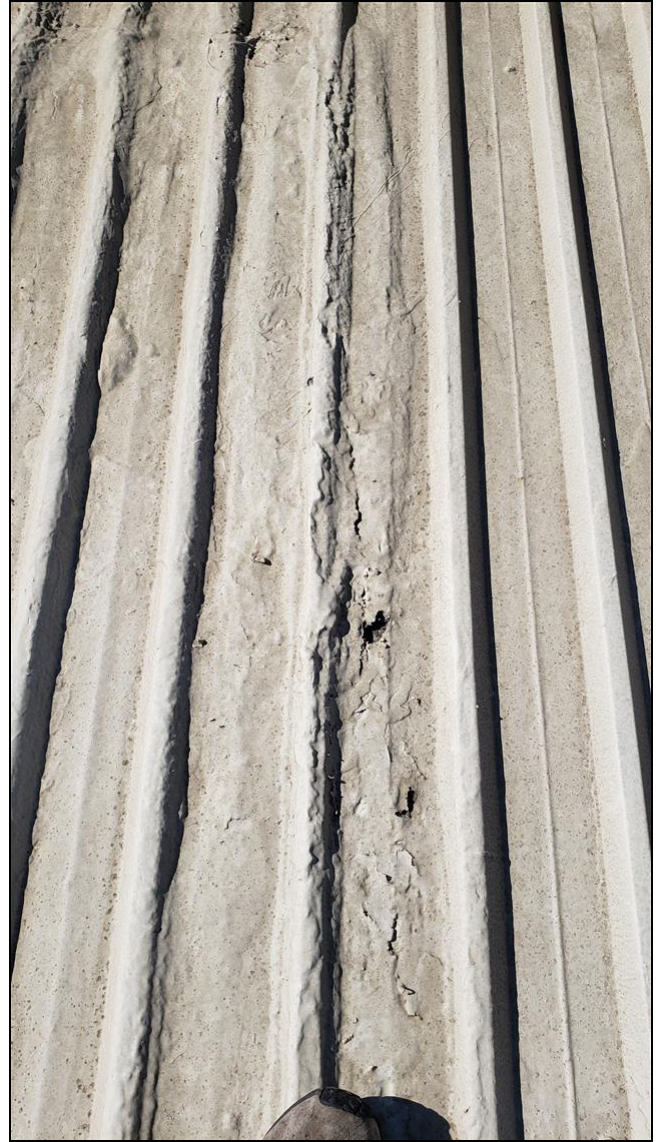
(3) Extensive leaking of the roof noted as evident by the multitude of stains inside the structure. Deterioration of the roofing coatings noted in multiple areas.

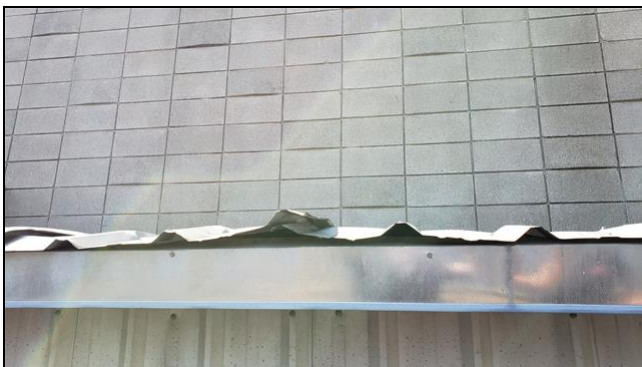
J. Item 11 (Picture)

(5) Loose, protruding or missing fasteners visible by movement noted at the time of the inspection. This condition should be corrected to avoid wind damage and/or damage from moisture intrusion. This condition will be challenging to correct with the coatings present. Recommend repair by a licensed and qualified roofing contractor.

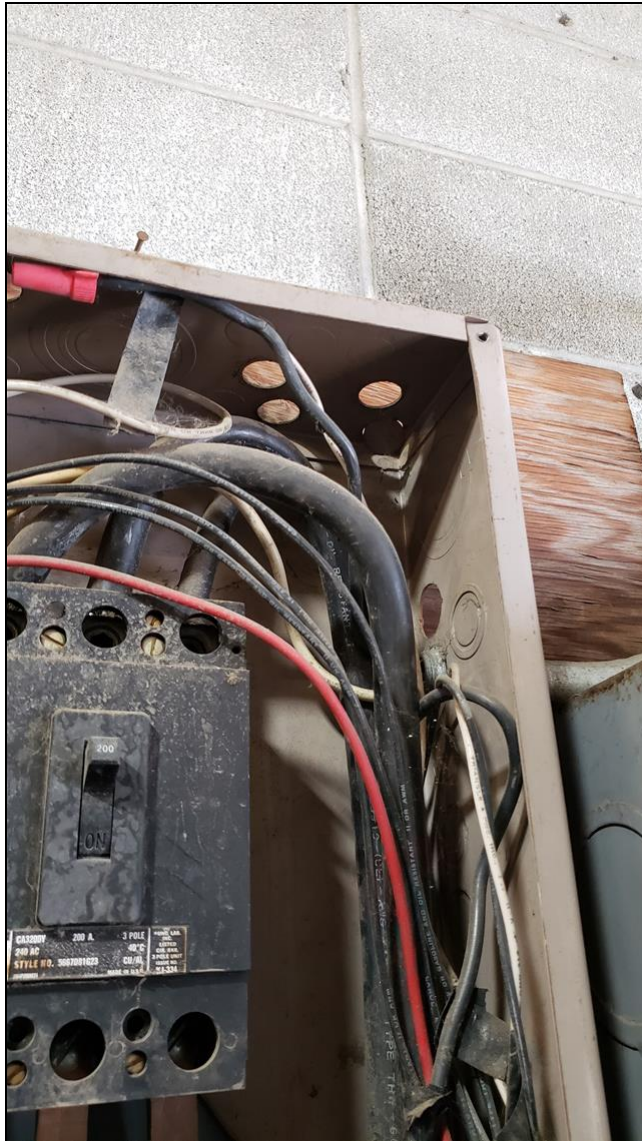
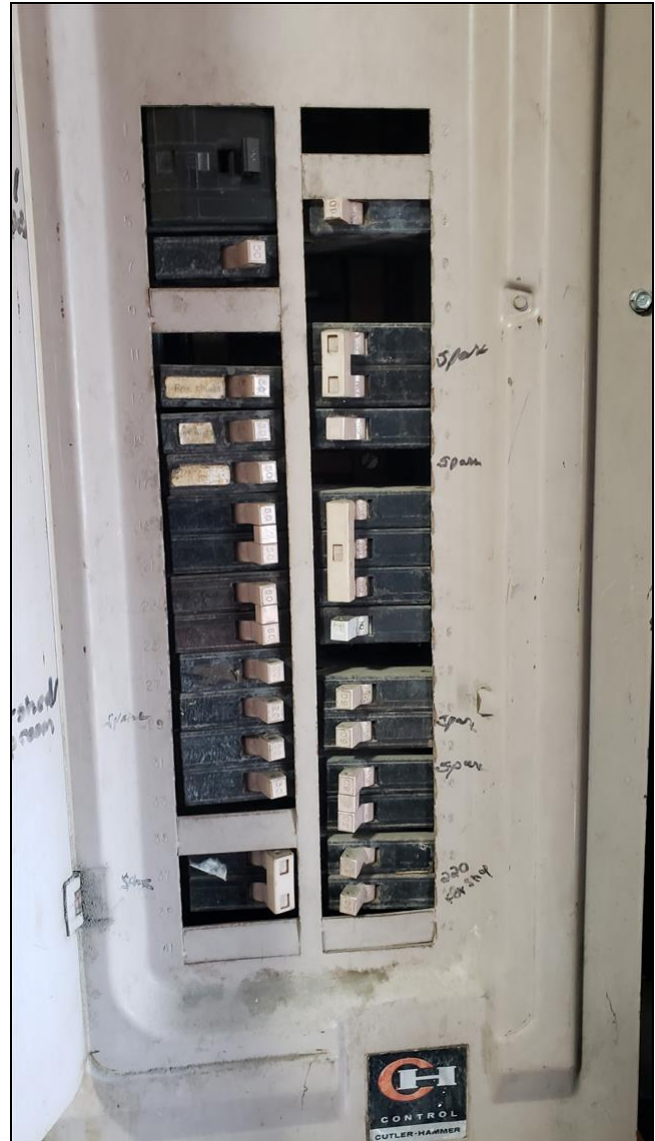
(3) Unfilled holes or knockouts in the main electrical service panel may allow persons to come into contact with energized electrical components. This condition is a potential shock/electrocution hazard and should be corrected by a licensed and qualified electrical contractor.

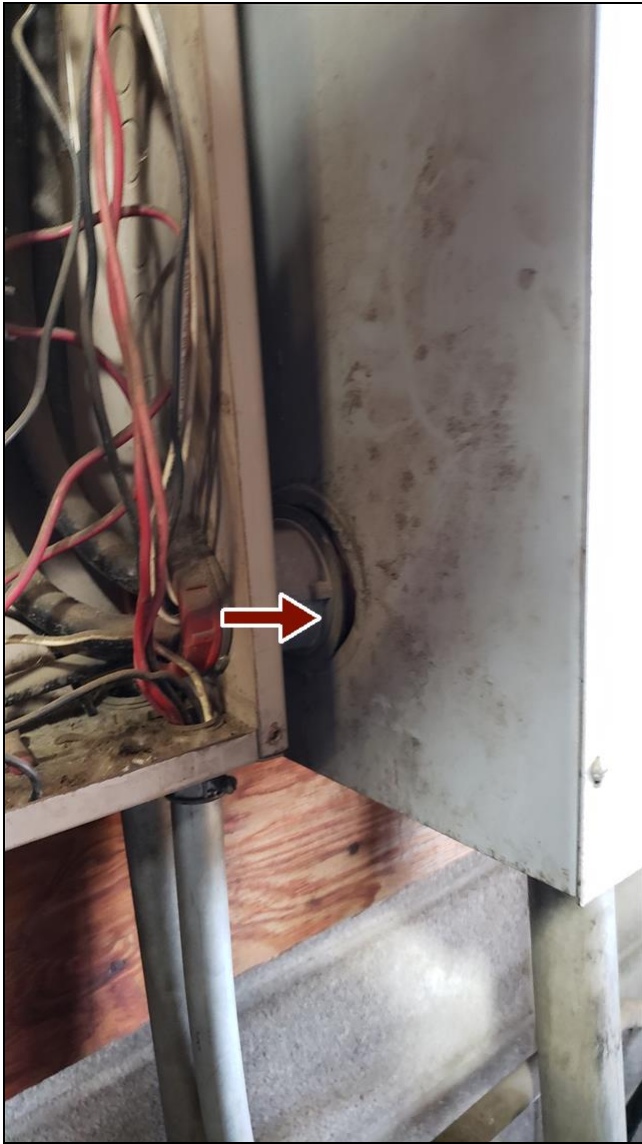
A. Item 5 (Picture)

(5) The two conduits for the service feeds to the panels from the transfer box are open. Recommend repair.

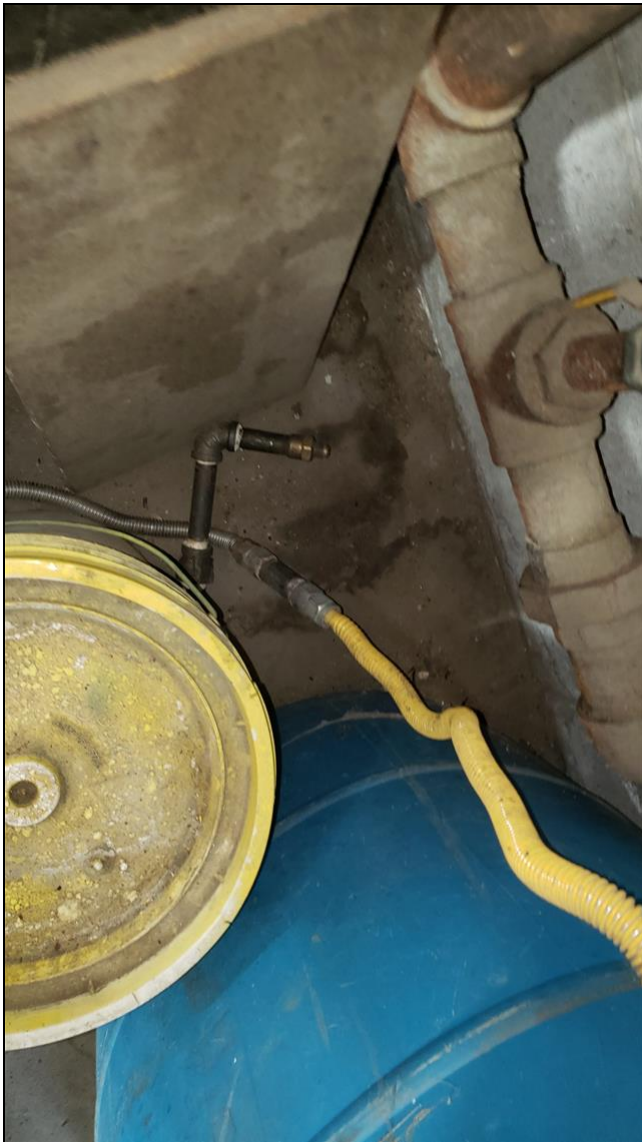
B. Item 1 (Picture)

Several gas pipes were not capped though turned off. This is a safety hazard if the knob gets bumped as gas could be released into the building. Recommend capping.

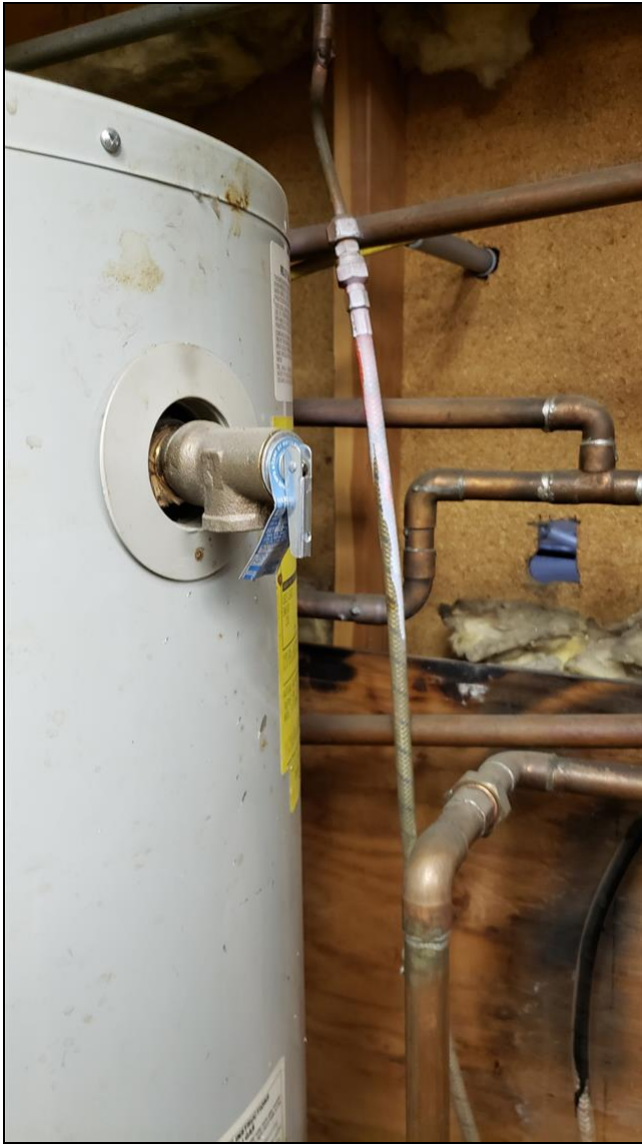
E. Item 1 (Picture)

The TPR valve on water heater needs a proper extension to extend within 6 inches of floor or other approved location visible to occupants. I recommend repair by a licensed and qualified plumbing contractor.

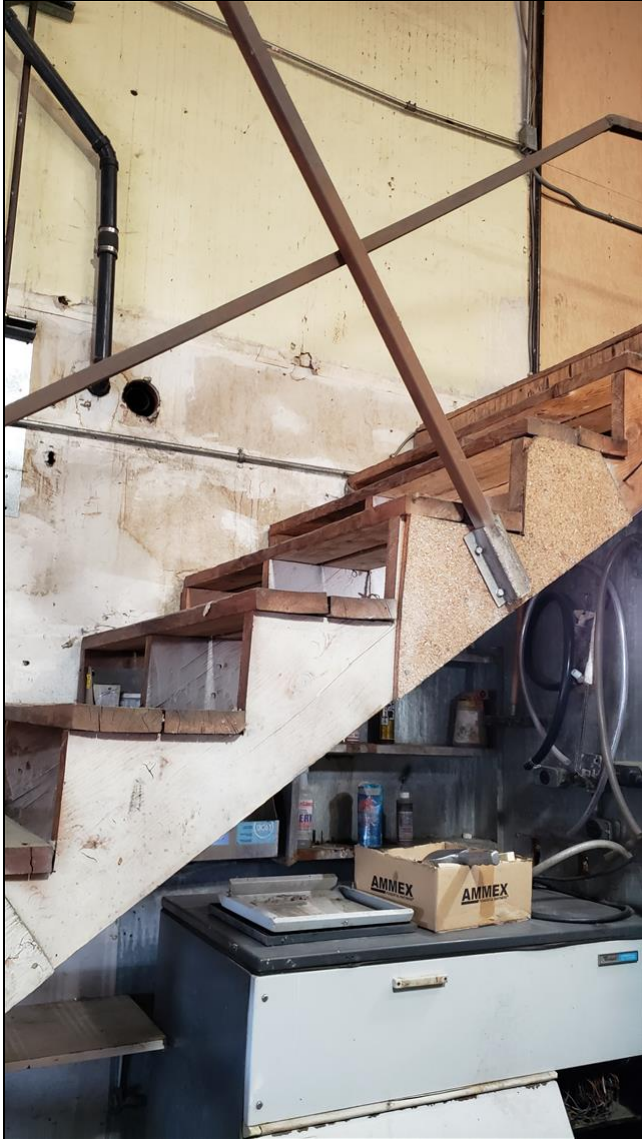
E. Item 1 (Picture)

(1) The handrails and guardrails had baluster spacings larger than 4 3/8". This can permit a small child to get their head stuck or fall through. Recommend correction when feasible.

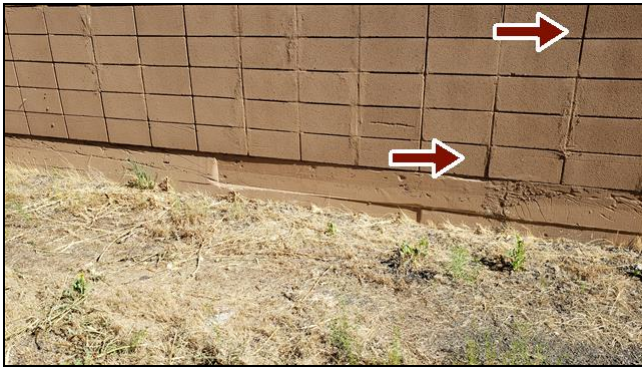
E. Item 4 (Picture)

(3) Mortar for the masonry work is deteriorating in several areas. Recommend repair.

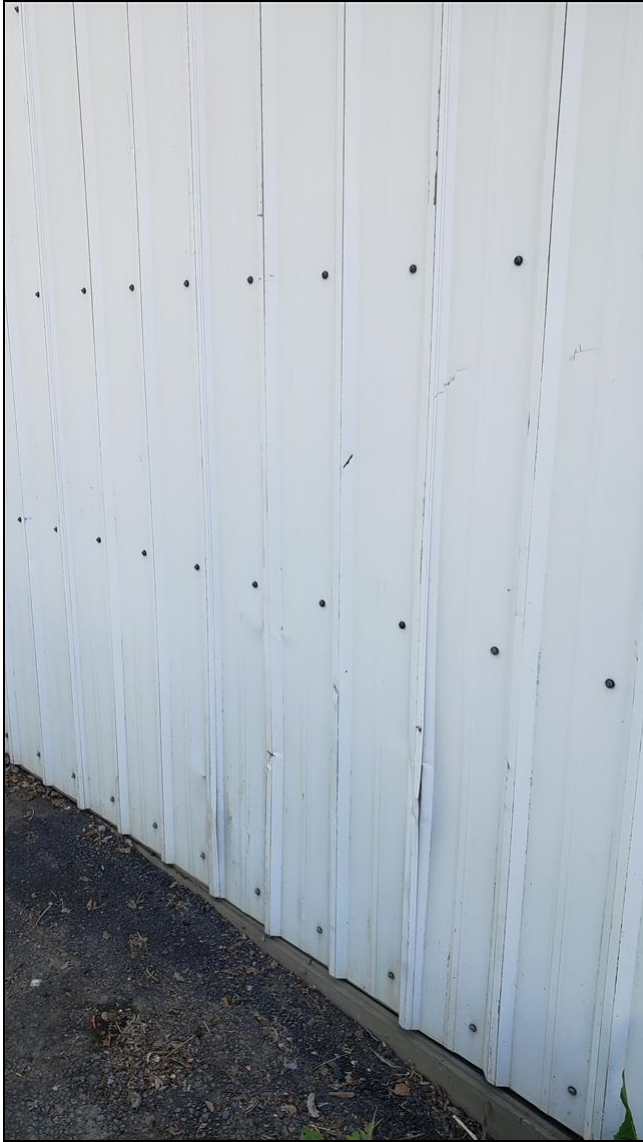
F. Item 2 (Picture)

(3) The siding had loose, protruding or missing fasteners at the rear addition visible at the time of the inspection. Minor dents and holes present. This condition should be corrected to avoid wind damage and/or damage from moisture intrusion.

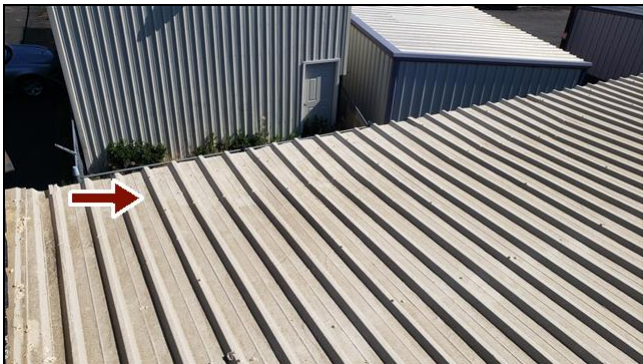
J. Item 4 (Picture)

(2) The roofing covering materials are approaching the end of their service life. Some areas are in worse condition than others. Materials in several areas show mechanical damage. While the roof may have some serviceable life left and does not appear to be currently leaking, an evaluation is needed to determine what repairs can be completed at this time and how much longer the roof will last. That evaluation should include the costs associated with any necessary repairs, as well as estimates of remaining service life of the materials. All work should be completed by a licensed and competent roofing contractor.
