Inspection Report

Safe@Home Inspections, LLC

Executive Summary

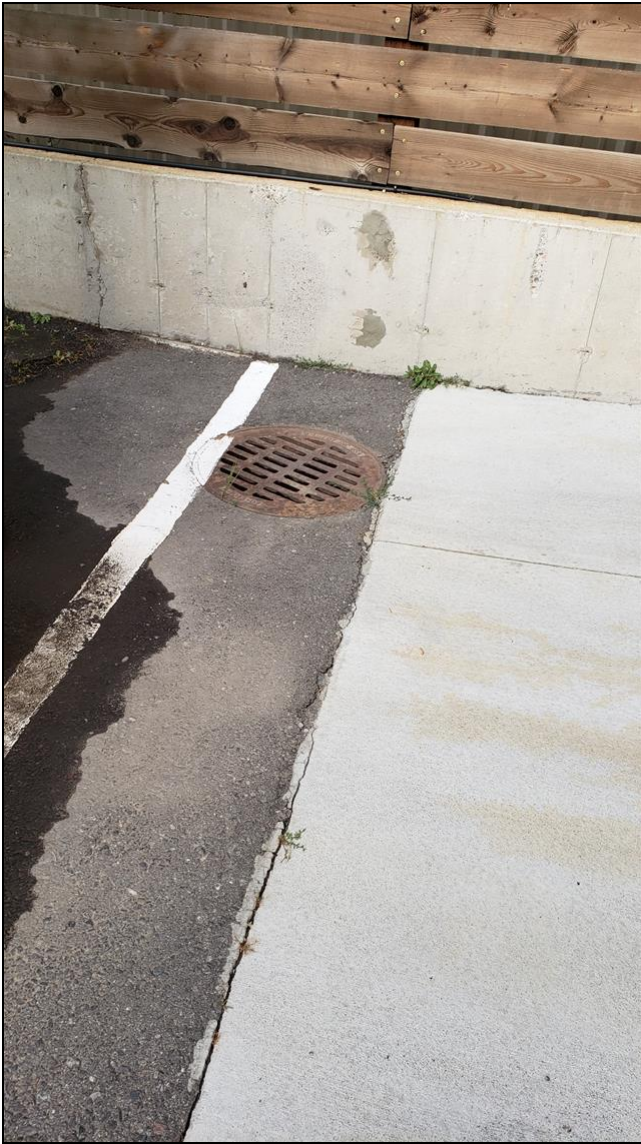
C. Item 1 (Picture)

Storm water run off is accomplished by sheeting action from the roof to surrounding surfaces. The parking lot sheets to Yellowstone Street in front and a sewer drain at the rear of the lot.

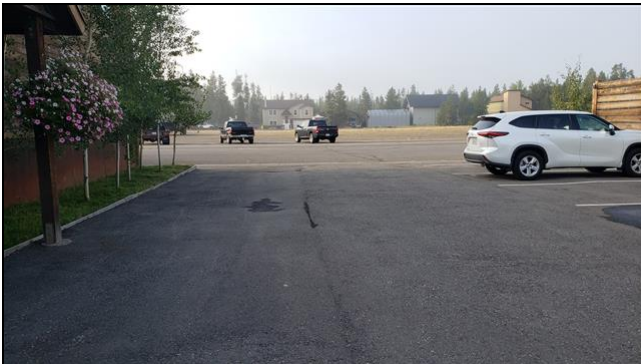
D. Item 1 (Picture)

There is a single point of access to the parking lot from Yellowstone Street.

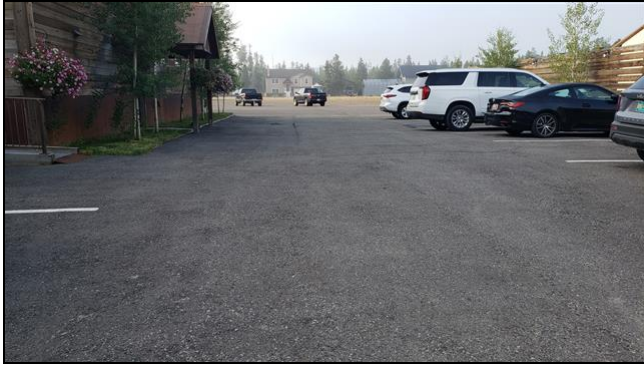
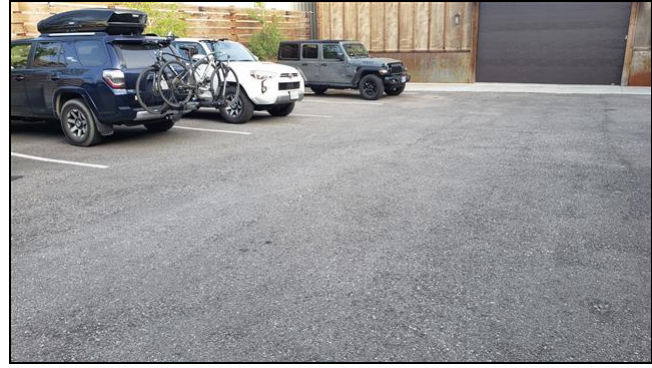
(2) The asphalt surface of parking lot generally is intact with some minor exceptions of cracks in some surface areas typical of its age. It is recommended to perform a maintenance coating which will require painting new lines for parking spaces .

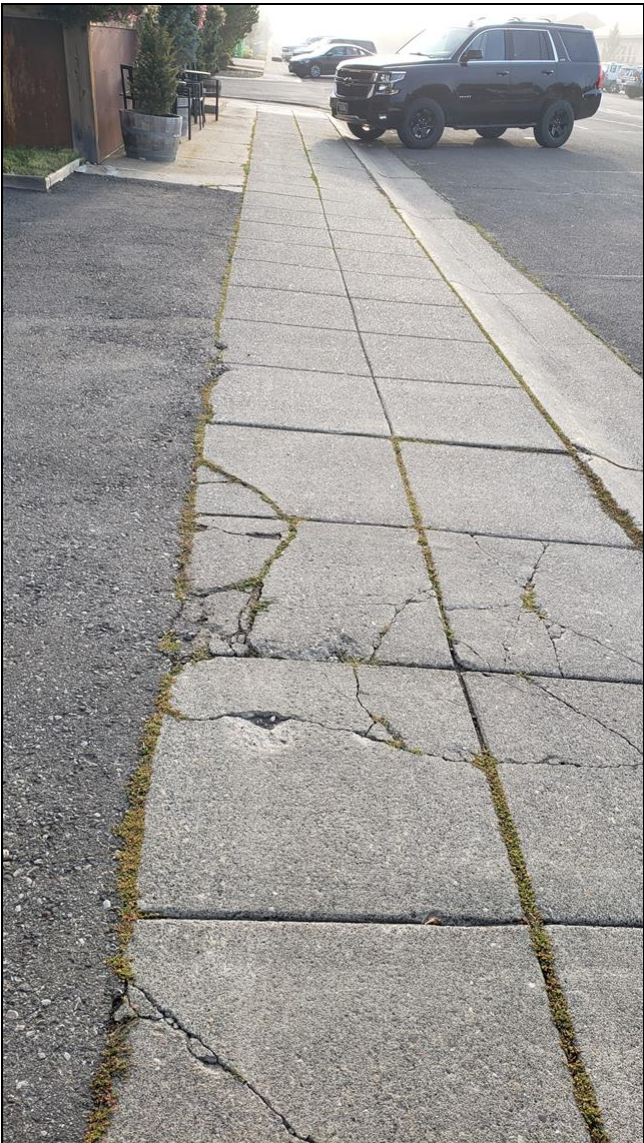
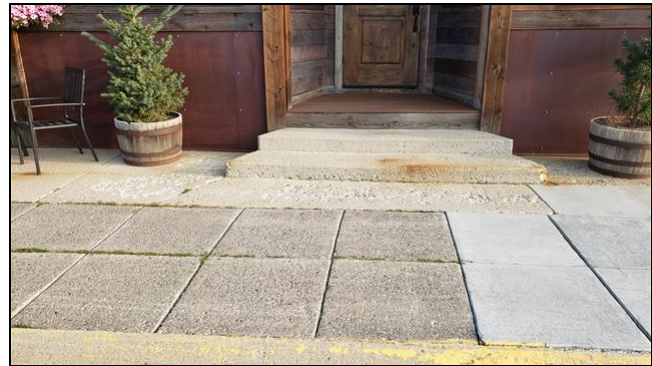
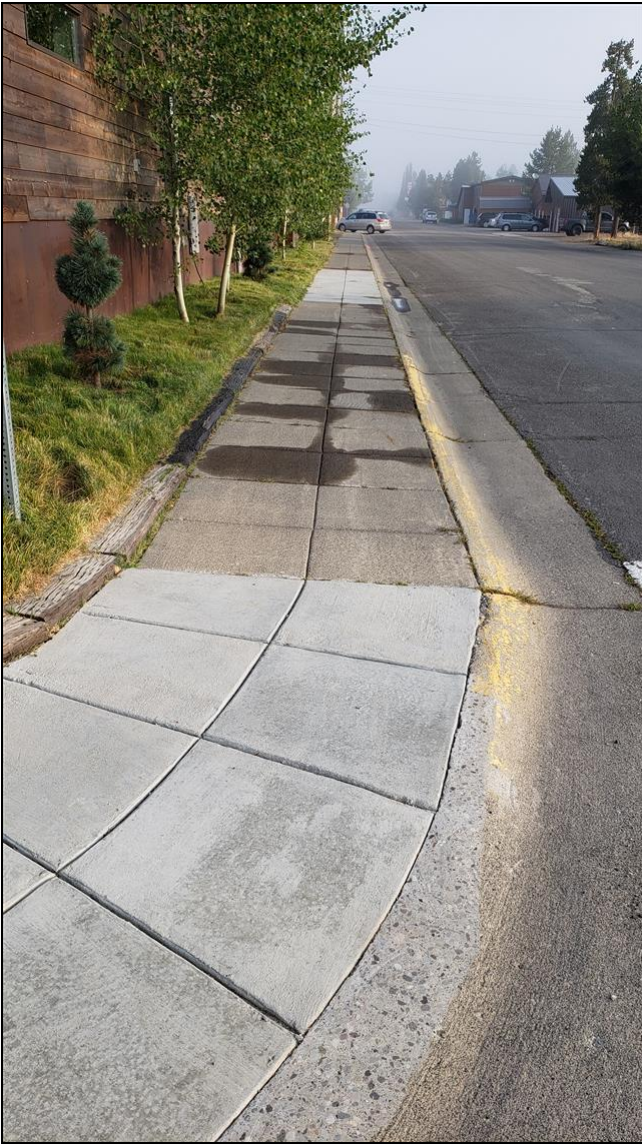
(1) The sidewalks are poured-in-place concrete. Typical wear and tear observed.

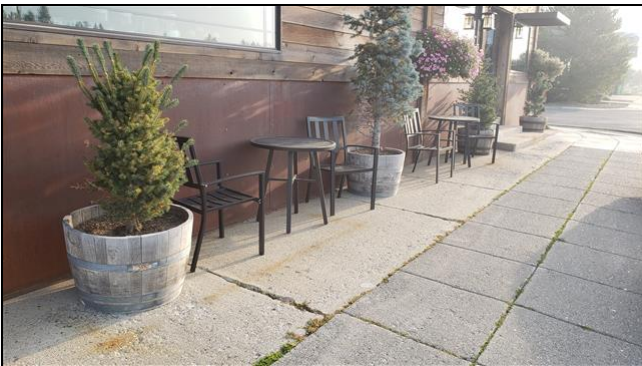
F. Item 4 (Picture)

(2) A small patio is integrated with the walkways along the front of the building.

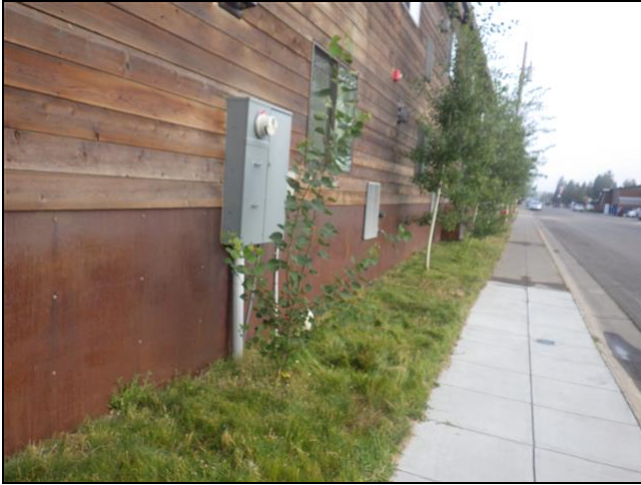
G. Item 1 (Picture)

Landscaping was present and consisted of shrubs, and trees along the sides with streets.

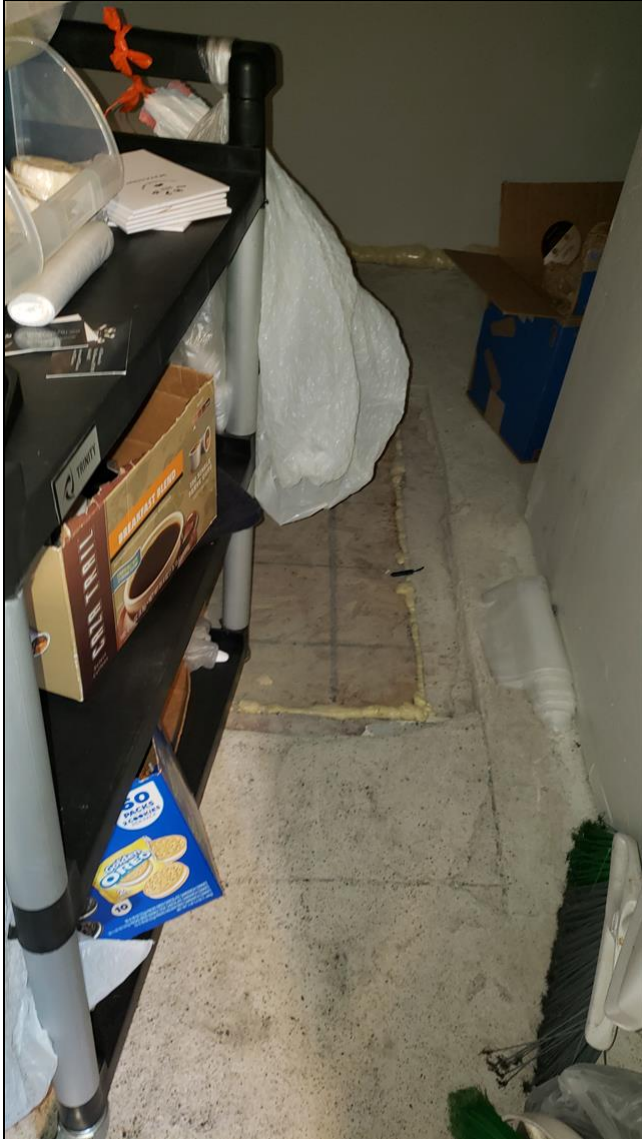
A. Item 1 (Picture)

(3) No access to the under-floor area was visible. Safe@Home Inspections was unable to view conditions in the crawlspace. Safe@Home Inspections recommends a proper access be created and crawlspace conditions be inspected by a qualified inspector after access to the crawlspace is provided.

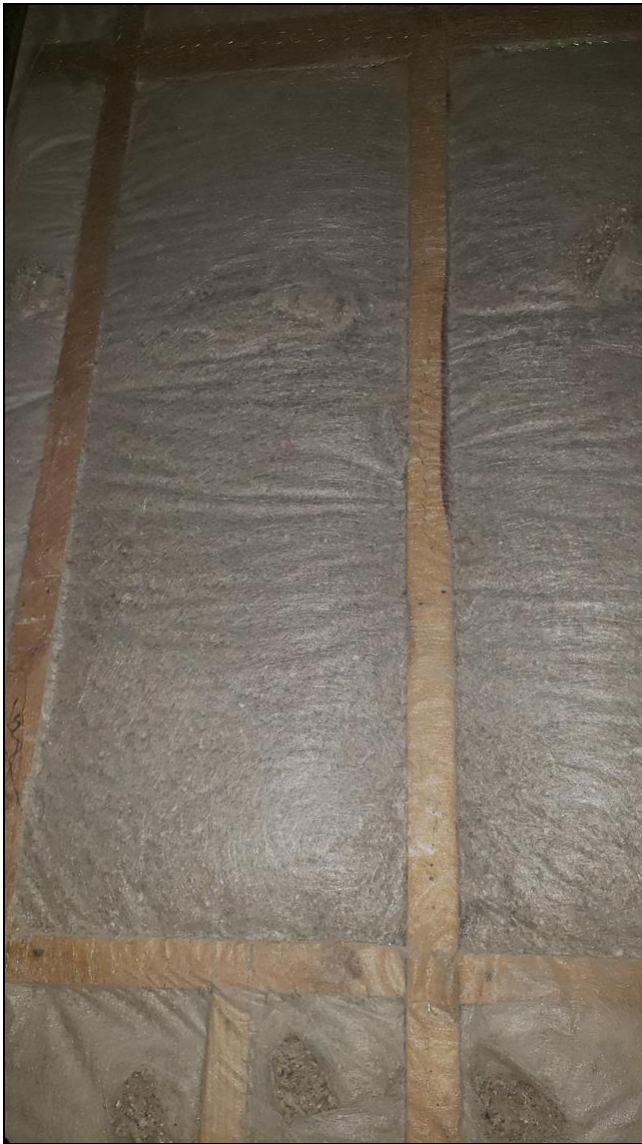
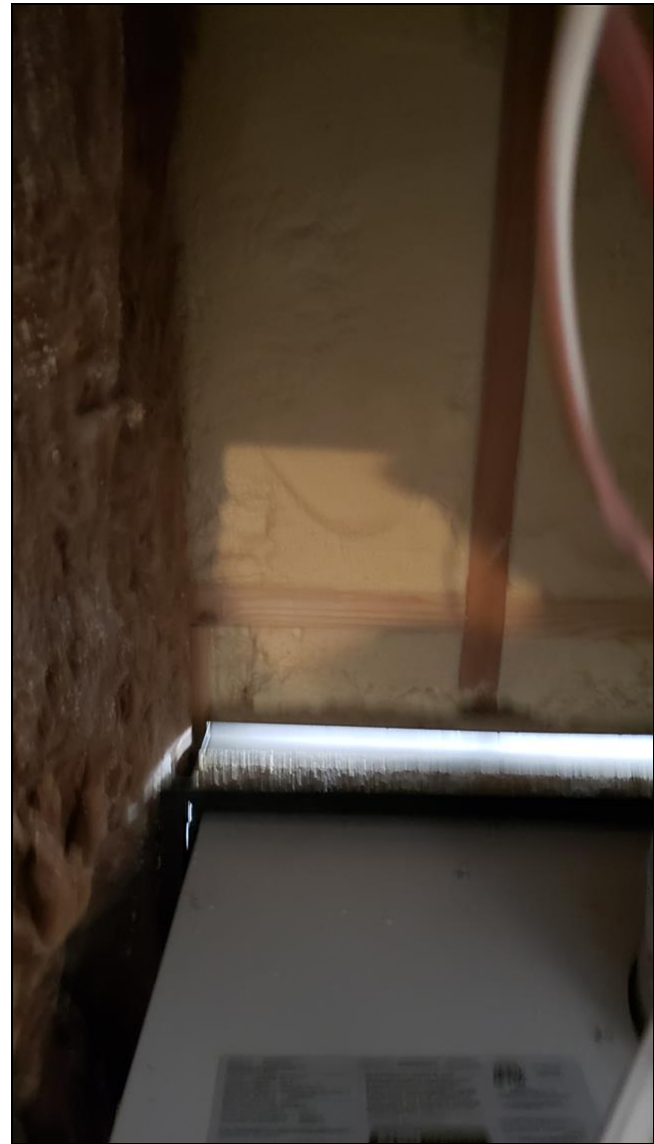
(2) Wall insulation was visible in the PTAC closets. There was a combination of blown cellulose and foam insulation present. No material defects were observed.

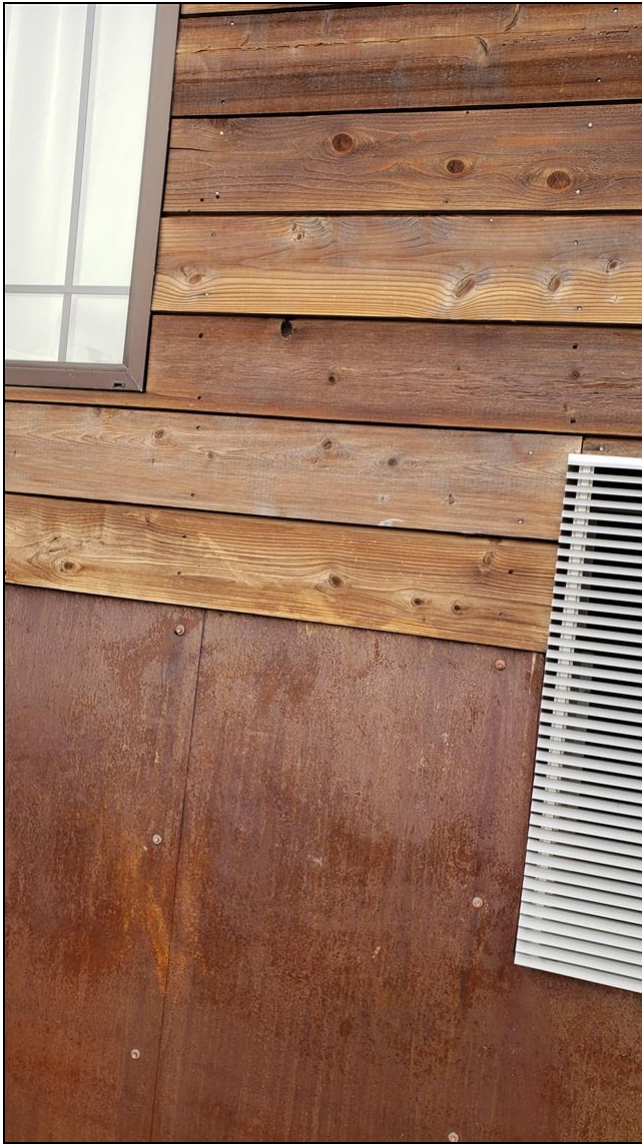
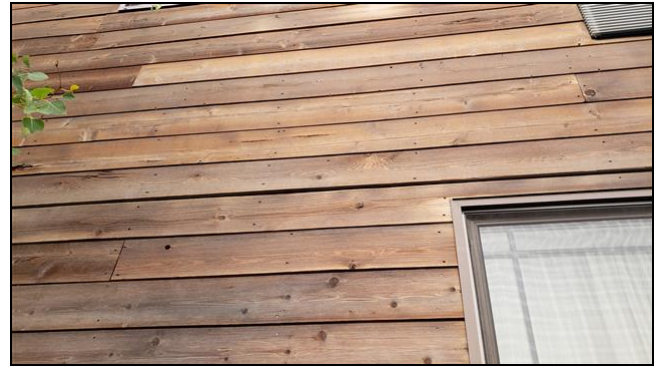
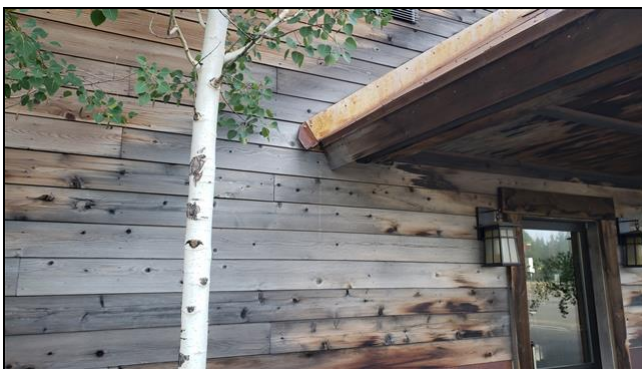
(2) At this time the extent of paint failure might best be described as substantial. The exterior paint or finish is blistering/peeling/cracking/missing. Recommend consulting a licensed and qualified paint contractor to obtain estimates for re-painting the home. Repainting is recommended at the earliest possible opportunity.

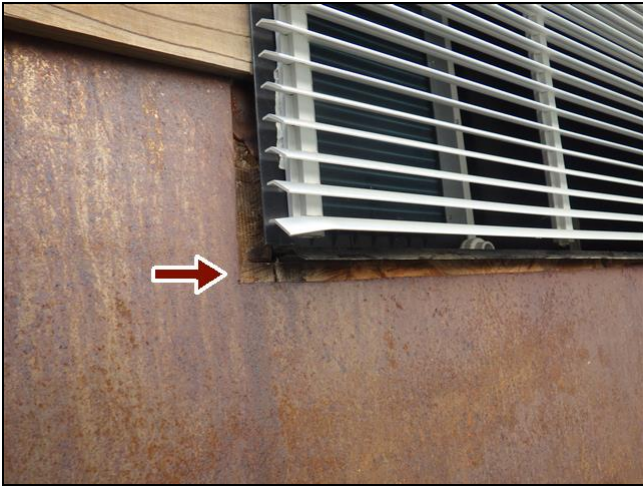
C. Item 4 (Picture)

(3) No water resistive barrier was observed behind the metal plating at limited openings. Bare OSB was observed. It is possible that the WRB degraded in weather. Recommend removal of several to verify that a water resistive barrier is present. If it is not, recommend installation.

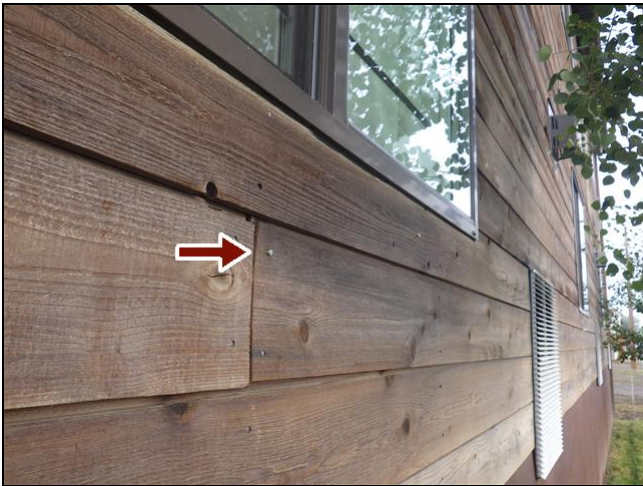
C. Item 5 (Picture)

(4) The siding had loose, protruding or missing fasteners visible at the time of the inspection. This condition should be corrected to avoid wind damage and/or damage from moisture intrusion.

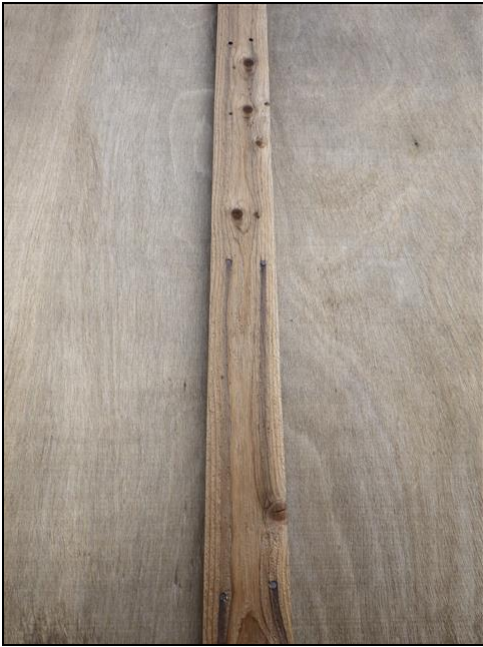
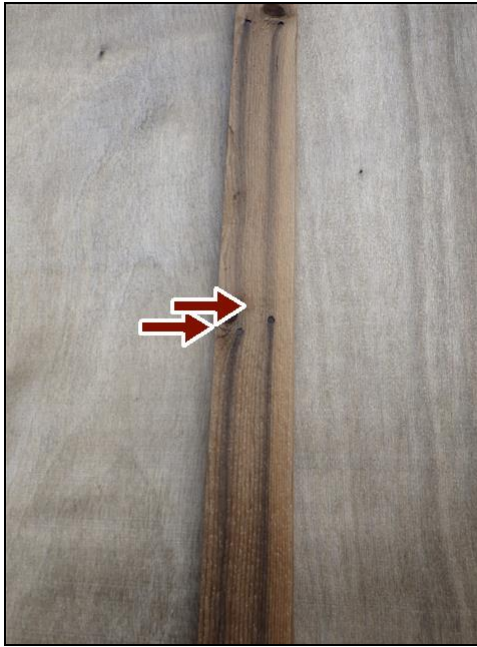
(5) Staining from nails present at the garage wood siding. This is usually a result of improper fasteners used with the wood siding. Recommend evaluation by a licensed and qualified siding contractor.

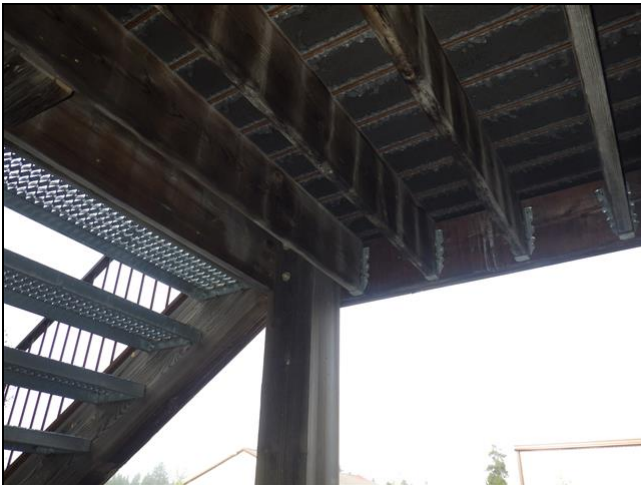
D. Item 1 (Picture)

The beams for the decks do not bear to a column. This is not an acceptable practice for deck construction. The deck stairs lack the proper hardware to attach to the deck. This can lead to separation of the stairs from the deck and a potential fall. Recommend further evaluation and repair of all such deficiencies by a licensed and qualified contractor.

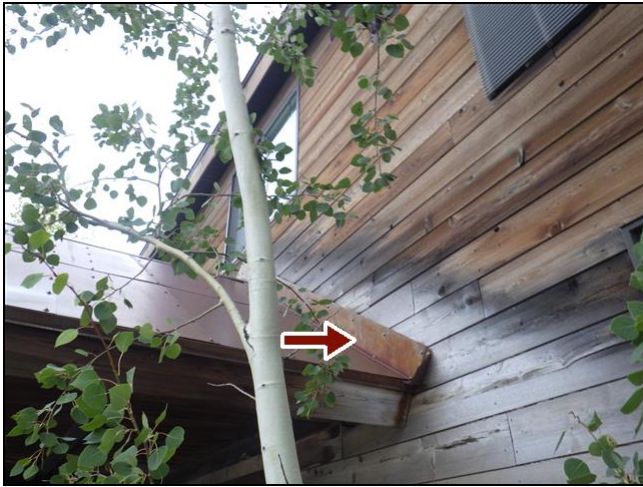
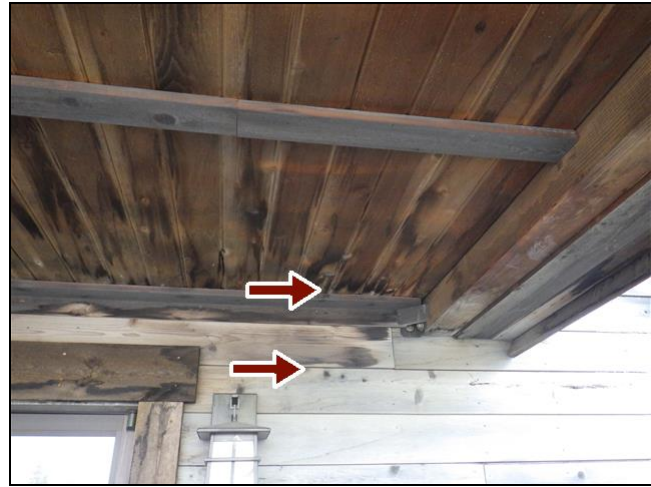
(3) The flashing at the walls at the awnings was not installed correctly. This flashing should be placed under the siding material rather than over it to prevent possible water intrusion. This did not happen here. Recommend repair by a qualified contractor.

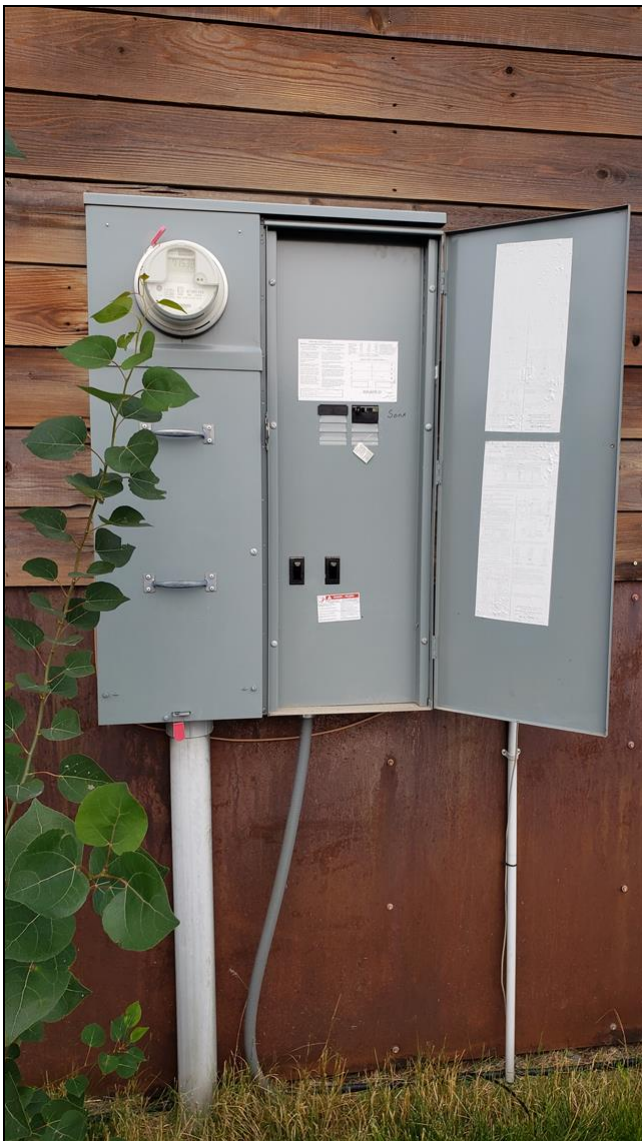
B. Item 1 (Picture)

The main electrical service is located on the east side of the property. The service is underground. The source for electricity Northwest Energy.

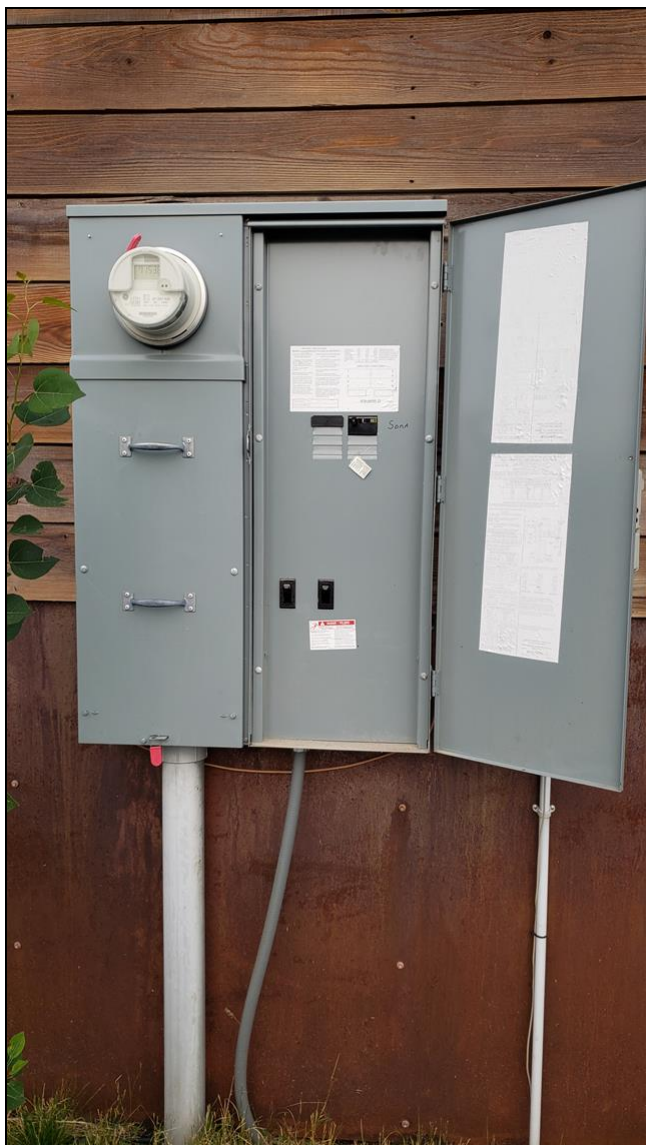
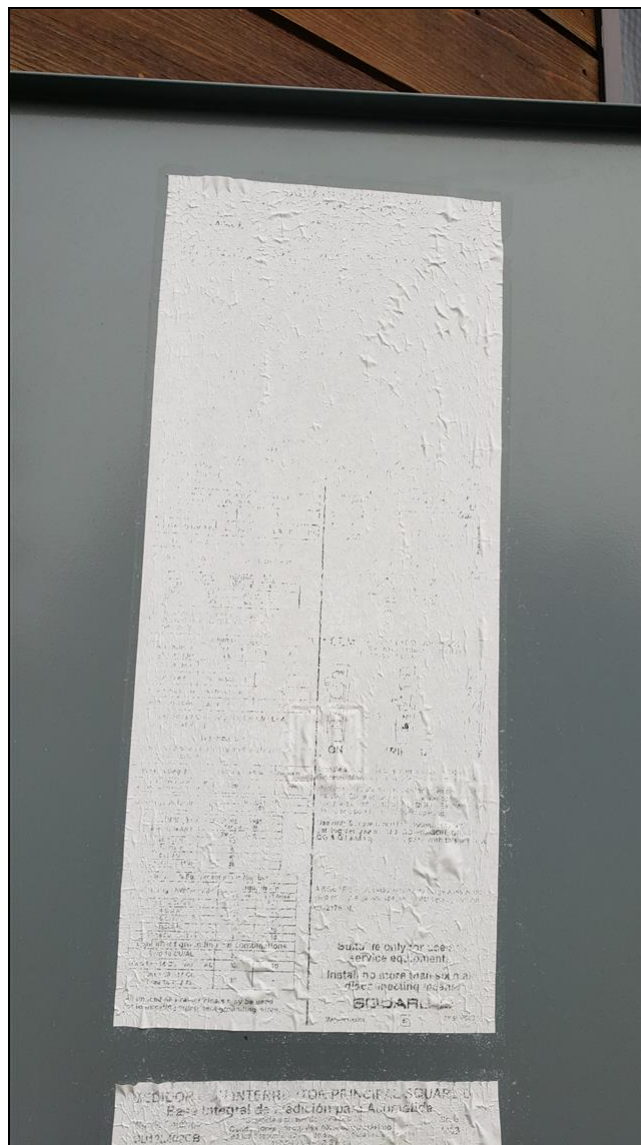
(1) The electrical service is on the side of the building. Service is an underground riser. This goes to a Square D combination panel that contains the meter and the main panel. The main panel is manufactured by Square D. The labels inside are very faded but it appears that this panel is rated for 120/240v, 400 amps.

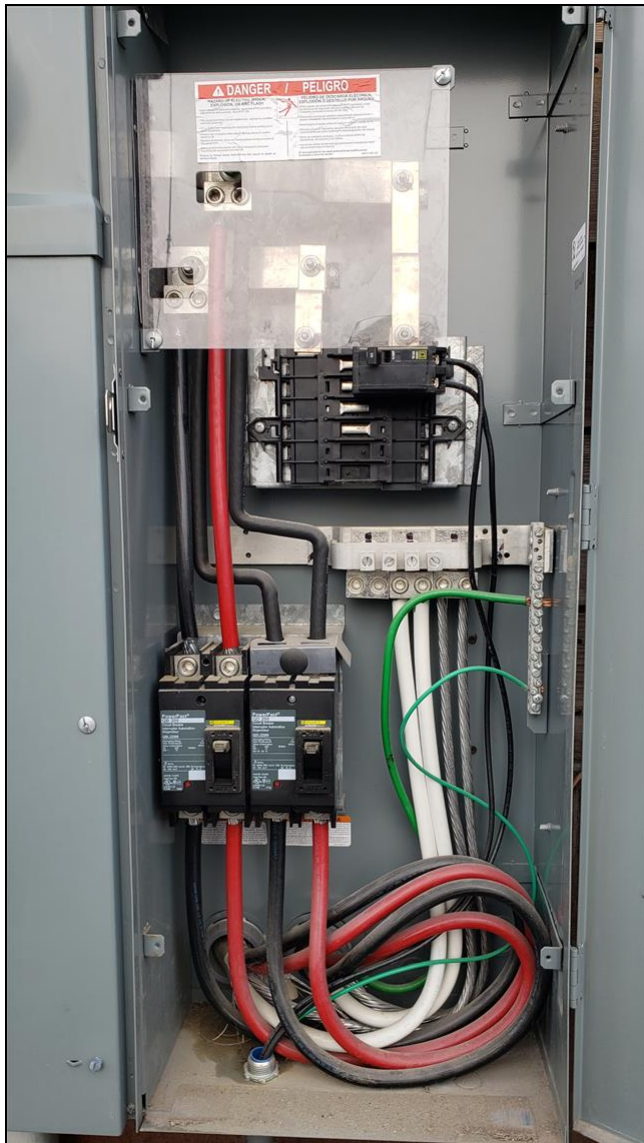
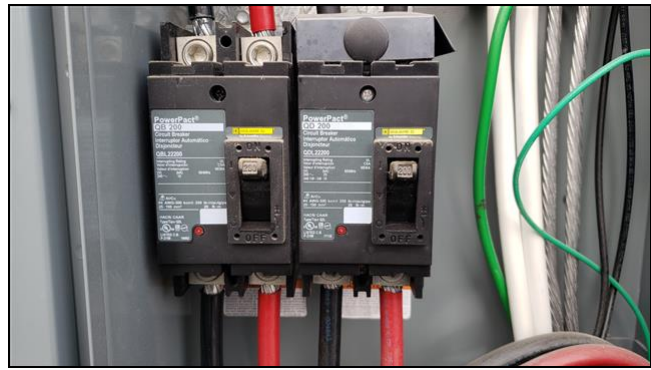
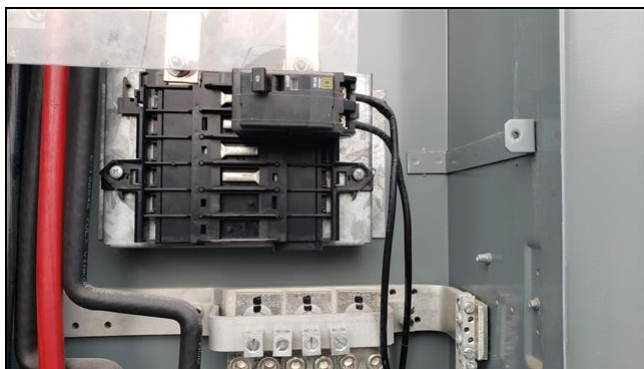
(2) Removal of the panel cover reveals 4/0 aluminum service entrances to each 200 amp breaker. There are two 200 amp Breakers present. There is also a 40 amp breaker installed in the panel. This breaker appears to be for the sauna.

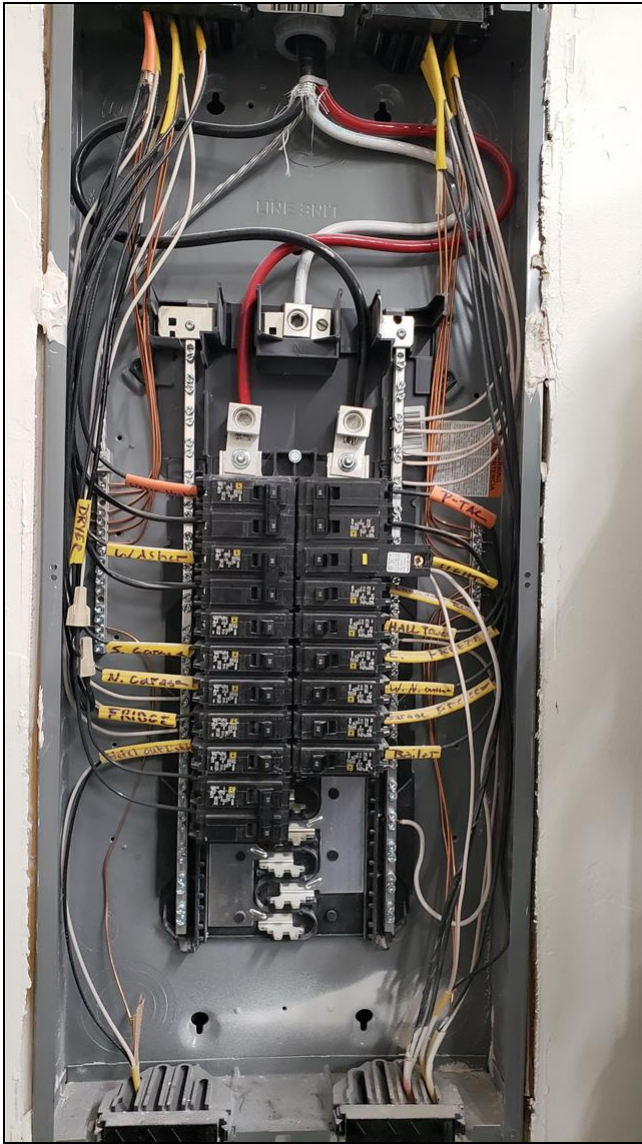
B. Item 1 (Picture)

(1) A total of three secondary panels were observed. They were each 200 amps. Two were located in the office. One was located within the new garage/laundry. No material defects were observed.

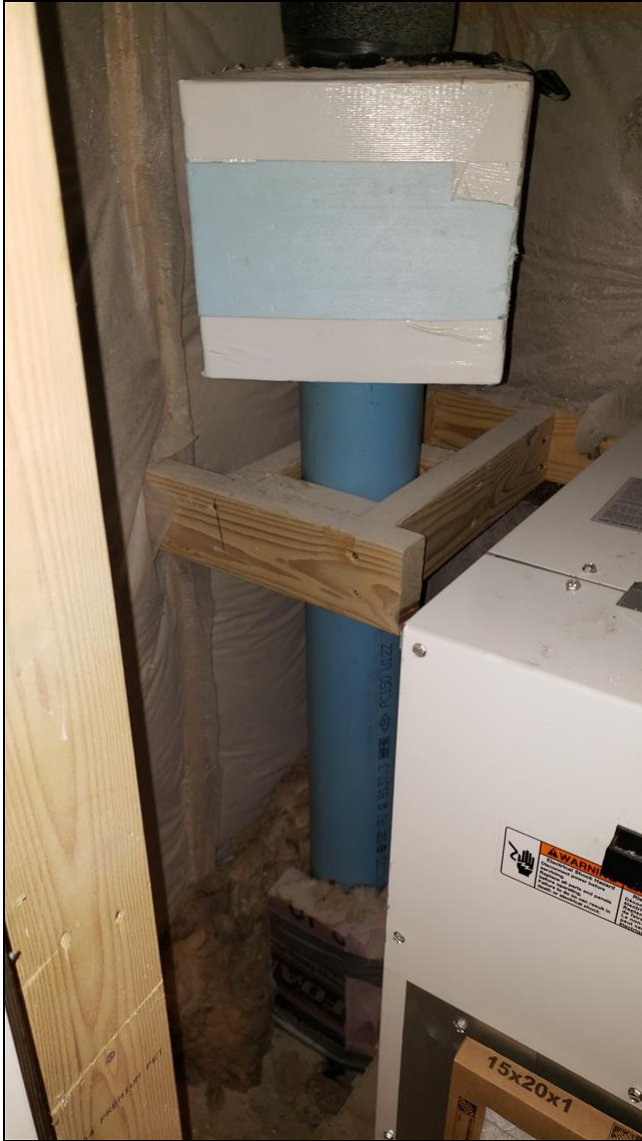
A. Item 1 (Picture)

(1) The plumbing main for the building is integrated with the fire suppression water supply. The shut-off is located in the PTAC enclosure in Room 2.

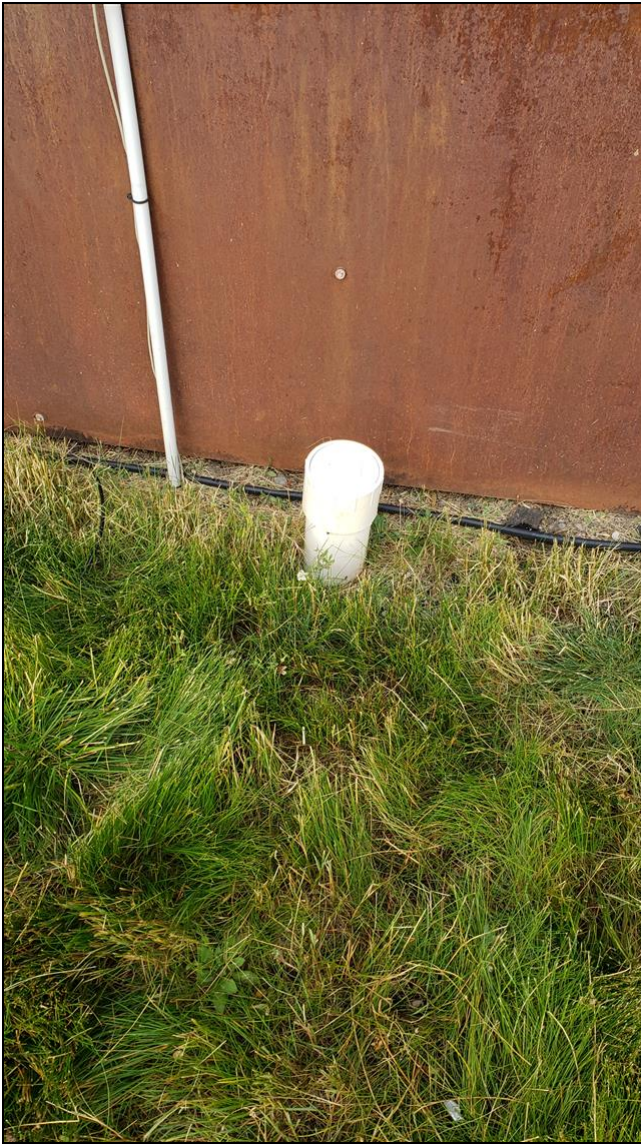
B. Item 1 (Picture)

(1) A newer sewer clean out was noted on the east side of the building. This is consistent with the owner's statement that the plumbing system was completely upgraded.

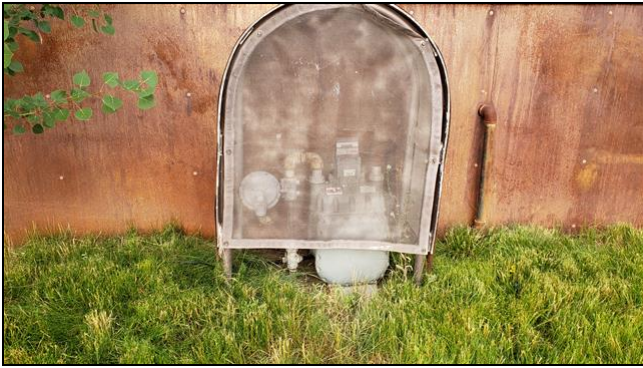
D. Item 1 (Picture)

The gas meter is located on the east side of the property. The gas meter appeared in functional condition. No indications of leakage present.

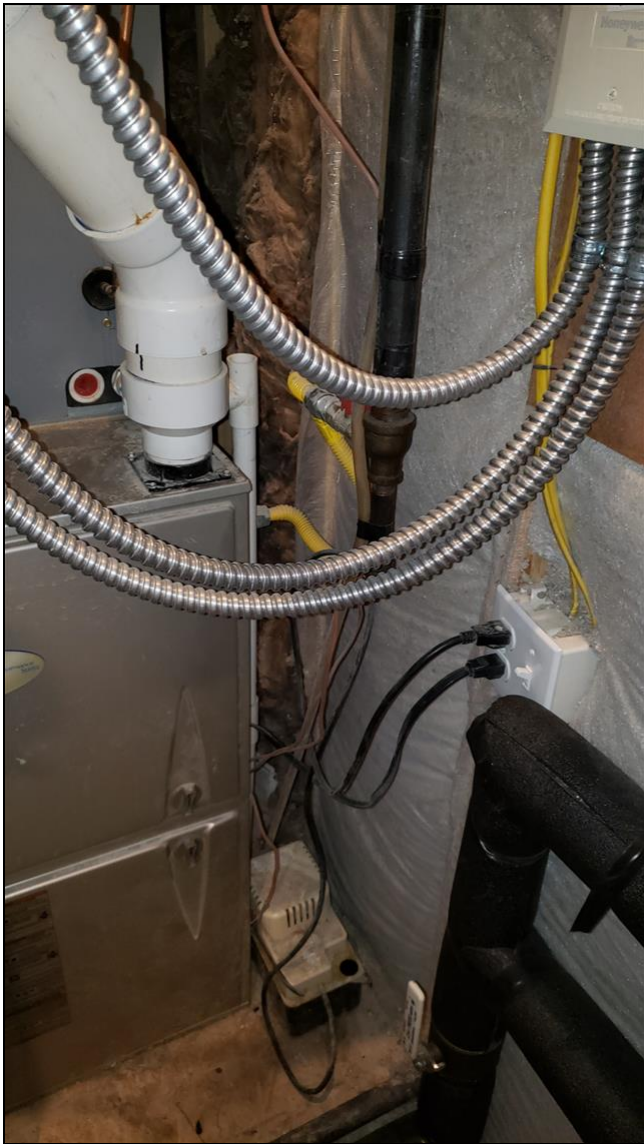
E. Item 1 (Picture)

The observed piping was black iron and flexible appliance connectors. Shut-offs and sediment traps were observed.

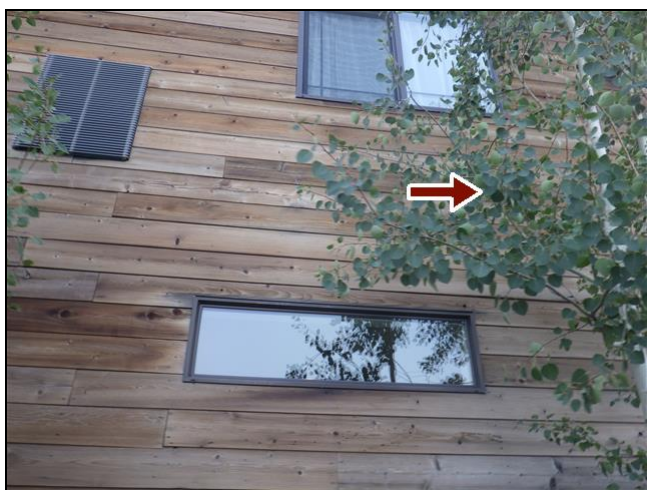
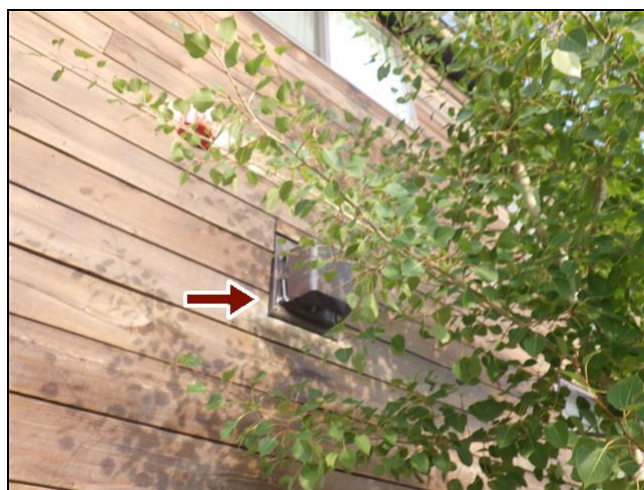
(5) Recommend trimming vegetation from the terminations of the gas insert fireplaces to prevent potential fires.

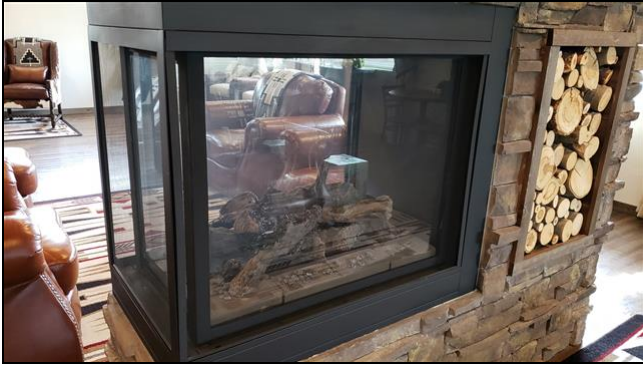
A. Item 5 (Picture)

(6) There is a gas insert fireplace in the common room.

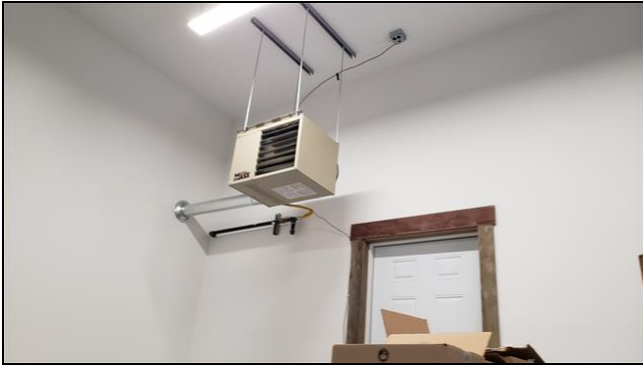
A. Item 6 (Picture)

(7) There is a gas-fired furnace ceiling-mounted in the garage. No data tag was readily accessible. Since the entire garage was rebuilt in 2019, it is presumed to be of that vintage.

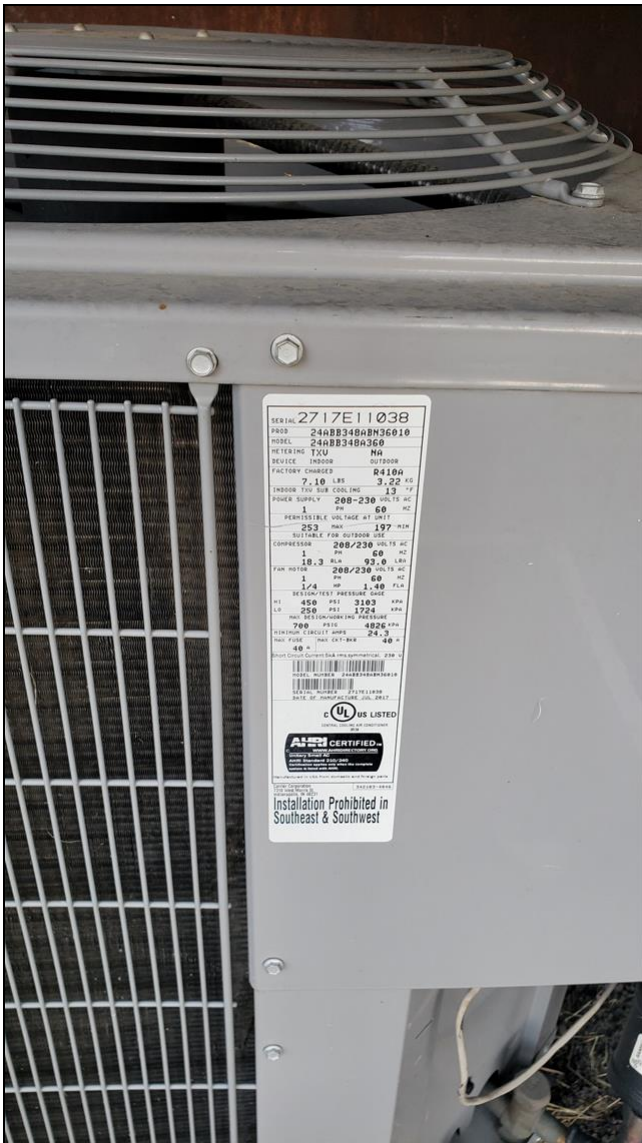
B. Item 1 (Picture)

(1) The air conditioning for the common room area is a Carrier air conditioner rated at 4 tons of cooling capacity. This unit is 5 years old. Temperatures were too cold to test the unit.

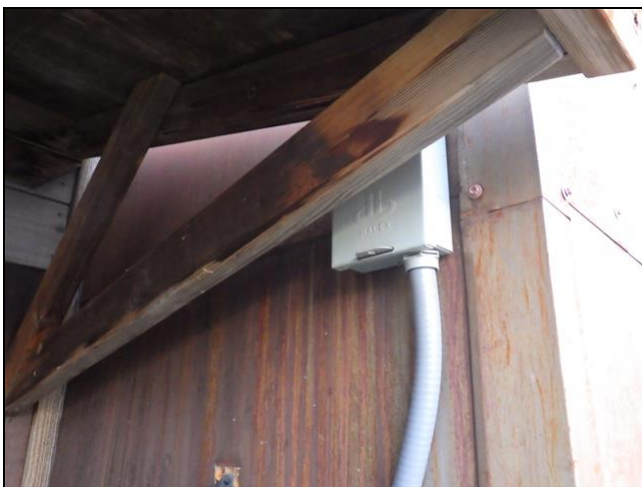
B. Item 2 (Picture)

(2) The serviceman's safety switch cannot be accessed due to the cover over the unit. Recommend redesigning the cover to allow for proper access.

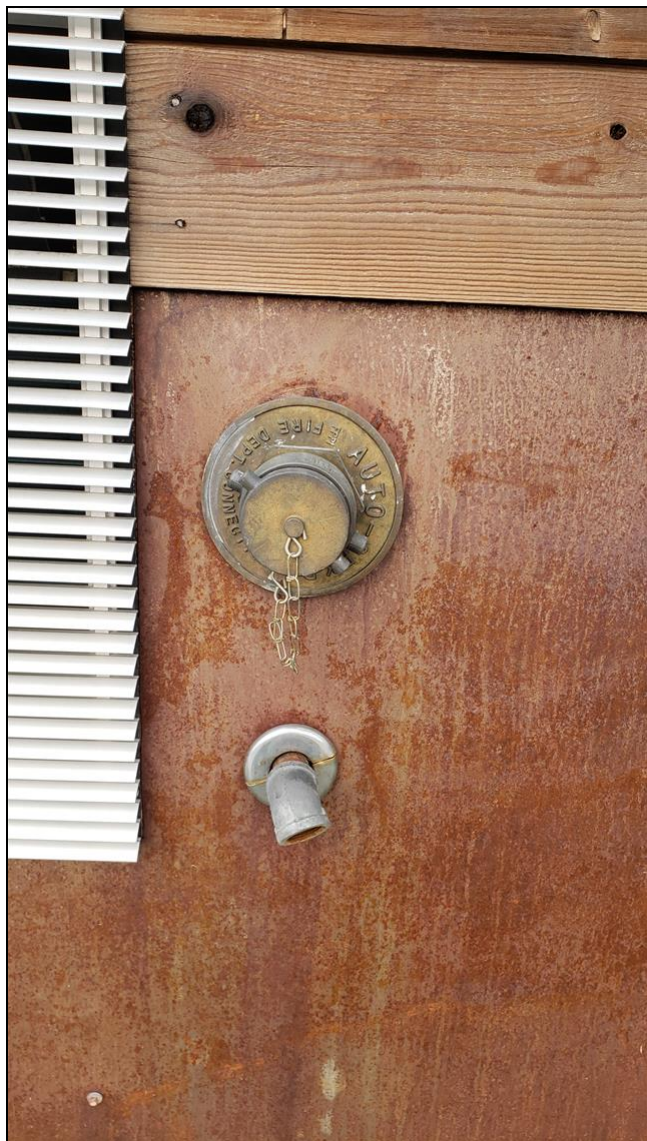
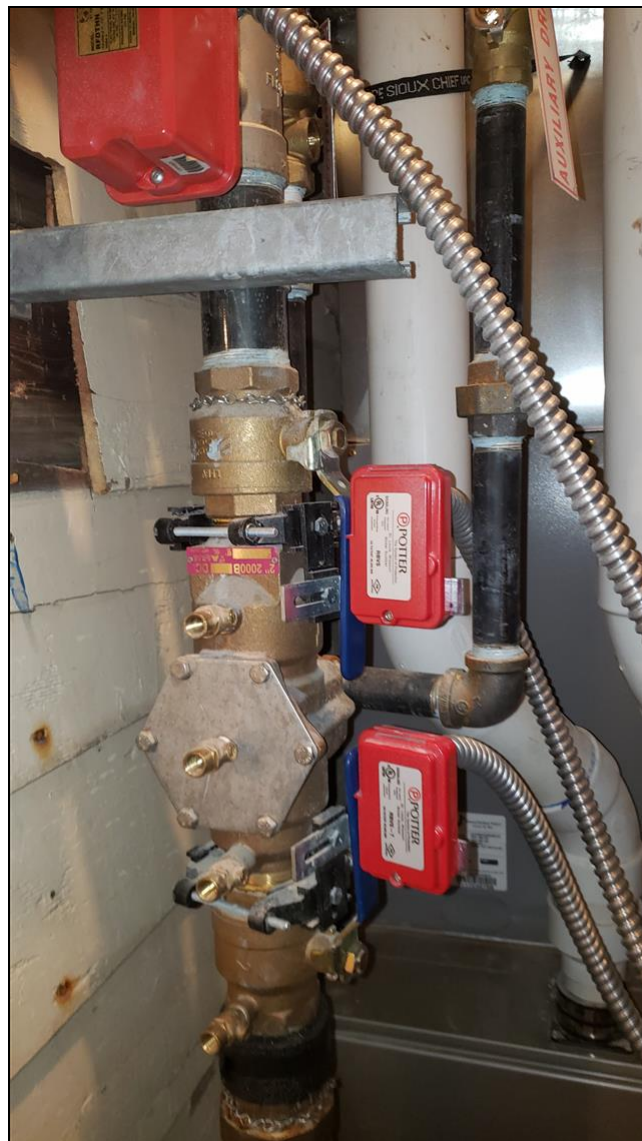
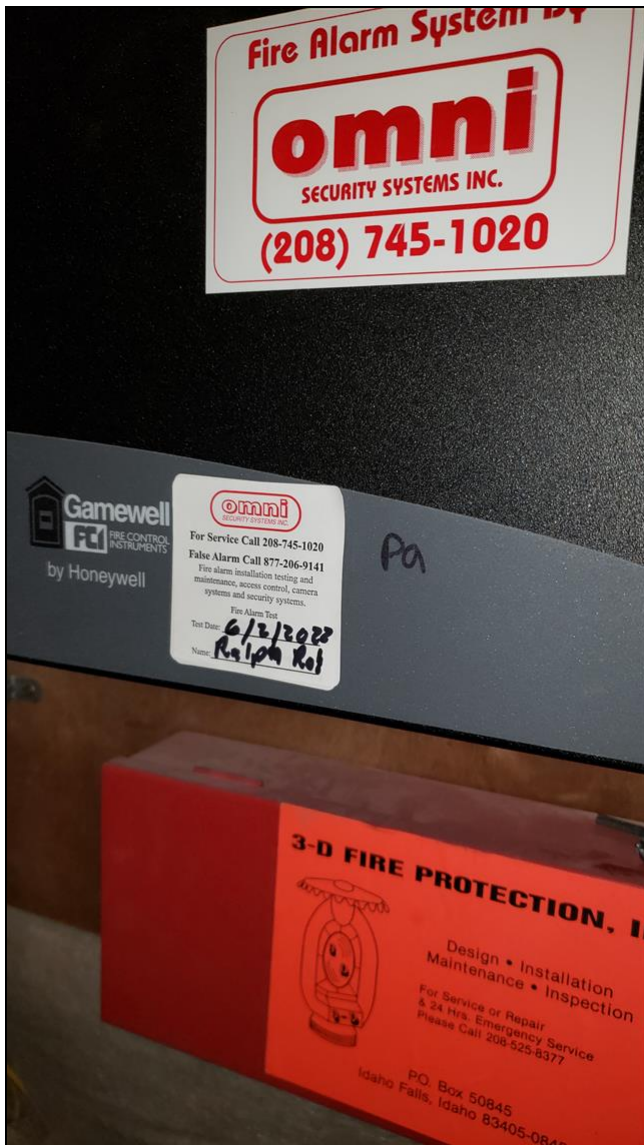
A fire suppression system is installed. This appears to be a wet charged system. The servicing company (also the monitoring company) is Omni Security. The last test on the alarm system was June of 2022.

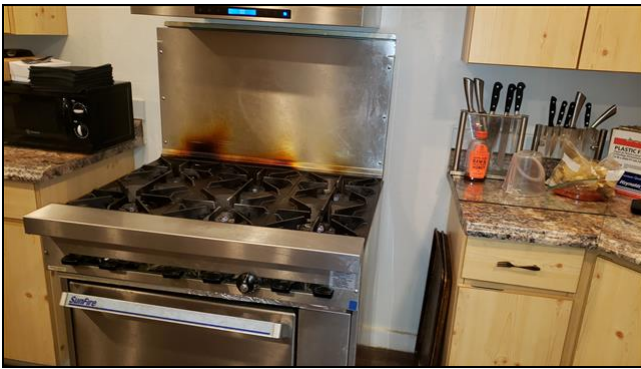
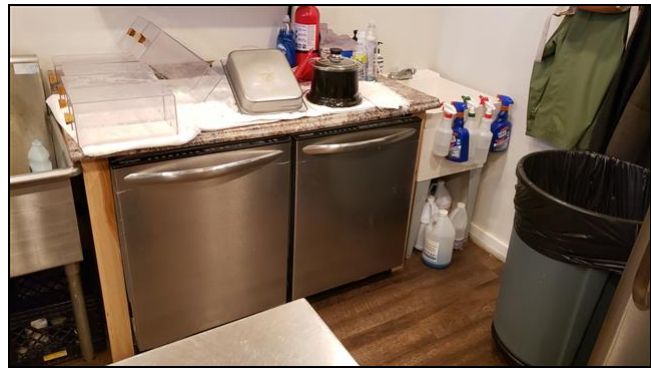
There is a small commercial kitchen with gas-fired stove, two dishwashers, and a refrigerator.

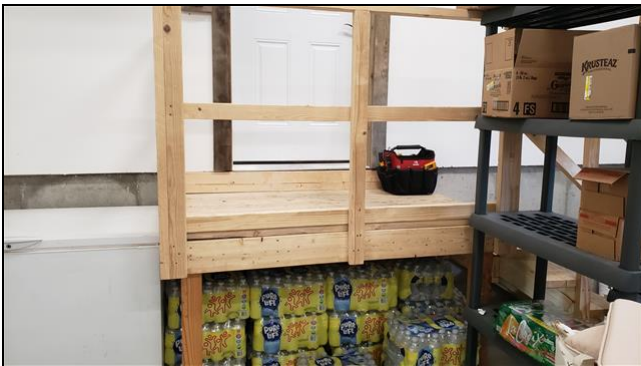
D. Item 1 (Picture)

The stairs to the garage lack proper balusters. Recommend installing.
