Inspection Report

Safe@Home Inspections, LLC

Executive Summary

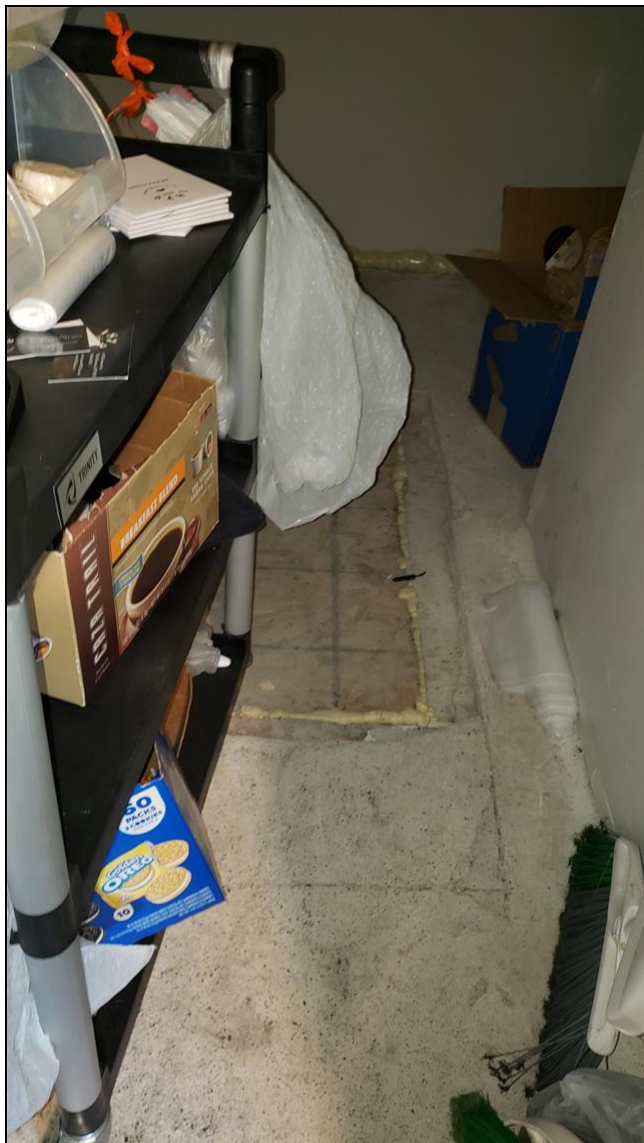
A. Item 1 (Picture)

(3) No access to the under-floor area was visible. Safe@Home Inspections was unable to view conditions in the crawlspace. Safe@Home Inspections recommends a proper access be created and crawlspace conditions be inspected by a qualified inspector after access to the crawlspace is provided.

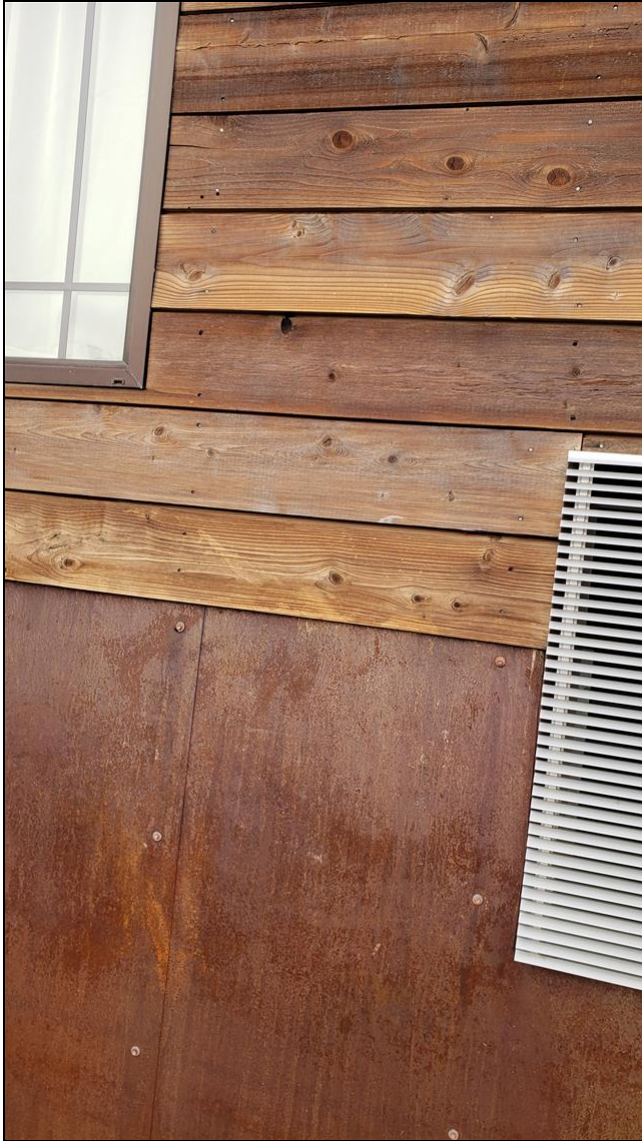
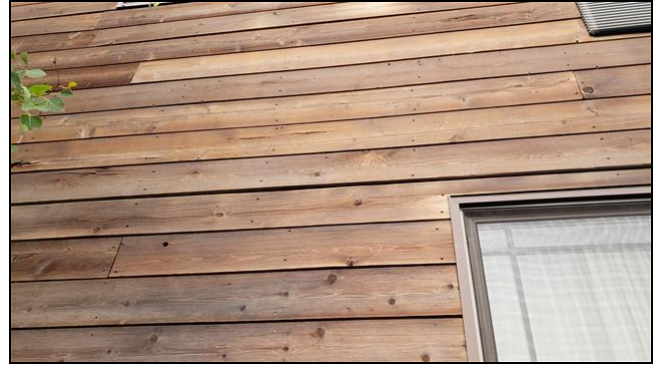
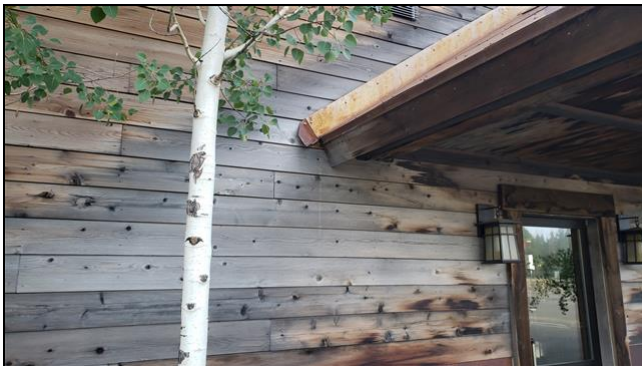
(2) At this time the extent of paint failure might best be described as substantial. The exterior paint or finish is blistering/peeling/cracking/missing. Recommend consulting a licensed and qualified paint contractor to obtain estimates for re-painting the home. Repainting is recommended at the earliest possible opportunity.

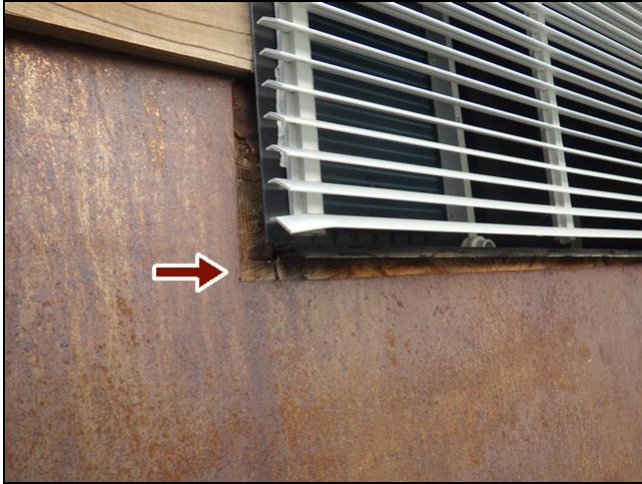
C. Item 4 (Picture)

(3) No water resistive barrier was observed behind the metal plating at limited openings. Bare OSB was observed. It is possible that the WRB degraded in weather. Recommend removal of several to verify that a water resistive barrier is present. If it is not, recommend installation.

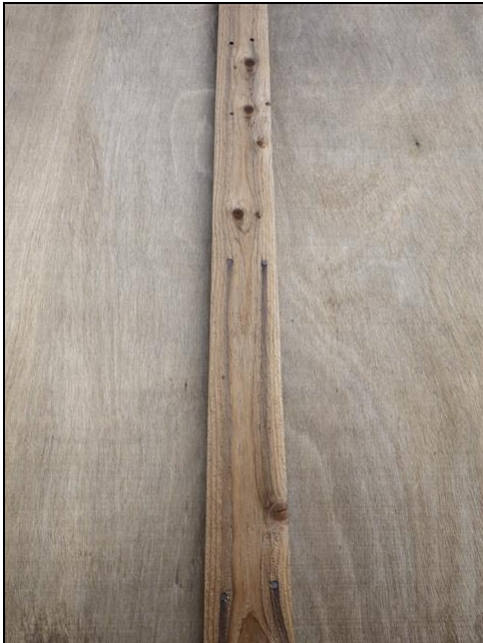
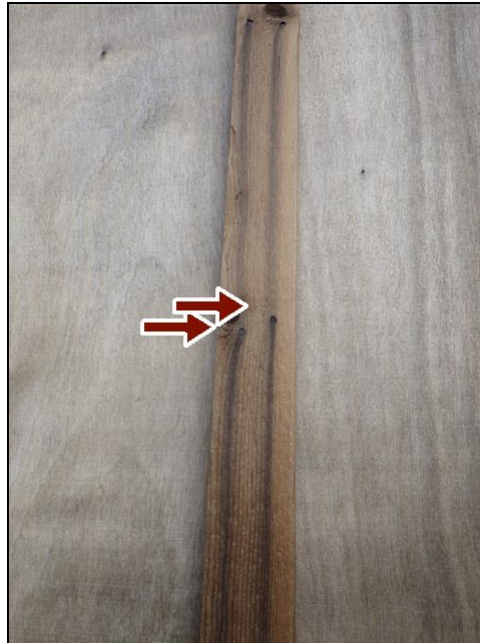
(5) Staining from nails present at the garage wood siding. This is usually a result of improper fasteners used with the wood siding. Recommend evaluation by a licensed and qualified siding contractor.

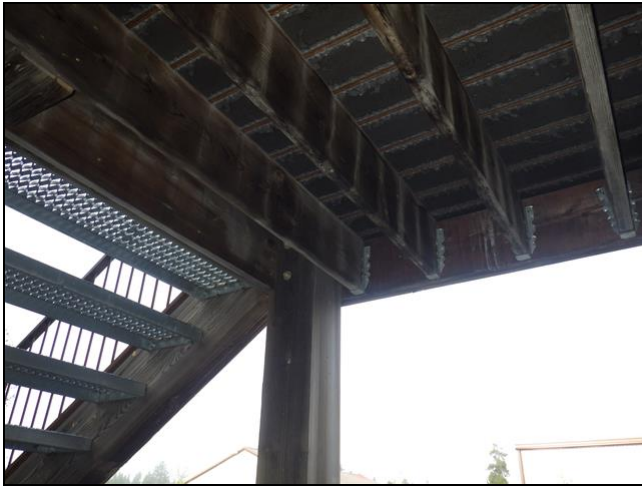
D. Item 1 (Picture)

The beams for the decks do not bear to a column. This is not an acceptable practice for deck construction. The deck stairs lack the proper hardware to attach to the deck. This can lead to separation of the stairs from the deck and a potential fall. Recommend further evaluation and repair of all such deficiencies by a licensed and qualified contractor.

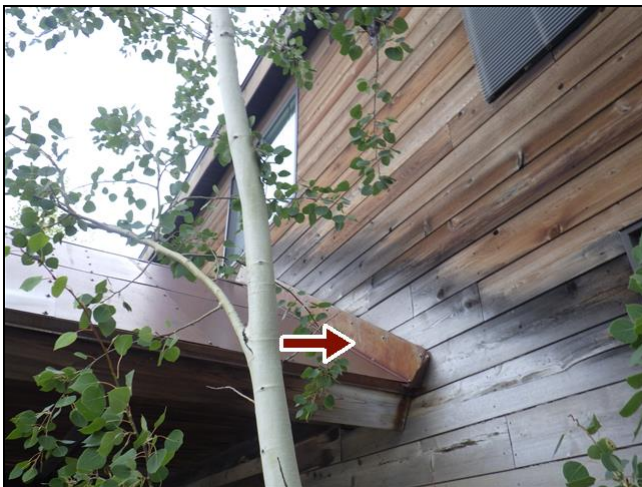
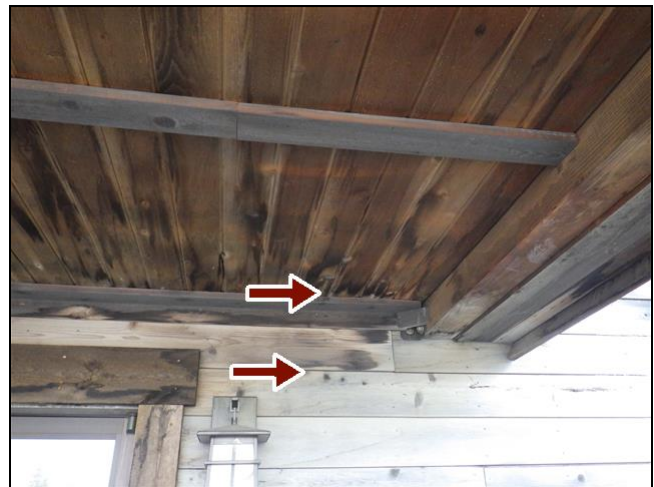
(3) The flashing at the walls at the awnings was not installed correctly. This flashing should be placed under the siding material rather than over it to prevent possible water intrusion. This did not happen here. Recommend repair by a qualified contractor.

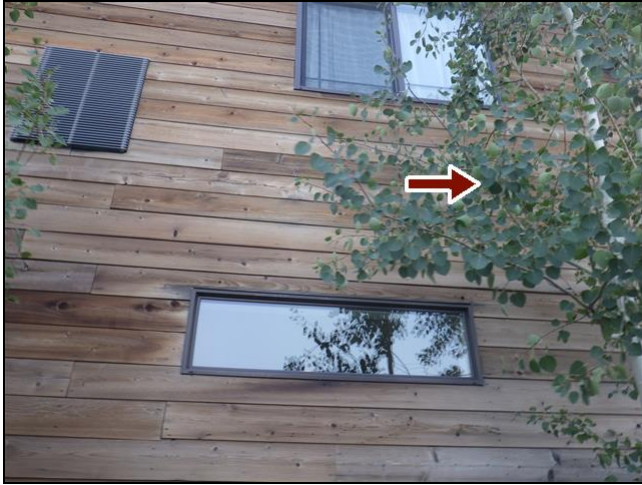
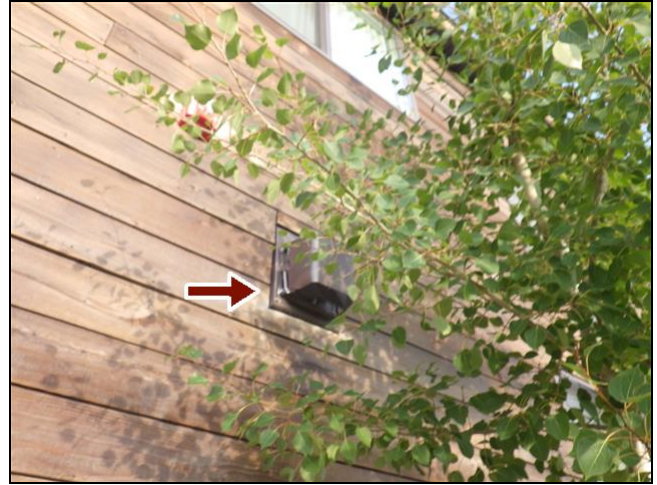
(5) Recommend trimming vegetation from the terminations of the gas insert fireplaces to prevent potential fires.

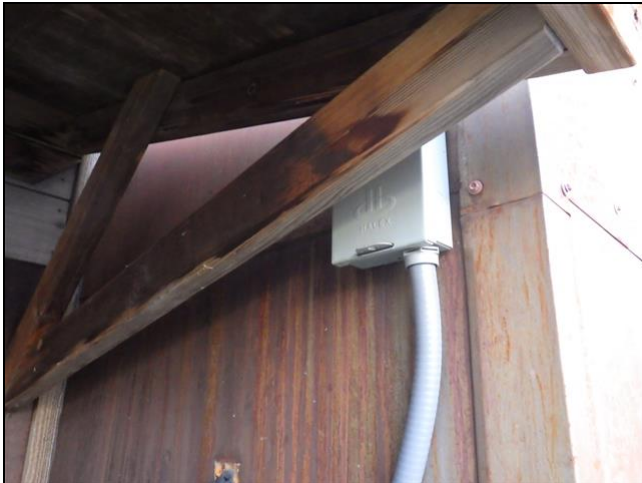
B. Item 2 (Picture)

(2) The serviceman's safety switch cannot be accessed due to the cover over the unit. Recommend redesigning the cover to allow for proper access.

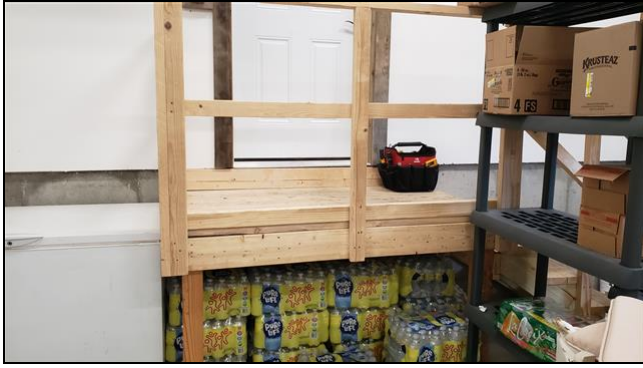
D. Item 1 (Picture)

The stairs to the garage lack proper balusters. Recommend installing.

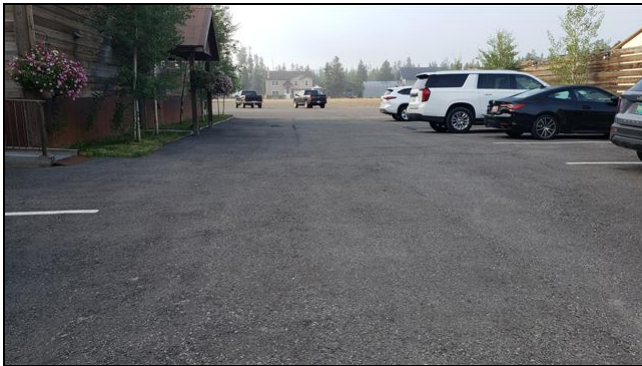
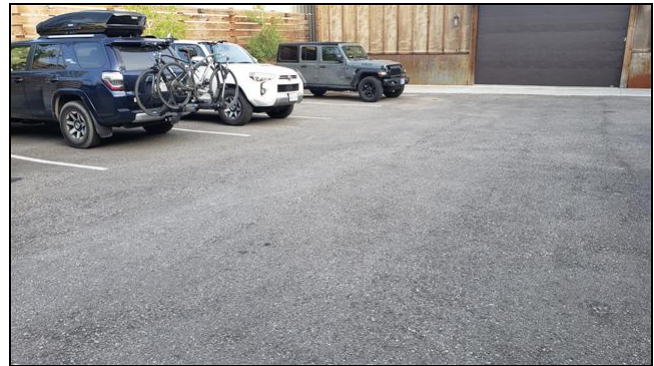
(2) The asphalt surface of parking lot generally is intact with some minor exceptions of cracks in some surface areas typical of its age. It is recommended to perform a maintenance coating which will require painting new lines for parking spaces .
