Inspection Report

Professional Investor

Safe@Home Inspections, LLC

Executive Summary

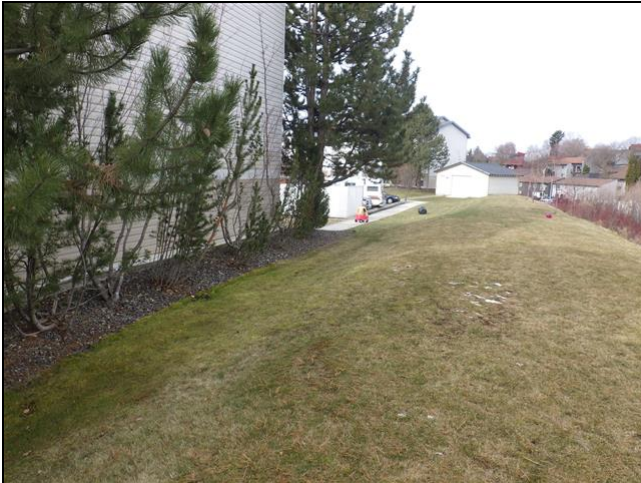
B. Item 1 (Picture)

(1) The property is sloped from the back to the front. This would be generally east to west toward Northwood Drive. Building D sits at the the slope with building a sitting at the bottom of the slope.

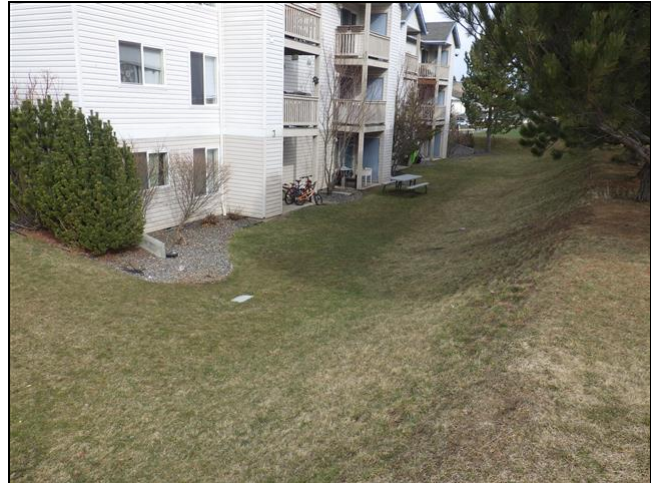
B. Item 2 (Picture)

(2) There is a berm along the East and North sides of the property to separate it from wheat fields and water runoff into a retention zone.

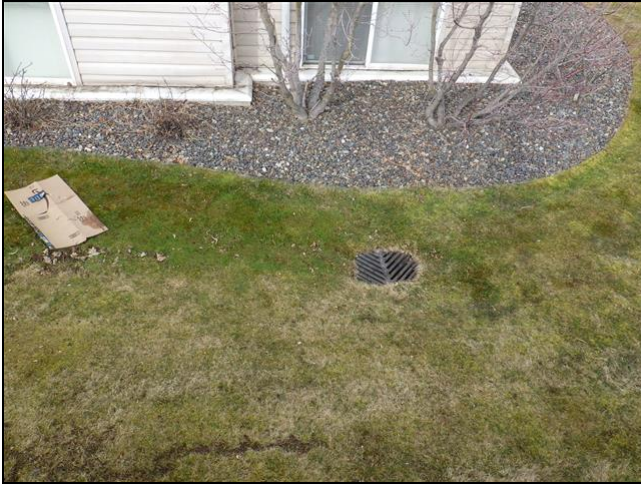
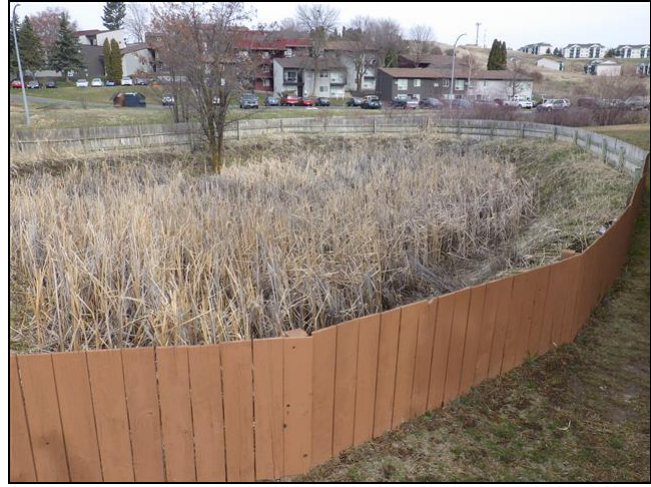
Stormwater drainage is accomplished through a combination of means. Stormwater runoff from the buildings are collected in gutters hung at the eaves at the buildings and directed into underground drains. The landscaped lot has drain at the low points around the buildings. Excess runoff flows to a retention pond that parallels Northwood Drive. Parking lots have stormwater collectors that are fed by sheeting action.

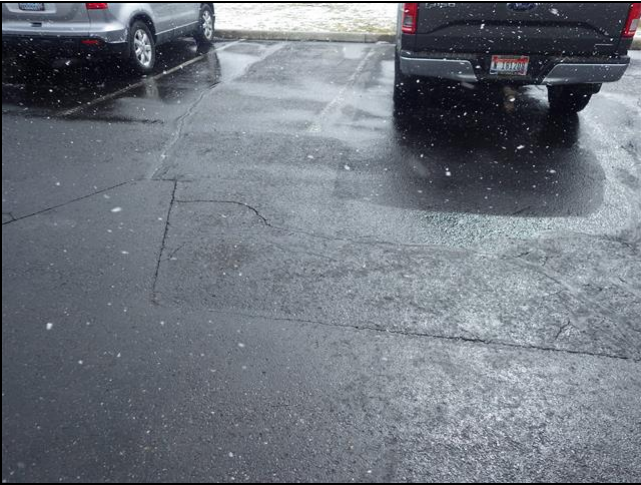
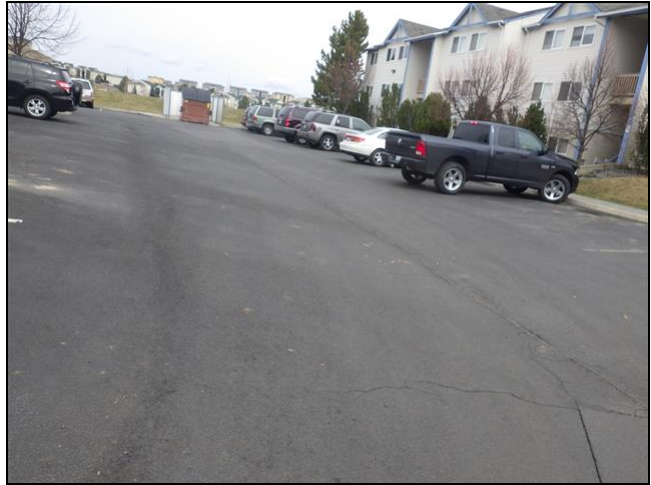
(1) The parking lot and driveway is asphalt over a compacted gravel base. It appears that previous repairs have been made to the asphalt as evident by the patches along the center line or water can be expected to accumulate.

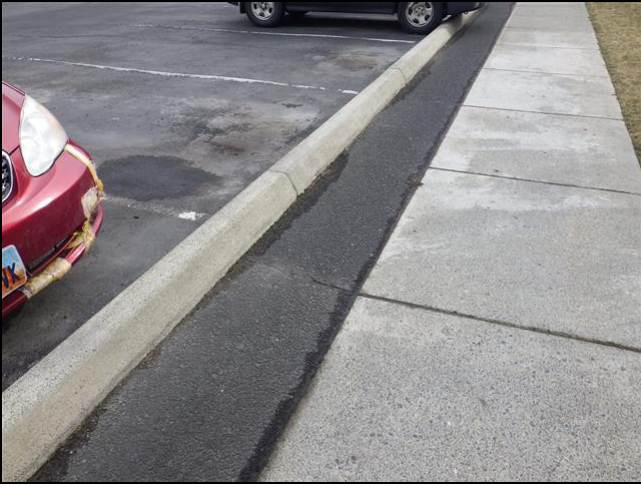
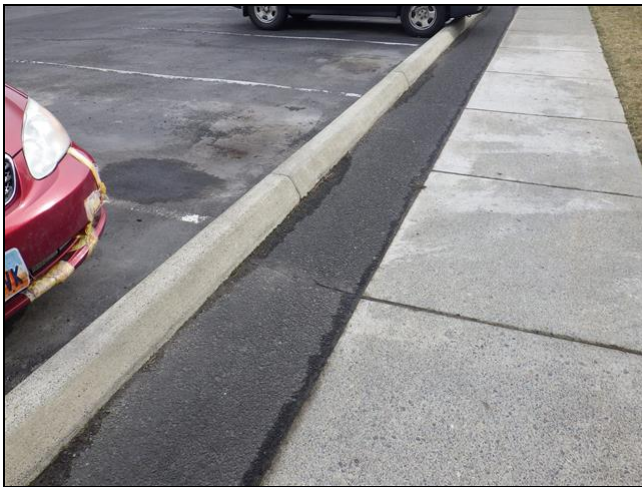
E. Item 3 (Picture)

(4) Striping for the parking lot is in poor repair and do for upgrade.

Estimate: \$1,000 - \$2,500

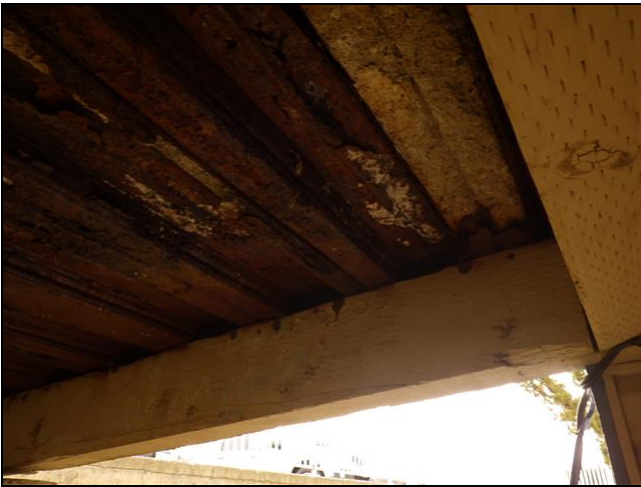
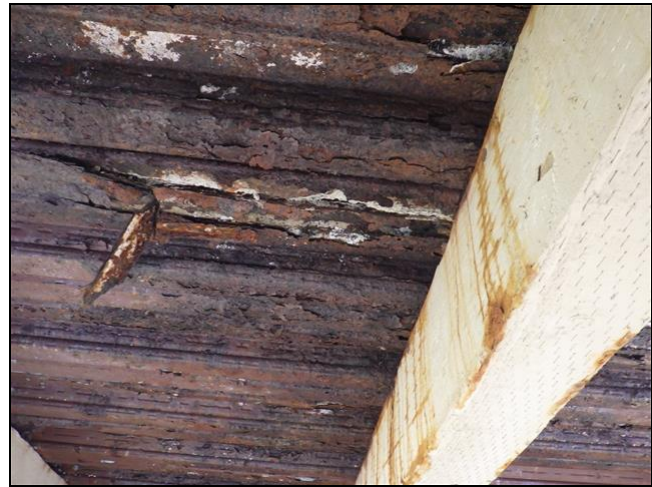
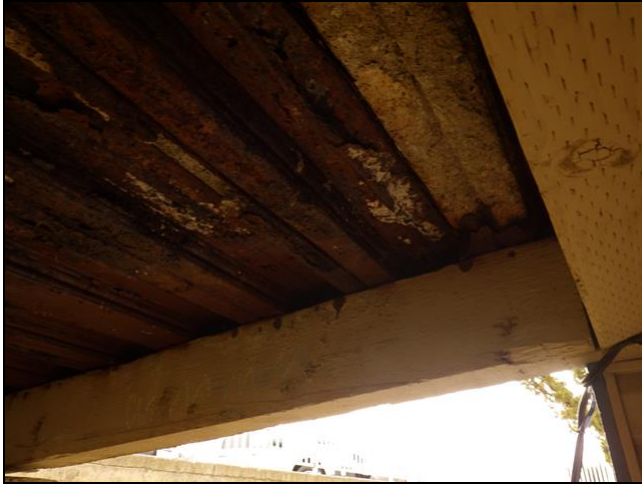
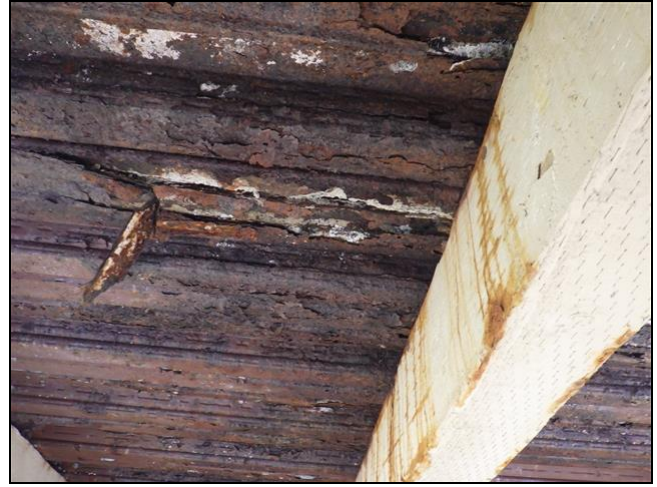
- (1) All the flat work on the property is constructed from concrete.
- (2) There are a pair of access bridges to Building A. These are concrete over steel pans. The steel has rusted. Recommend consulting with a concrete contractor for the need and cost of repairs.

(2) There are a pair of access bridges to Building A. These are concrete over steel pans. The steel has rusted. Recommend consulting with a concrete contractor for the need and cost of repairs.

Estimate: Detailed quotation required.

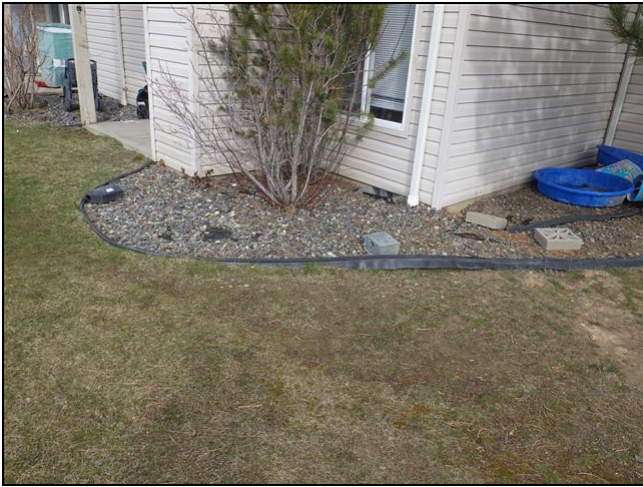
G. Item 1 (Picture)

- (1) The majority of the non-paved lot is covered with grass. Trees and shrubs have been planted. In general, the landscaping appears to be well-maintained.
- (2) Maintenance of the landscaping is performed by the on-site maintenance personnel. The equipment that they use is stored in the shed located next to building E. The shrubs and trees are somewhat overgrown and due for trimming.

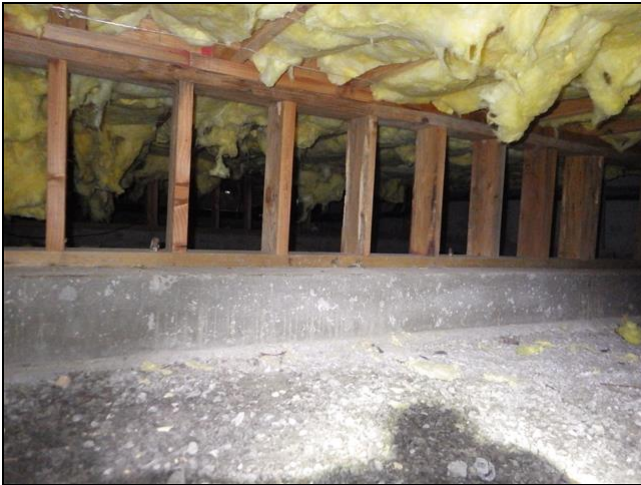
A. Item 1 (Picture)

- (1) The foundation is a reinforced concrete perimeter wall with poured-in-place concrete footings in the crawlspace. All five buildings are on crawlspaces. No deficiencies were noted on the concrete foundation.
- (2) Sub-structure framing was built of 2x10 joists bearing to 2x6 cripple walls. In a change from the original plans, cripple walls were used along the perimeter of the buildings instead of using hangers.

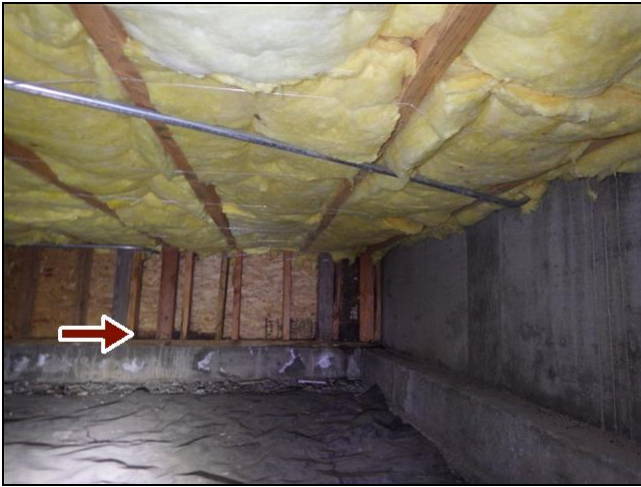
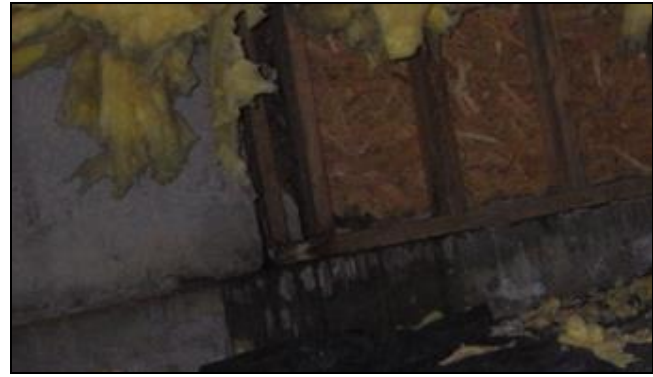
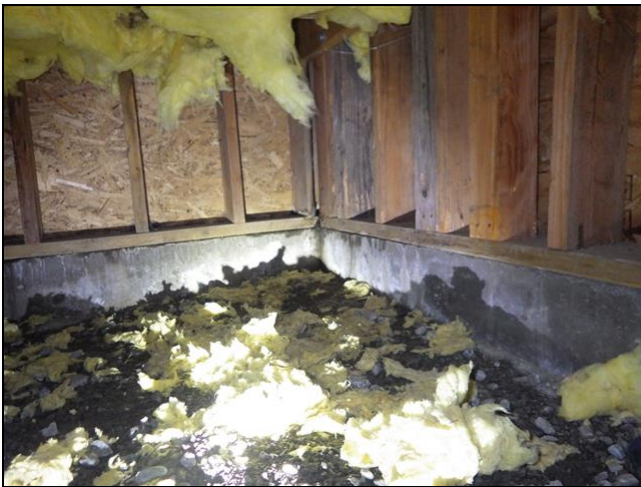
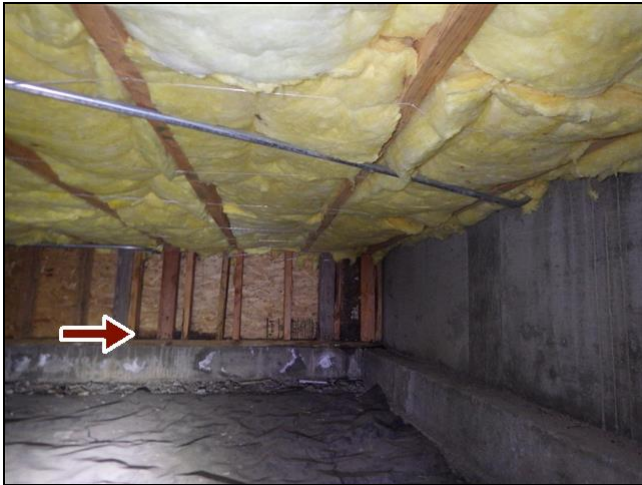
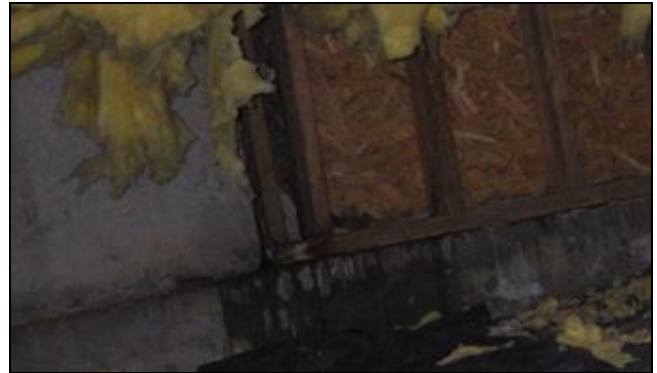
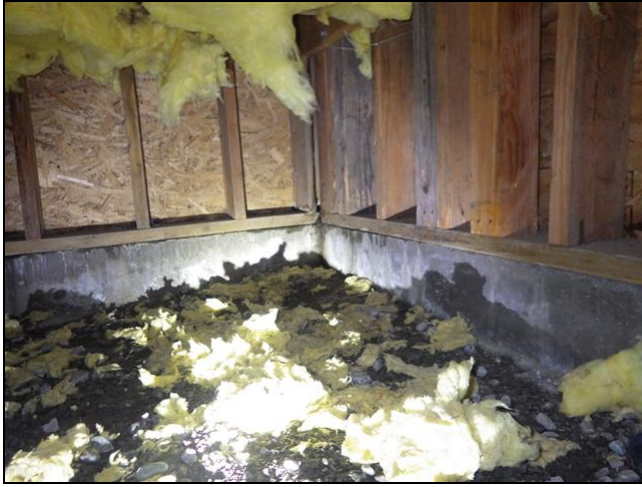
- (3) Entry into several crawlspaces revealed that vapor barriers were poorly installed in spots. Recommend correction.
- (4) Wood rot and mold were visible in the crawlspaces accessed. This appears to be due to water intrusion into the space and the use of framing members immediately against the concrete foundation wall. Recommend remediation of the fungal growths by a mold remediation specialist. Recommend correction of the water intrusion by a foundation specialist.

(4) Wood rot and mold were visible in the crawlspaces accessed. This appears to be due to water intrusion into the space and the use of framing members immediately against the concrete foundation wall. Recommend remediation of the fungal growths by a mold remediation specialist. Recommend correction of the water intrusion by a foundation specialist.

Estimate: Detailed quotation required.

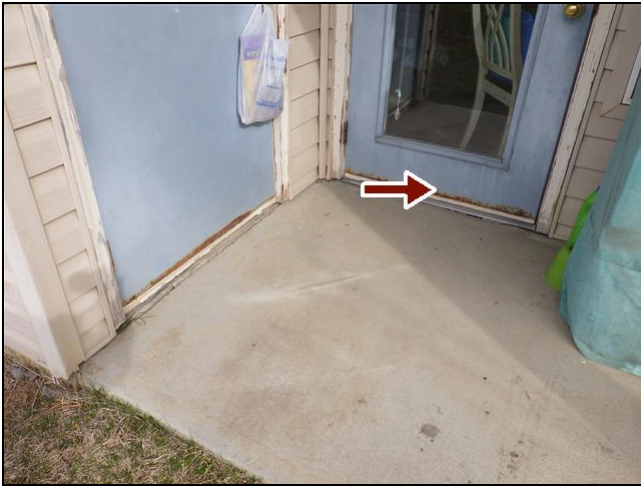
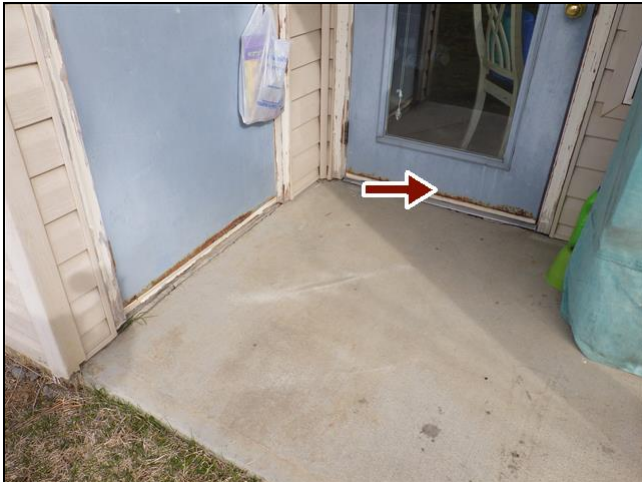
(5) The garden doors showed signs of significant rust due to poor maintenance. These will likely need replacement in the next five years.

Estimate: \$15,000-\$20,000

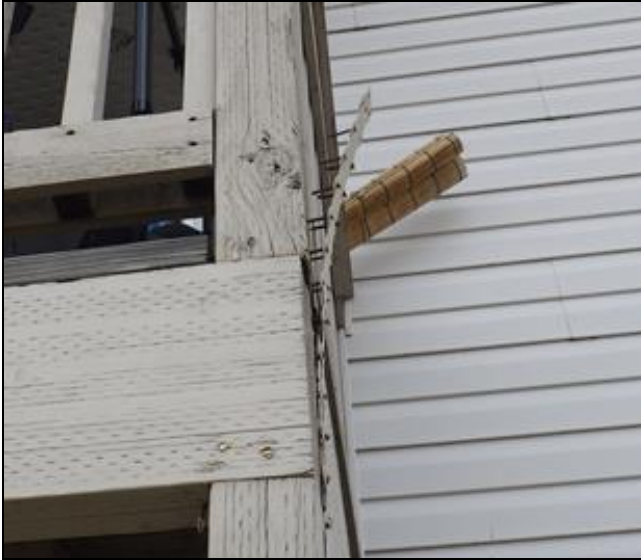
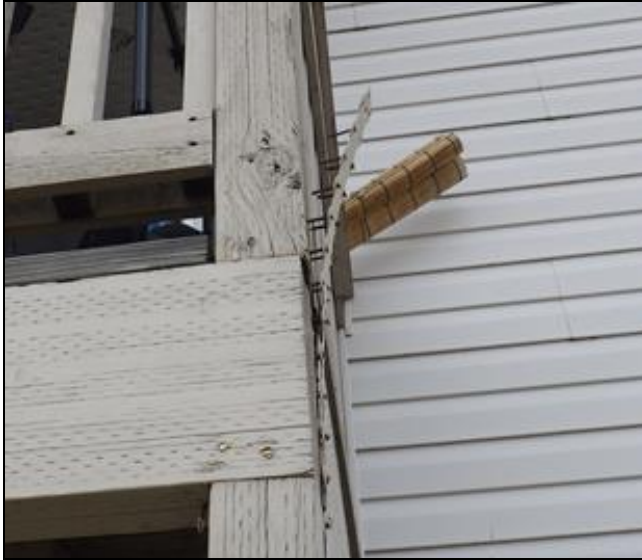
- (1) The deck framing was wood. In general, the decking materials were in satisfactory condition.
- (2) Deck hardware was in poor repair. Recommend correction.

(2) Deck hardware was in poor repair. Recommend correction.

Estimate: \$1,000 - \$2,500

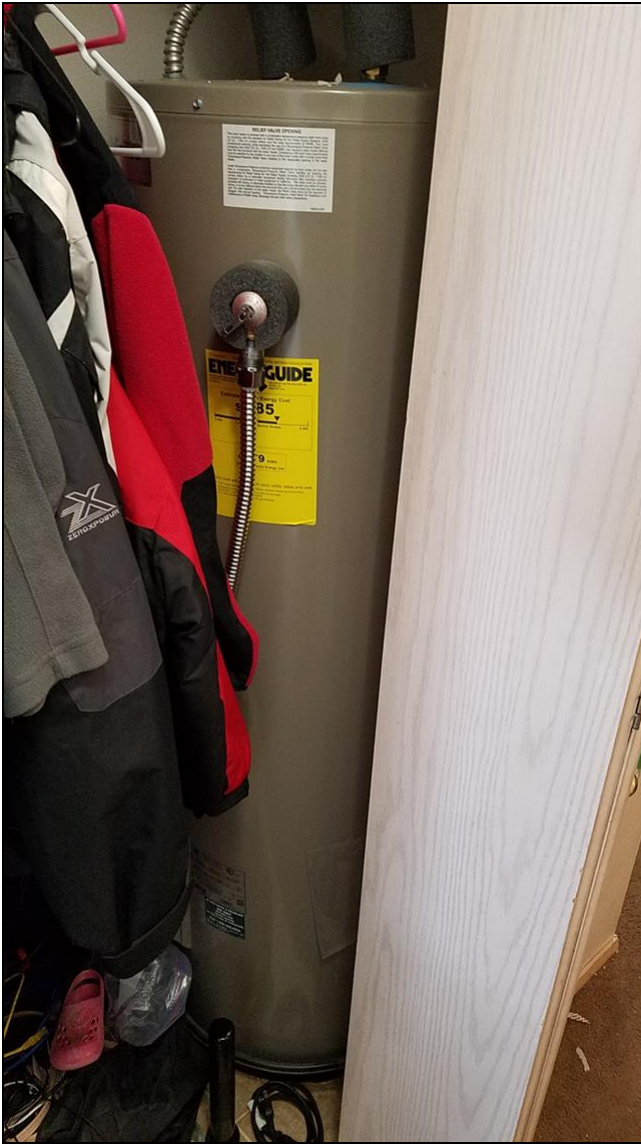
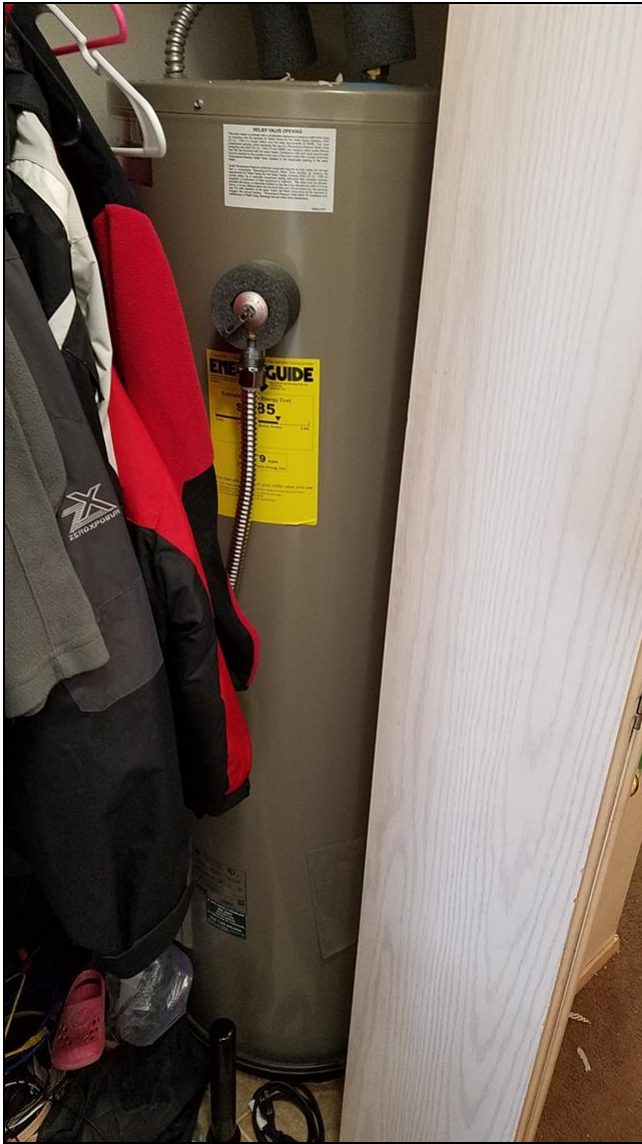
- (4) It does not appear that any of the newer water heaters were installed according to the codes in effect at the time of their installation. Among other findings, we note that drip pans are missing, seismic strapping for water heaters installed after 7/1/2016 were missing, extensions were missing, and extensions were not able to drain by gravity. Also of note is that none of the water heaters were permitted/inspected. Recommend correction of all deficiencies.

(4) It does not appear that any of the newer water heaters were installed according to the codes in effect at the time of their installation. Among other findings, we note that drip pans are missing, seismic strapping for water heaters installed after 7/1/2016 were missing, extensions were missing, and extensions were not able to drain by gravity. Also of note is that none of the water heaters were permitted/inspected. Recommend correction of all deficiencies. Estimate: \$1,000 - \$2,500

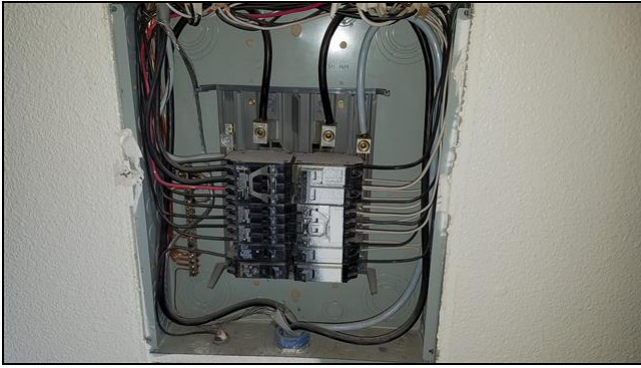
G. Item 1 (Picture)

(1) Inside the units, there were 100 amp secondary panels. A number of covers were removed. No deficiencies were noted.
