# Inspection Report

**Professional Investor**

**Safe@Home Inspections, LLC**

### Executive Summary

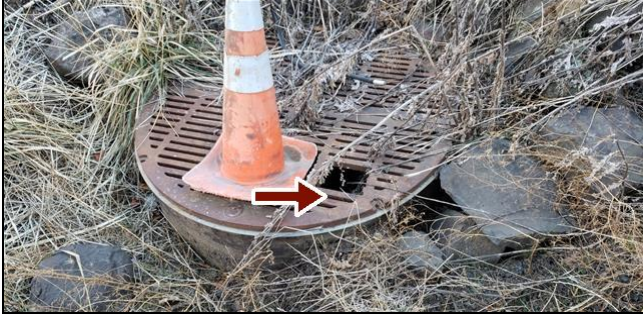
C. Item 1 (Picture)

- (2) It appears that storm water drainage sheets downhill towards the buildings. There is evidence of erosion (settled concrete, foundation cracks) present. Recommend mitigating water sheeting by re-landscaping the lot.
- (3) The cover of one storm water drain is broken. This is a safety hazard. Recommend replacement.

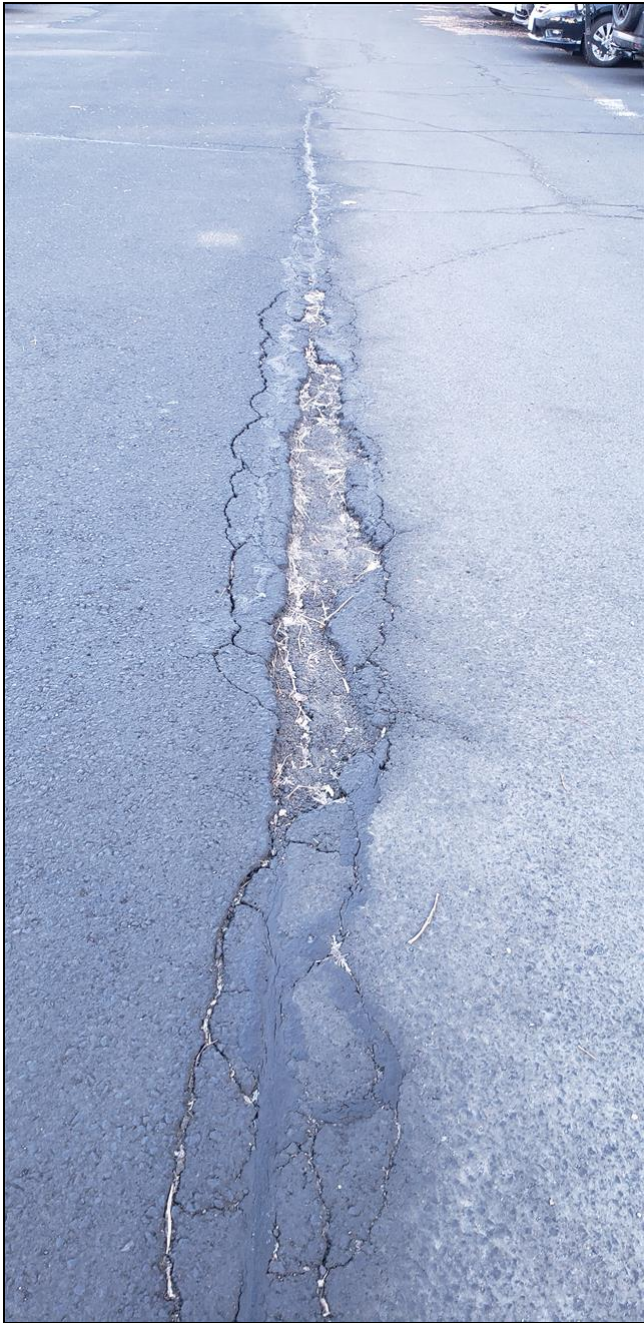
E. Item 1 (Picture)

- (1) The paving is asphalt over a stabilized base with curb stops at Buildings C and D and curbing at west parking lot for the other buildings. The west parking lot appears to have an asphalt overlay on older asphalt.
- (2) The asphalt surface is cracked and is deteriorated in multiple areas. It is recommended to consult further with a paving contractor as to what is necessary to repair and resurface.

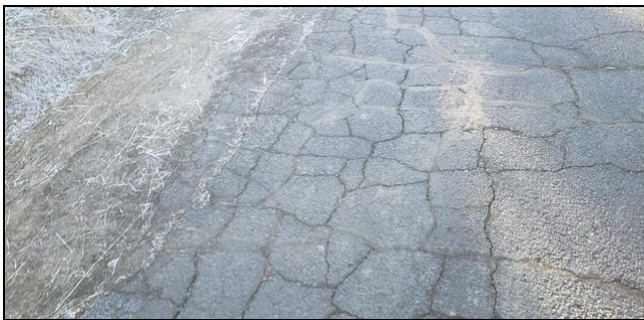
E. Item 3 (Picture)

(3) Striping is substantially faded and is overdue for repair.

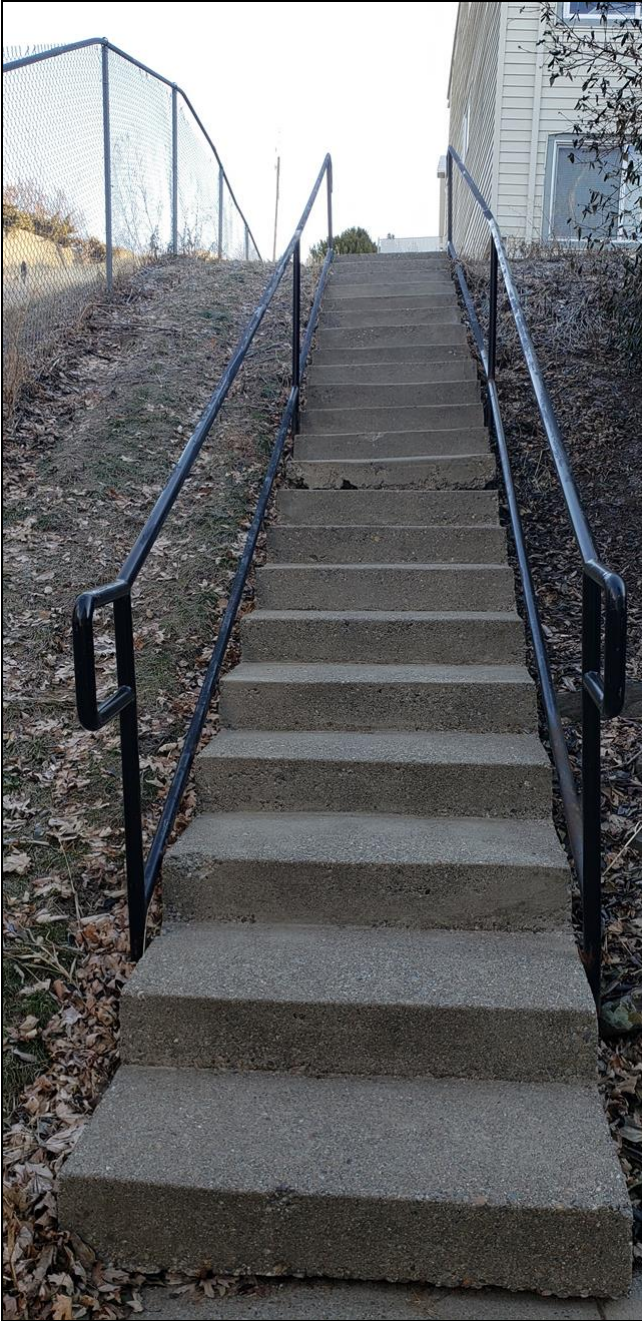
F. Item 1 (Picture)

(1) Stairs from the upper level to the lower are in poor repair with cracking and settlement. This is a potential fall hazard. Recommend replacement.

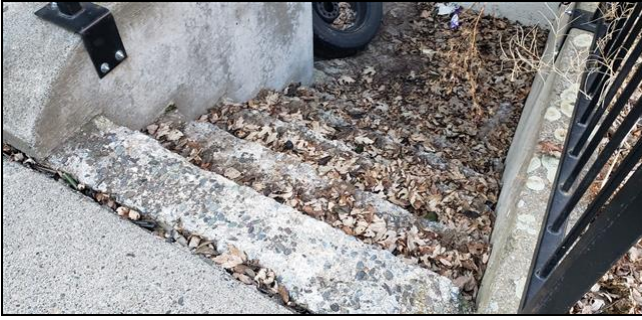
F. Item 2 (Picture)

(2) The stairs to the rear units are in very poor repair with substantial spalling present. The treads are also undersized to modern safety standards. Both pose a hazard of a fall. Recommend replacement.

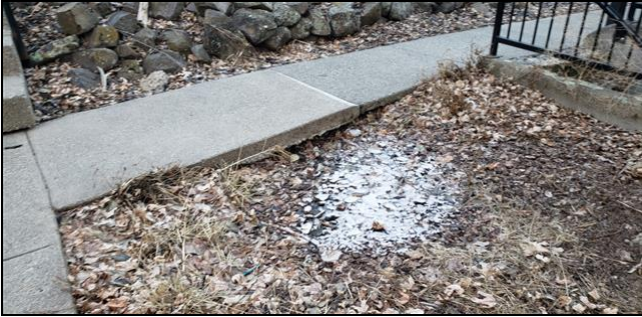
F. Item 3 (Picture)

(3) Walkways show signs of erosion and settlement. In several cases, the walkways have been undermined. All such should be shored up, or where the walkways are too damaged, replaced.

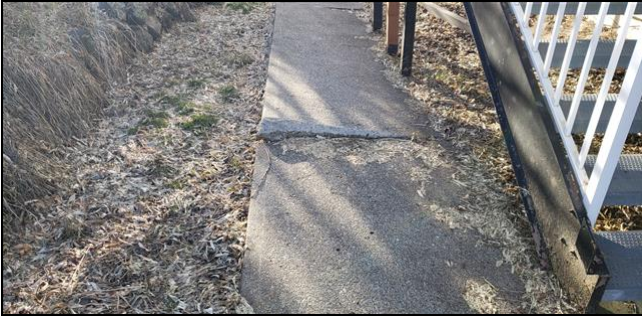
F. Item 5 (Picture)

(4) The concrete for the older walkways has considerable spalling. These pieces will need eventual replacement. Reserves should be held for this.

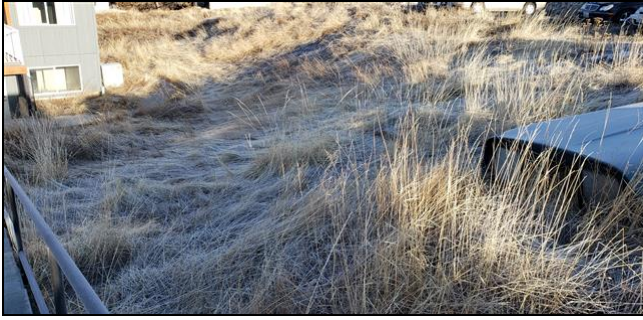
G. Item 1 (Picture)

(1) Significant part of the subject property is devoted to green space. However, this area is very poorly maintained. It appears as overgrown with wild grasses. Trees are in poor condition and in need of attention. And irrigation system appears to be present but probably not functional. Significant improvements are necessary.

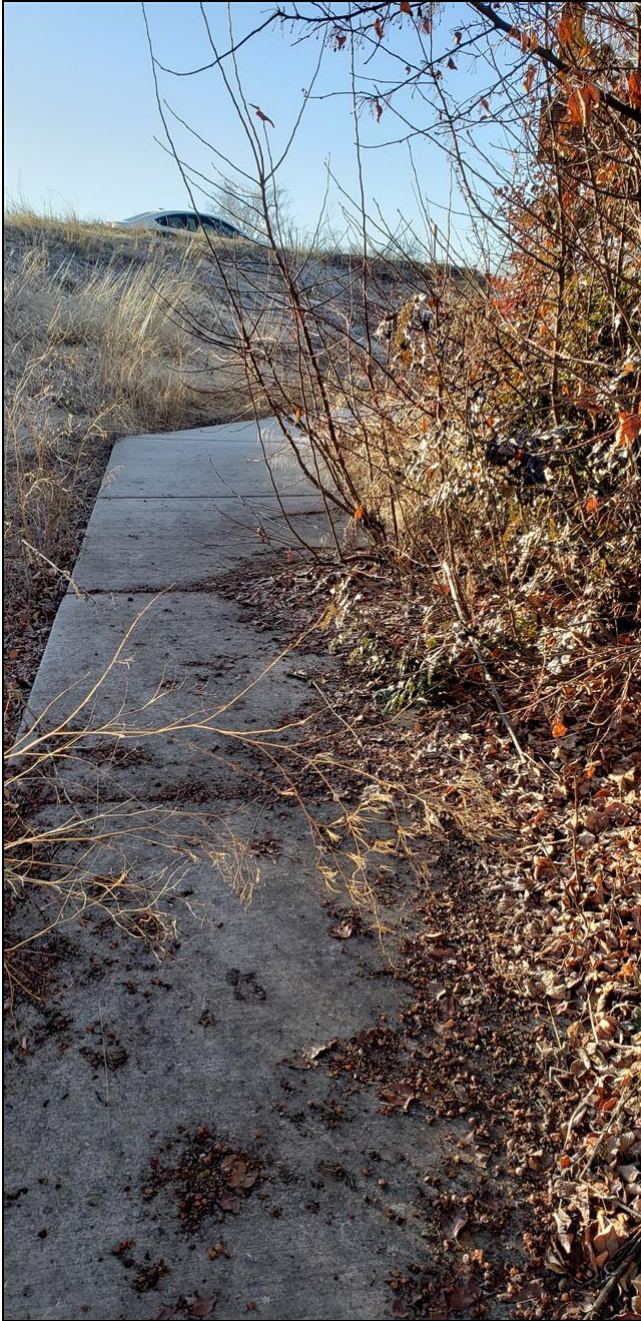
G. Item 3 (Picture)

(2) The volume of overgrown vegetation is a fire hazard. Recommend correction.

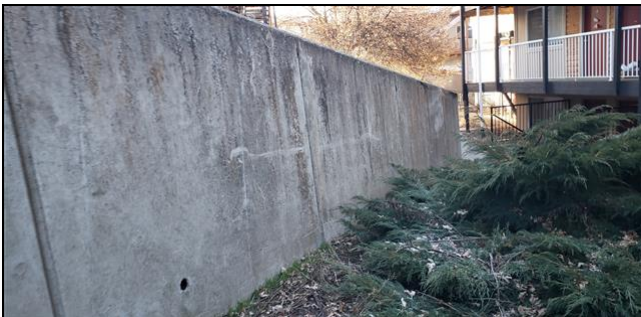
G. Item 4 (Picture)

(3) Concrete retaining walls are present. These appear to be functioning as intended. No significant deficiencies were noted.

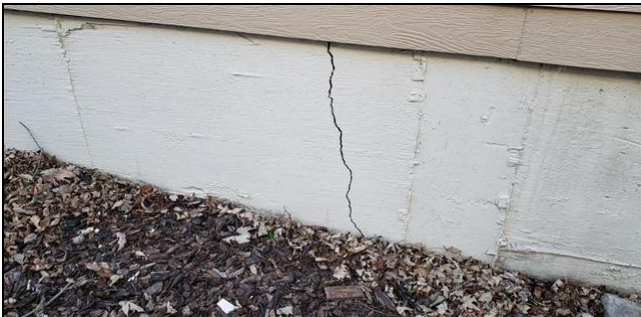
B. Item 1 (Picture)

(2) Cracks were observed on the north side of Buildings B and C. The width of the crack is the larger of the two and is approximately 1/2 inch in width. Given the indications of erosion and undermining of flatwork, this crack, which is larger than typical, may not be stable long-term. Recommend structural engineering evaluation.

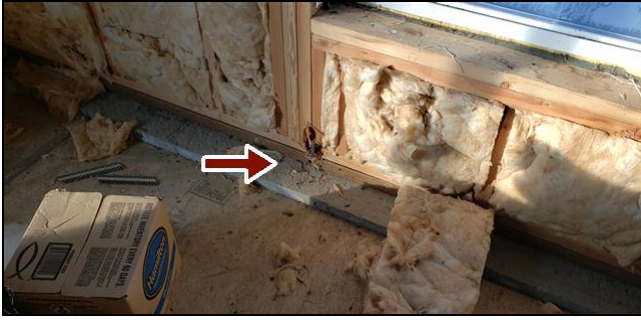
B. Item 2 (Picture)

(3) Anchor bolts at the Leasing Office were not properly located in the middle third of the sole plate as required by building codes. This compromises the uplift resistance and earthquake protection of the anchor bolts. Bolts should be installed every six feet along the plate with a bolt located within 6"-12" of the end of each plate. Recommend repair by a licensed and qualified contractor.

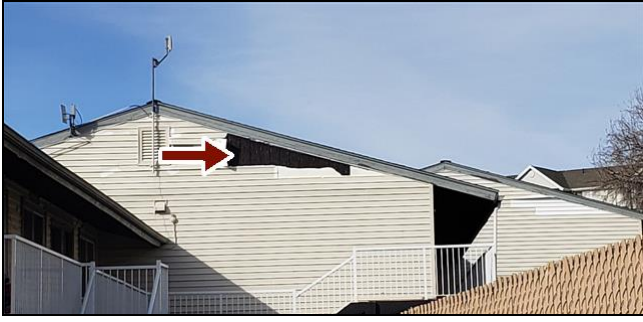
D. Item 1 (Picture)

(2) The vinyl siding is failing. It is detaching in wind. Replacement is necessary.

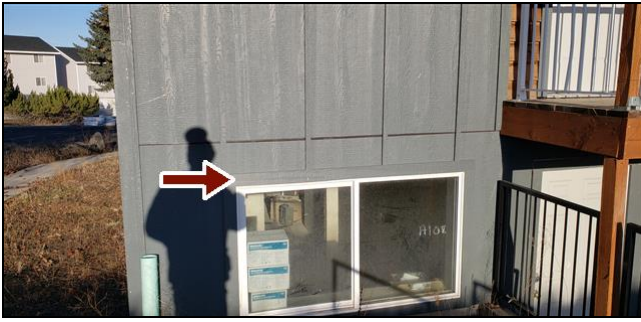
D. Item 4 (Picture)

(4) Head flashing is missing above the doors and windows and at horizontal planes that might accumulate water. This lack of flashing can create water issues within the home. This element is required under the manufacturer's installation specifications and the building codes dating back to 2009. Recommend contacting the contractor to have the flashing installed to the manufacturer's installation specifications.

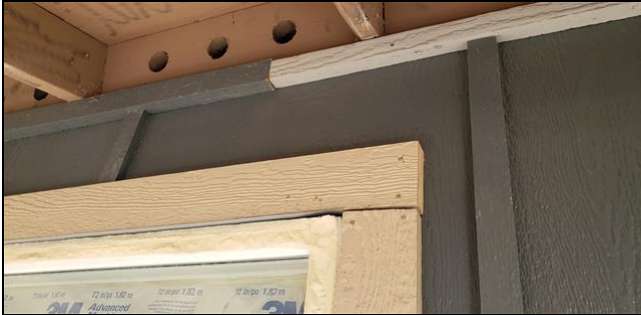
D. Item 5 (Picture)

(5) The fit and finish of the trim work on the hardboard is very poor. Replacement of elements of the trim is likely necessary.

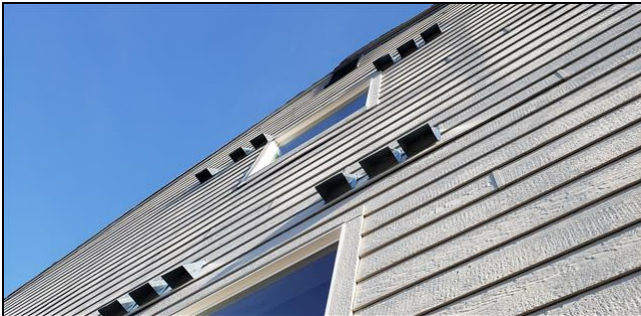
D. Item 7 (Picture)

(6) The hardboard does not appear well-secured. Portions are bulging away from the wall. Recommend evaluation by a licensed and qualified siding contractor.

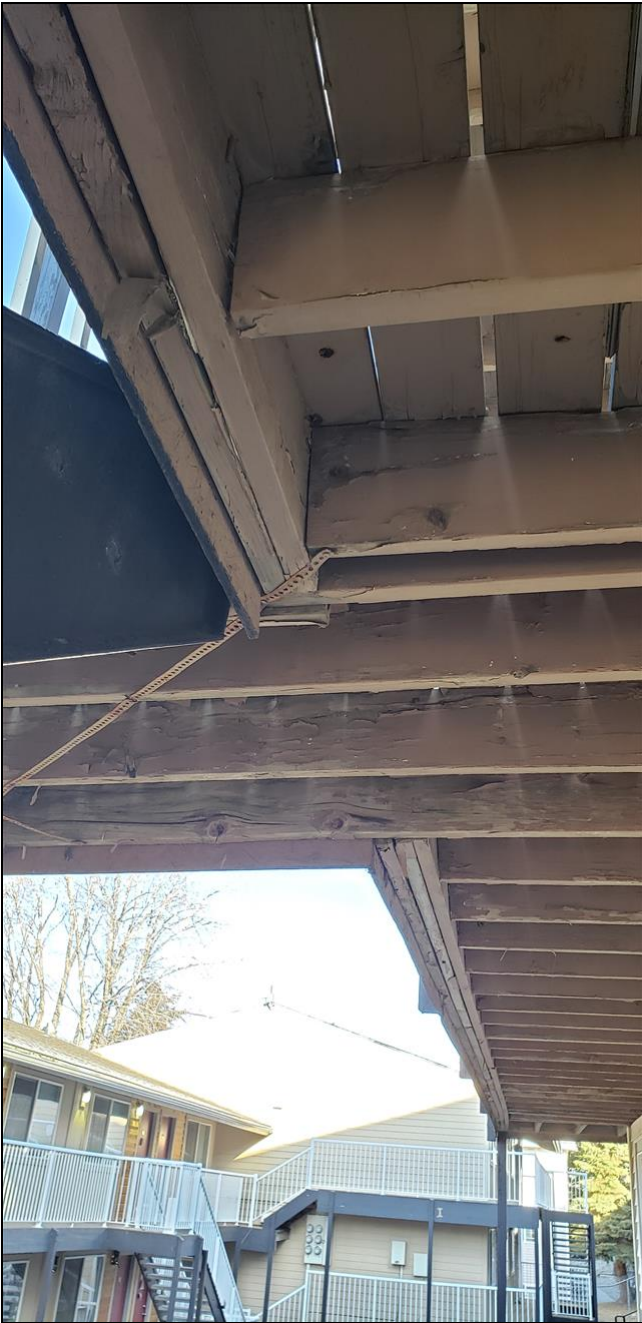
E. Item 1 (Picture)

(4) The joists were not all connected to the framing by use of joist hangers. Recommend installing hangers where missing. Recommend further evaluation and repair by a licensed and qualified contractor.

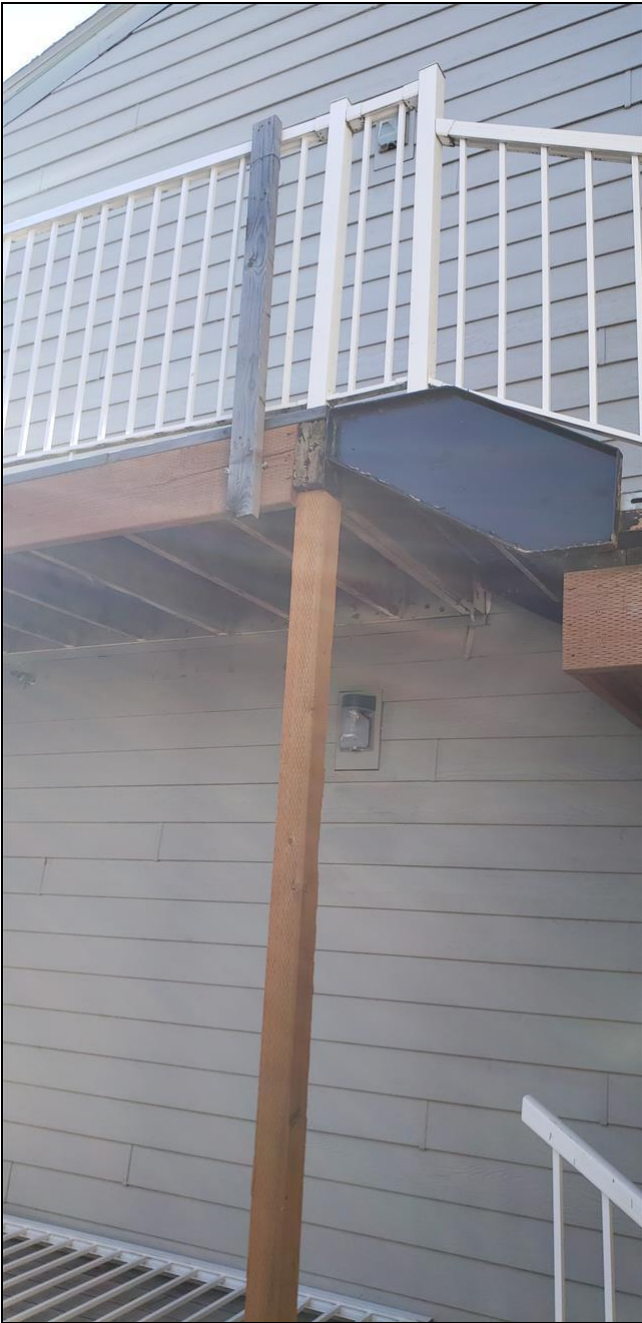
E. Item 2 (Picture)

(5) The maximum allowable height for a 4x4 column is six feet. Most of the columns exceeded this height and should be replaced.

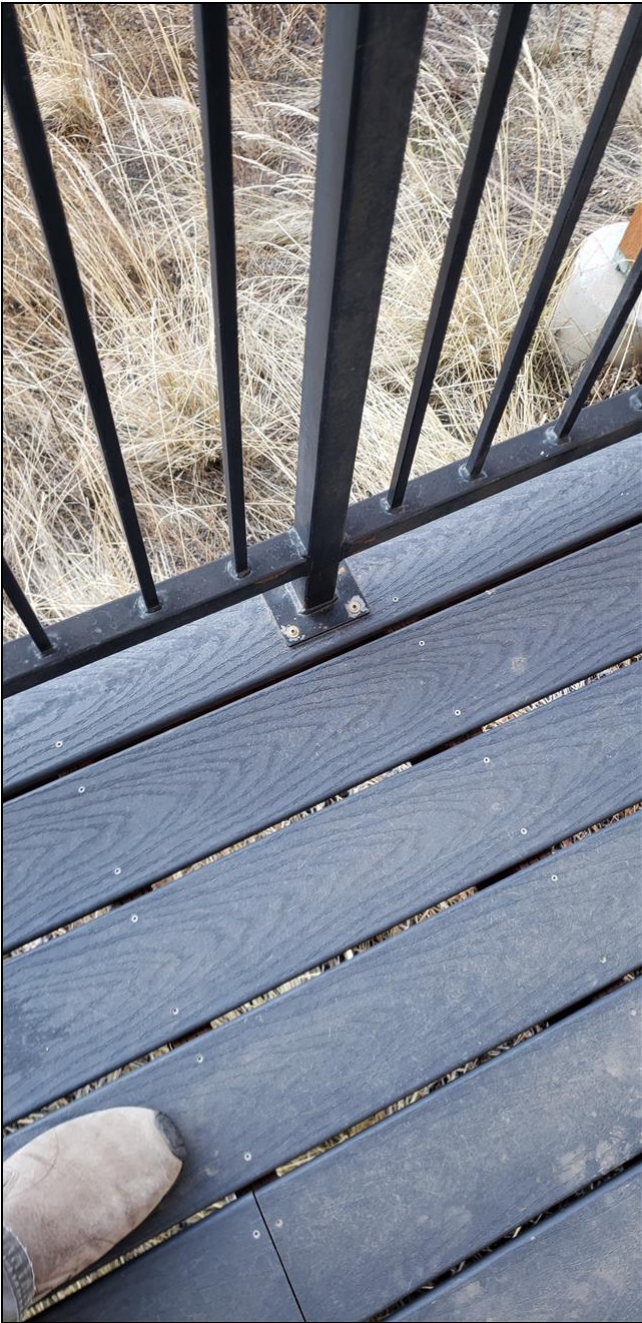
E. Item 3 (Picture)

(7) The railings are universally loose and will not perform as intended. This applies to all five buildings. The Leasing Center railings are not installed to manufacturer specifications for wood composite decking. Blocking is missing and cabinet screws are not permitted.

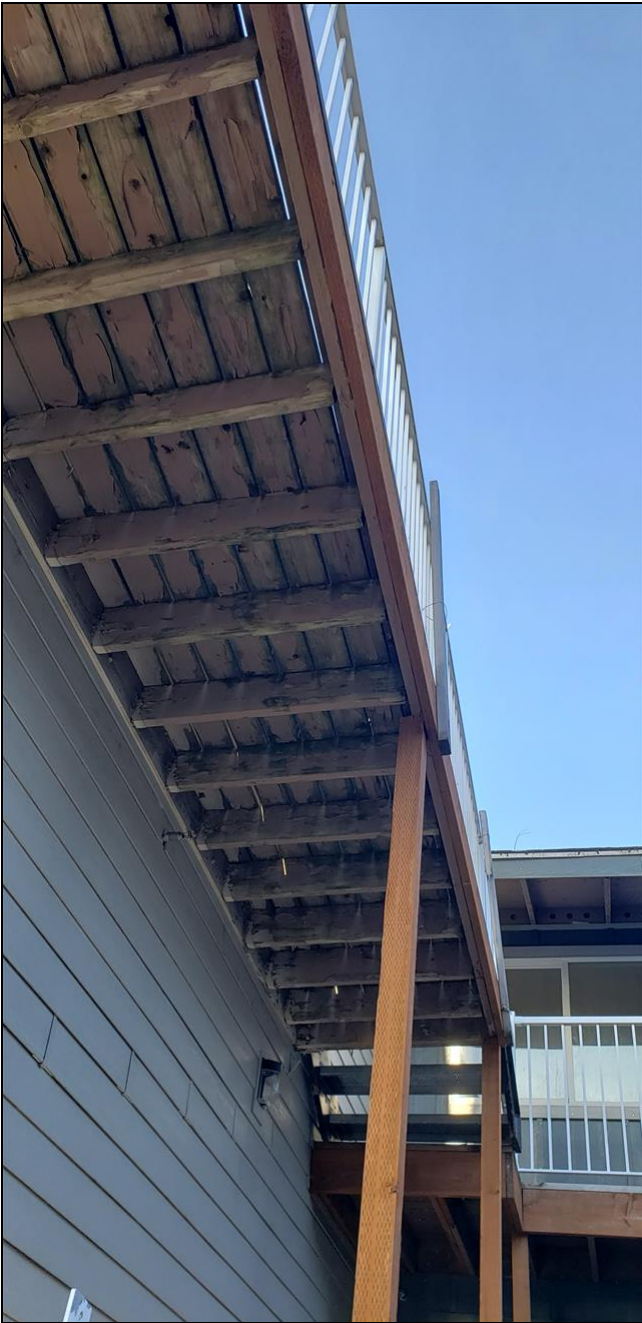
E. Item 4 (Picture)

(8) Beams are built from a single 2-inch dimensional board. The minimum allowable beam width is a 4x6 component. The undersized beam does not provide the same structural support and may be prone to failure. Recommend further evaluation and correction of all such deficiencies by a competent and qualified contractor.

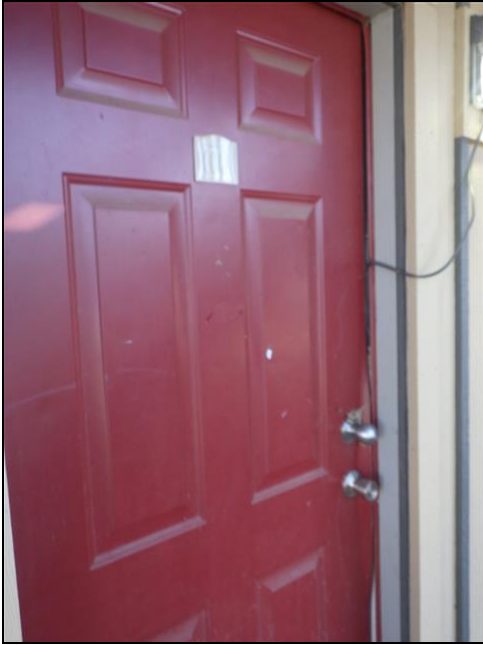
G. Item 1 (Picture)

(2) Each bedroom has an exterior steel door. The doors on Buildings C and D appear original. They are in poor condition and should be replaced.

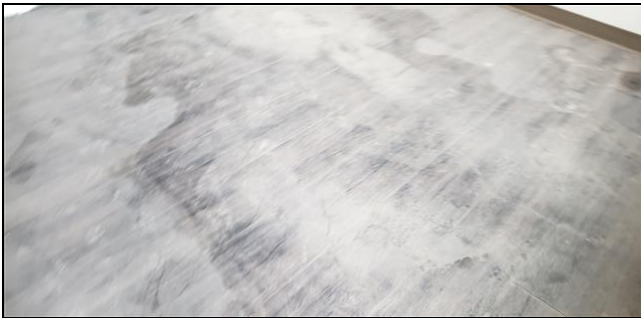
G. Item 2 (Picture)

(3) The doors on Buildings A, B, and the Leasing Center do not appear to have been properly installed, flashed, and sealed as there are multiple units that have water intrusion occurring. Recommend repair.

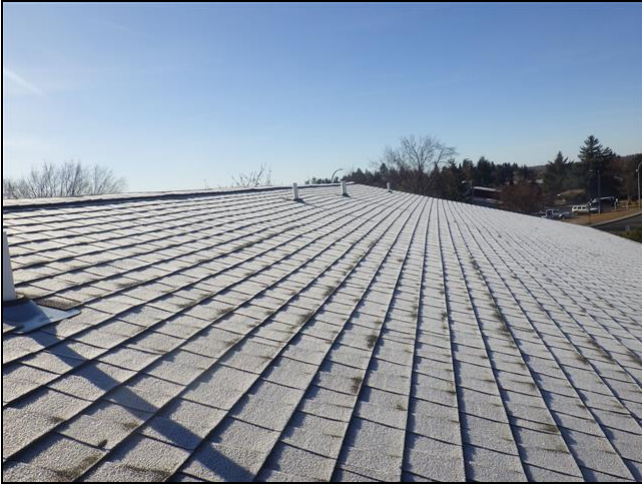
I. Item 1 (Picture)

(1) The roofing for all buildings was an architectural shingle. It appears that the west facing roofs were replaced in 2016. The east facing sides are older shingles with at least three layers.

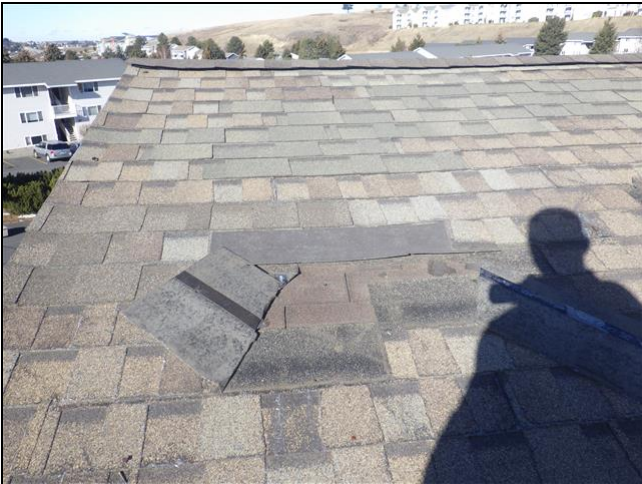
I. Item 2 (Picture)

(2) The roof covering is in very poor condition on the east facing sides of all buildings except the Leasing Office. The roof may not be leaking at time of inspection (this is dependent on weather conditions at the time of the inspection.). The roof is beyond life expectancy. It is unlikely the existing roof covering is or will be water tight. Although some roofing materials in this condition MAY function for a short time, near term replacement of the roofing and flashing should be scheduled. Recommend replacement.

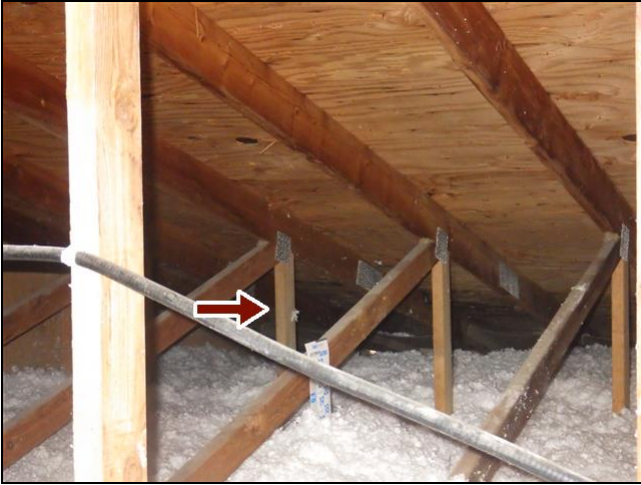
J. Item 1 (Picture)

(2) There were indications of plywood delamination present. In at least one are (Building A) it appears that there is an active water leak. Sheathing will likely need to be replaced when the roofs are replaced.

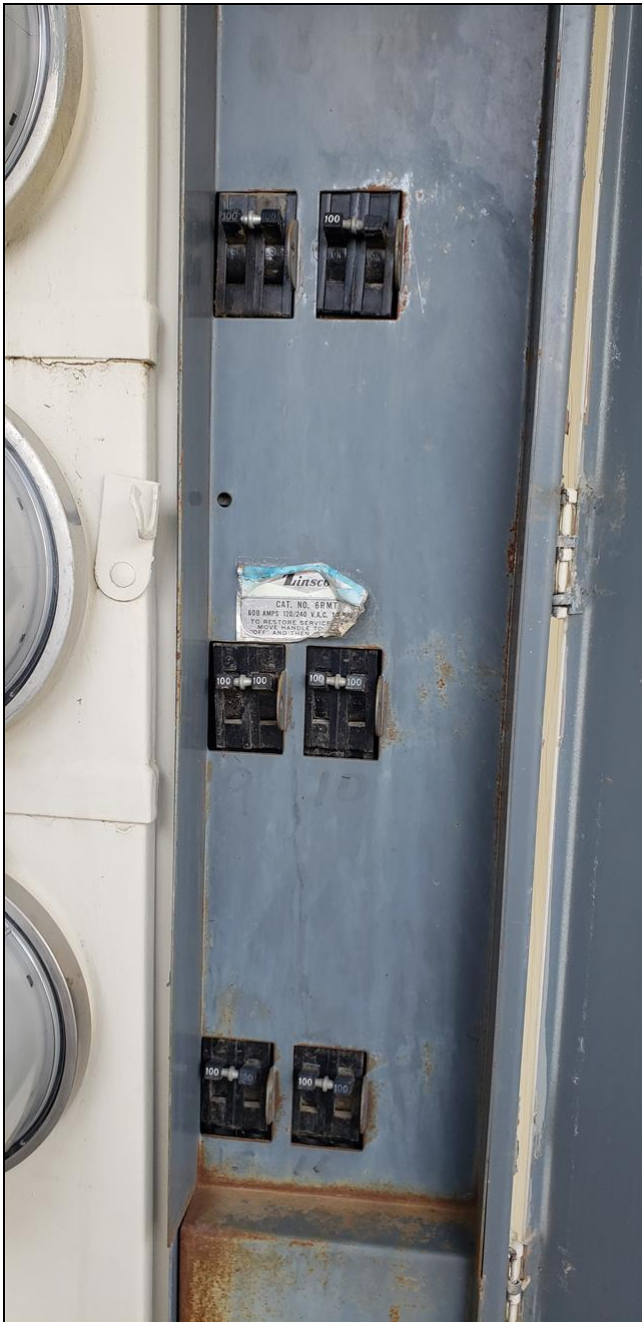
A. Item 3 (Picture)

(2) Buildings C and D were equipped with multiple 120/240 400 amp exterior mounted panels from Zinsco. These panels have long been considered problematical by the industry. The blade type bus bars in these panels were made using an aluminum alloy and tend to corrode, burn, and deteriorate where the breakers attach with a clip. The breakers fail to

lock securely onto the bus bar and this allows the breaker to move and slide around. This increased resistance causes heat, and sometimes fire. Recommend replacement.

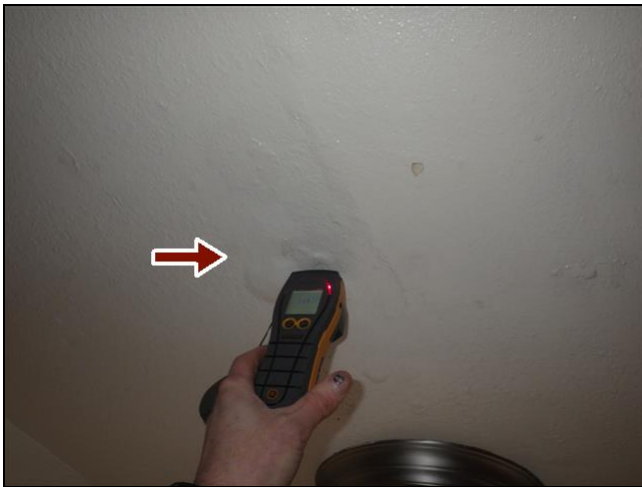
A. Item 1 (Picture)

(3) Active water intrusion/leakage was noted in the ceiling of Unit 4 in Building C. The leakage was taking place between floors so could be supply plumbing or waste. Multiple units had ceiling and wall repairs suggesting plumbing failures. Given this additional information, it appears that the existing plumbing systems, including supply have reached the end of their functional use. Recommend reserves for replacement in Buildings C and D.

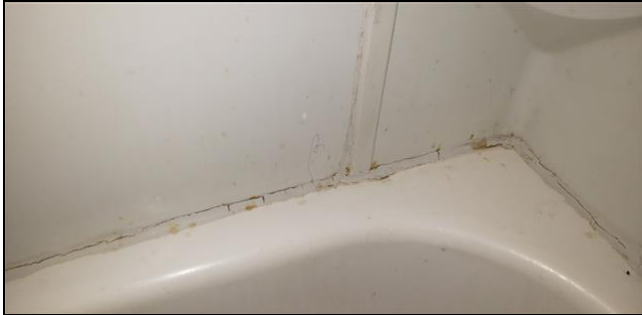
C. Item 1 (Picture)

(2) In Buildings C and D, the shower tubs are generally older and deteriorated. Where repairs have been made, the workmanship has been generally sub-standard. Substantial upgrades for these will be necessary in the next five years.

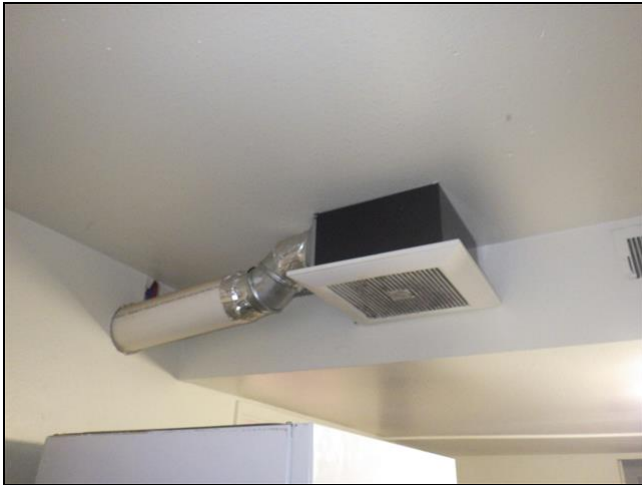
D. Item 1 (Picture)

(3) In the premium units of Buildings C and D (those with washer/dryers), new vents were added. These were not installed in a workmanlike manner. Recommend correction. Exterior terminations lack covers.

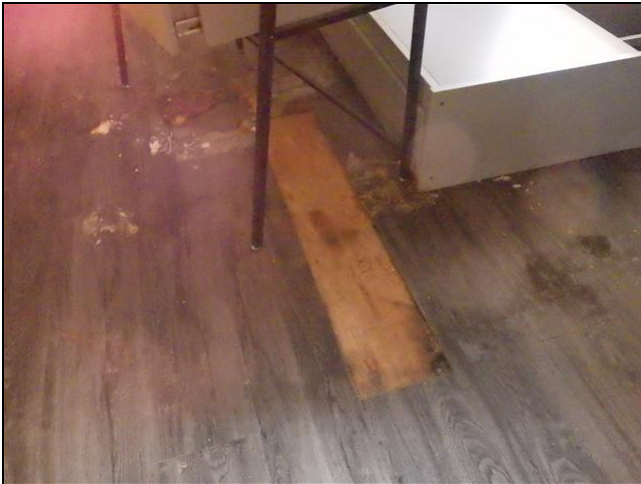
A. Item 1 (Picture)

(3) Flooring in Buildings C and D was uniformly poorly installed. Given the quality of workmanship, replacement is likely the best alternative.

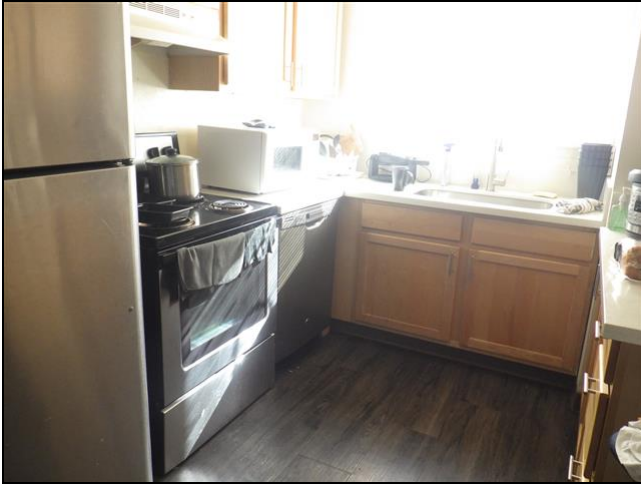
B. Item 1 (Picture)

The kitchen countertops, cabinetry, and vanities in the bedrooms of Buildings C and D are worn and approaching the end of a normal service life. While still currently serviceable, eventual replacement will be necessary.

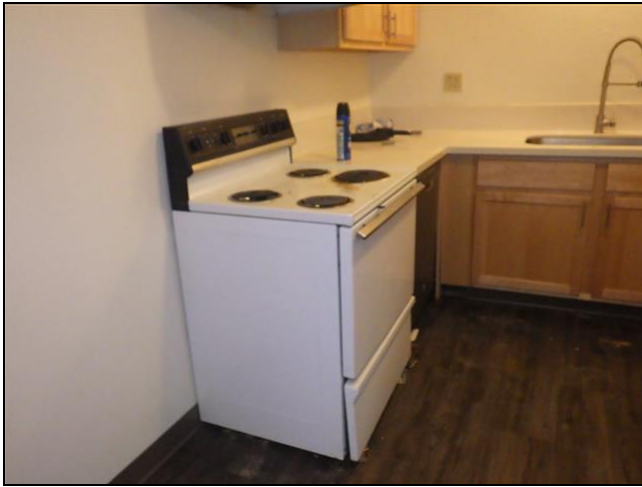
C. Item 1 (Picture)

(2) Many of the appliances of Building C and D are due for replacement.

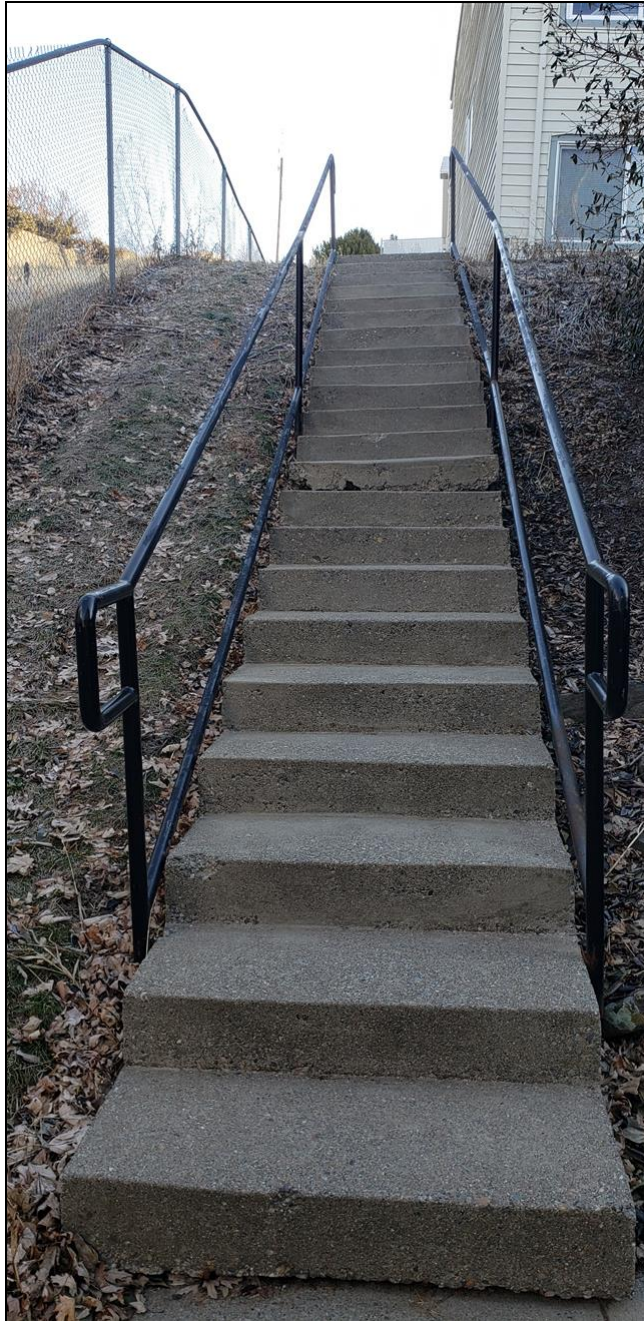
F. Item 1 (Picture)

(1) Stairs from the upper level to the lower are in poor repair with cracking and settlement. This is a potential fall hazard. Recommend replacement.  
Estimate: \$1,000 - \$2,500

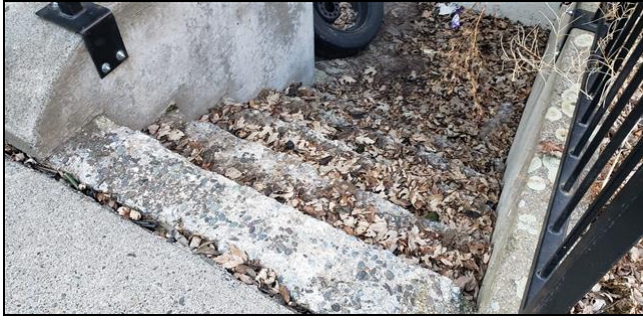
F. Item 2 (Picture)

(2) The stairs to the rear units are in very poor repair with substantial spalling present. The treads are also undersized to modern safety standards. Both pose a hazard of a fall. Recommend replacement.  
Estimate: \$5,000 - \$10,000

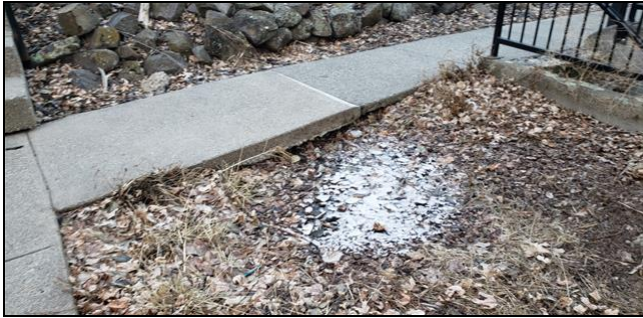
F. Item 3 (Picture)

(3) Walkways show signs of erosion and settlement. In several cases, the walkways have been undermined. All such should be shored up, or where the walkways are too damaged, replaced.  
Estimate: \$5,000 - \$10,000

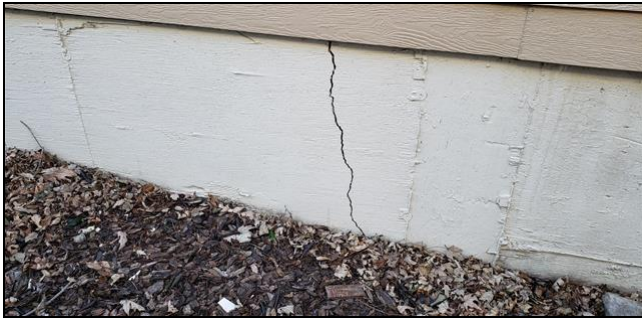
B. Item 1 (Picture)

(2) Cracks were observed on the north side of Buildings B and C. The width of the crack is the larger of the two and is approximately 1/2 inch in width. Given the indications of erosion and undermining of flatwork, this crack, which is larger than typical, may not be stable long-term. Recommend structural engineering evaluation.

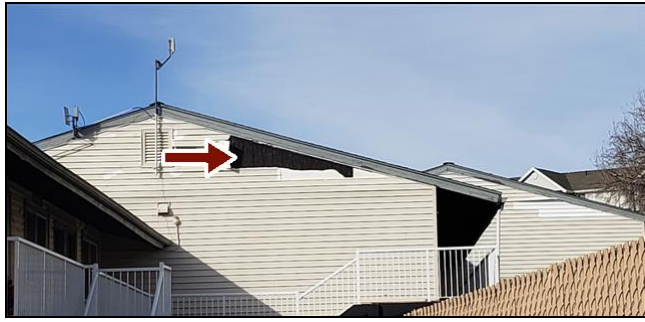
D. Item 1 (Picture)

(2) The vinyl siding is failing. It is detaching in wind. Replacement is necessary.

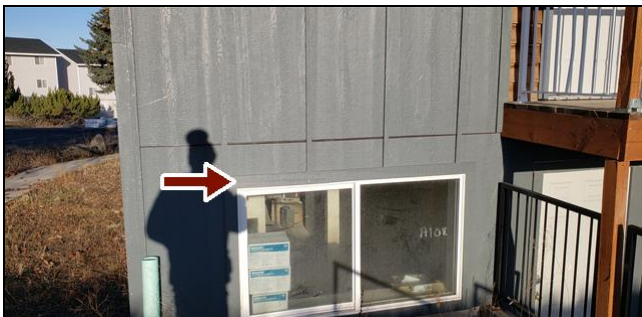
D. Item 4 (Picture)

(4) Head flashing is missing above the doors and windows and at horizontal planes that might accumulate water. This lack of flashing can create water issues within the home. This element is required under the manufacturer's installation specifications and the building codes dating back to 2009. Recommend contacting the contractor to have the flashing installed to the manufacture's installation specifications.

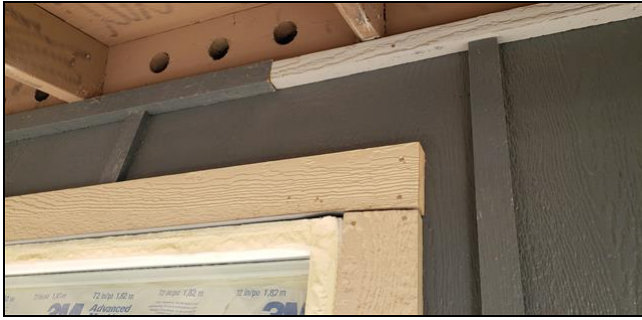
D. Item 5 (Picture)

(5) The fit and finish of the trim work on the hardboard is very poor. Replacement of elements of the trim is likely necessary.

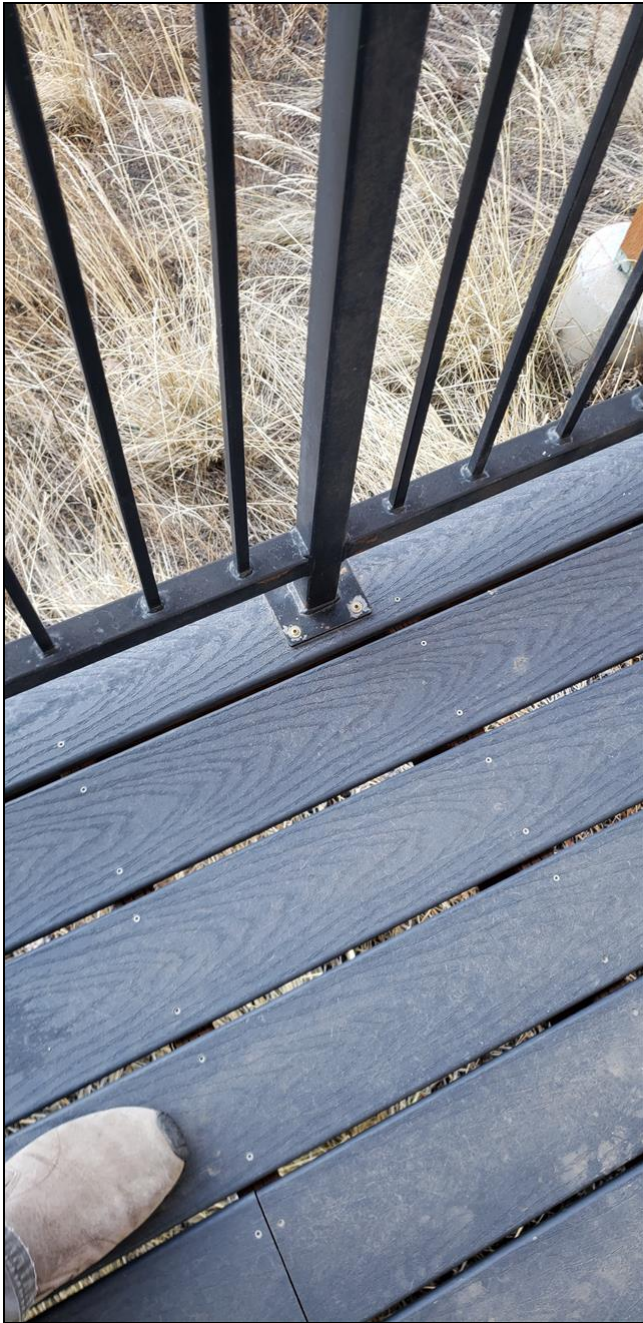
E. Item 3 (Picture)

(7) The railings are universally loose and will not perform as intended. This applies to all five buildings. The Leasing Center railings are not installed to manufacturer specifications for wood composite decking. Blocking is missing and cabinet screws are not permitted.

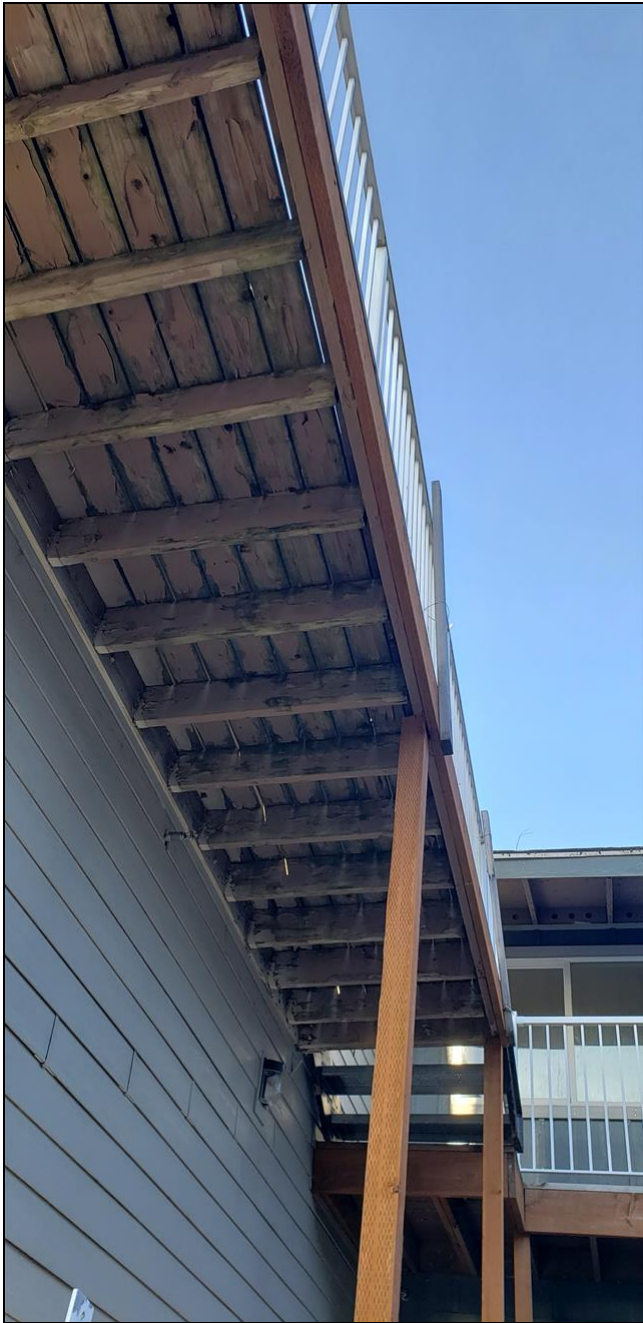
E. Item 4 (Picture)

(8) Beams are built from a single 2-inch dimensional board. The minimum allowable beam width is a 4x6 component. The undersized beam does not provide the same structural support and may be prone to failure. Recommend further evaluation and correction of all such deficiencies by a competent and qualified contractor.

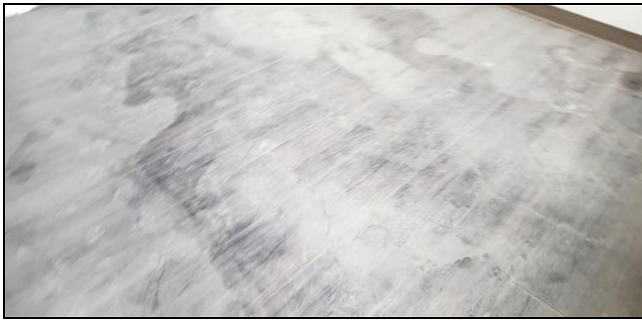
G. Item 2 (Picture)

(3) The doors on Buildings A, B, and the Leasing Center do not appear to have been properly installed, flashed, and sealed as there are multiple units that have water intrusion occurring. Recommend repair.  
 Estimate: Detailed quotation required.

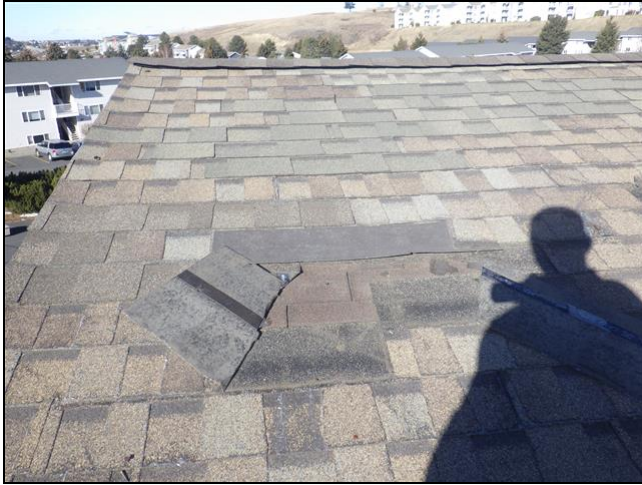
I. Item 2 (Picture)

(2) The roof covering is in very poor condition on the east facing sides of all buildings except the Leasing Office. The roof may not be leaking at time of inspection (this is dependent on weather conditions at the time of the inspection.). The roof is beyond life expectancy. It is unlikely the existing roof covering is or will be water tight. Although some roofing materials in this condition MAY function for a short time, near term replacement of the roofing and flashing should be scheduled. Recommend replacement.  
 Estimate: \$80,000-\$100,000.00

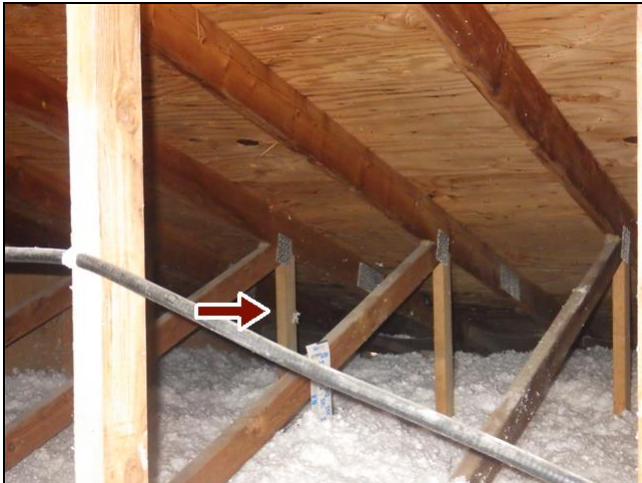
J. Item 1 (Picture)

(2) There were indications of plywood delamination present. In at least one area (Building A) it appears that there is an active water leak. Sheathing will likely need to be replaced when the roofs are replaced.

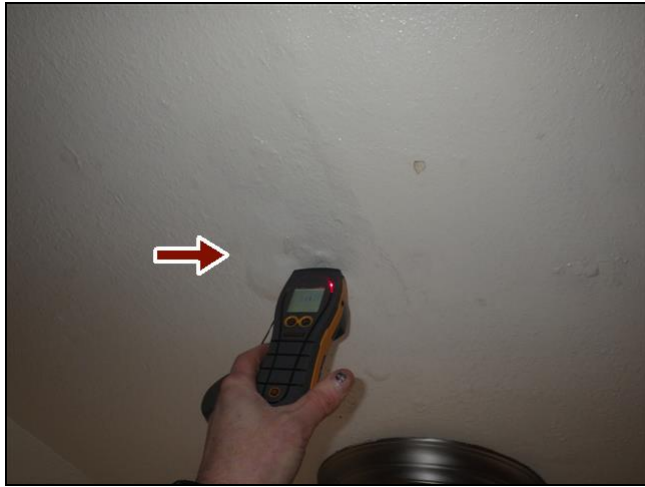
A. Item 1 (Picture)

(3) Active water intrusion/leakage was noted in the ceiling of Unit 4 in Building C. The leakage was taking place between floors so could be supply plumbing or waste. Multiple units had ceiling and wall repairs suggesting plumbing failures. Given this additional information, it appears that the existing plumbing systems, including supply have reached the end of their functional use. Recommend reserves for replacement in Buildings C and D. Estimate: Detailed quotation required.

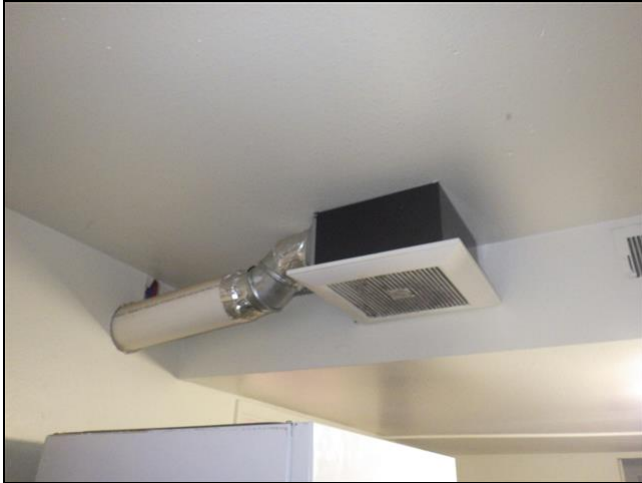
D. Item 1 (Picture)

(3) In the premium units of Buildings C and D (those with washer/dryers), new vents were added. These were not installed in a workmanlike manner. Recommend correction. Exterior terminations lack covers.

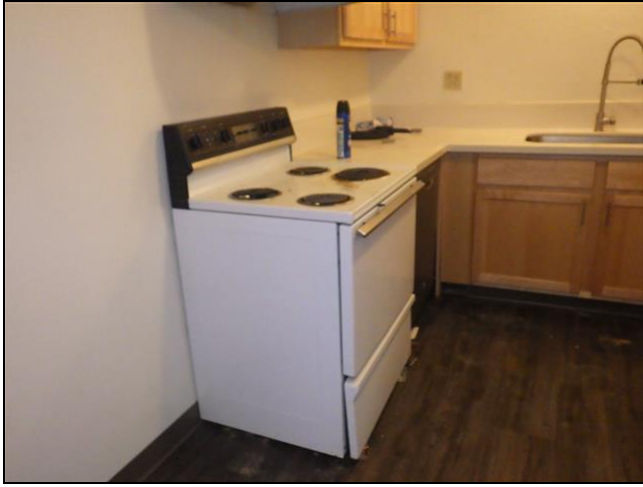
C. Item 1 (Picture)

(2) Many of the appliances of Building C and D are due for replacement.  
Estimate: Detailed quotation required.
