Inspection Report

Professional Investor

Safe@Home Inspections, LLC

Executive Summary

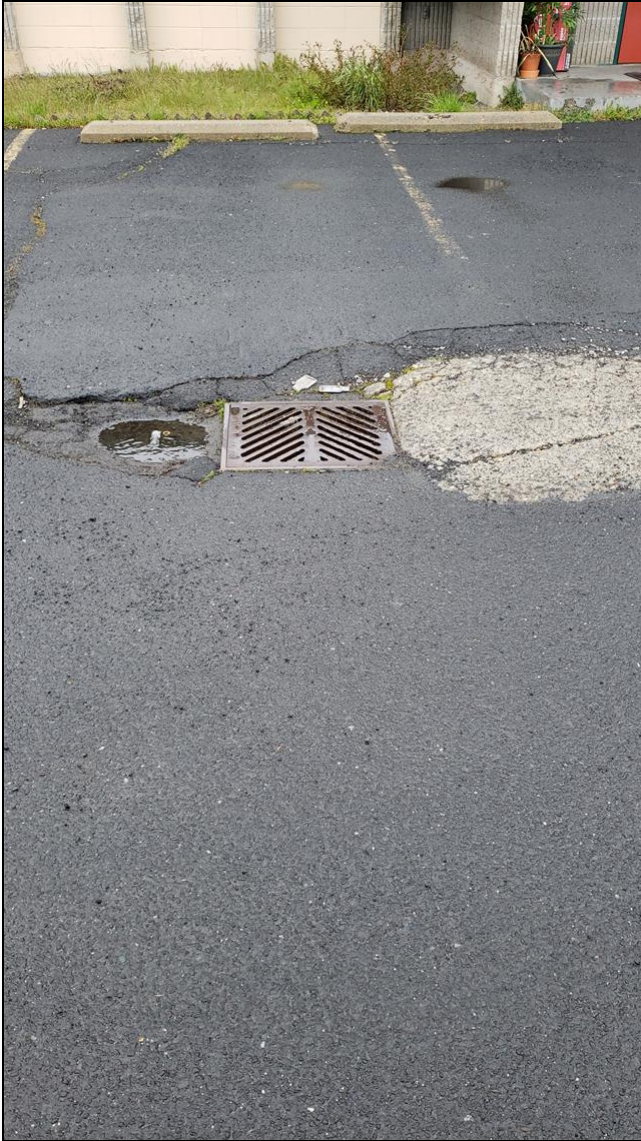
B. Item 1 (Picture)

The area around the storm drain is damaged the water does not properly drain. The roof drains on the rear of the building are damaged and leaking at the rear foundation. Recommend repair of both items.

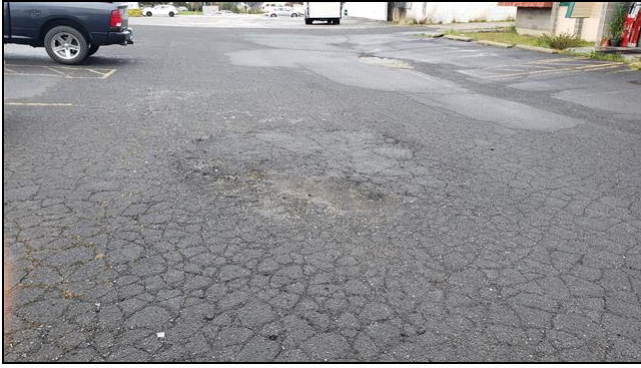
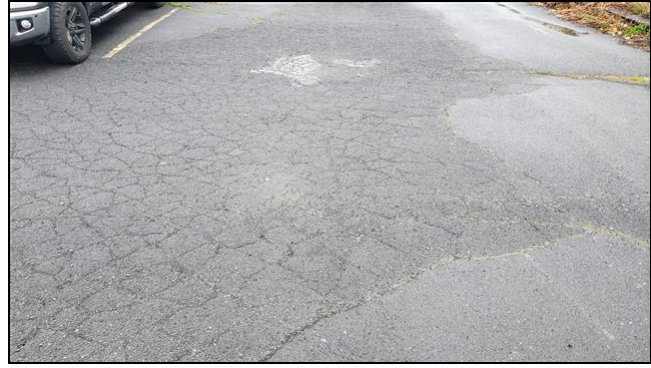
(1) Parking lot appears to be an asphalt system installed over compact gravel base.

(2) The parking lot has suffered severe deterioration. It is likely that the substructure soils have been compromised. Extensive cracking of the surface, missing asphalt, and areas of pumping noted. Recommend evaluation by a paving contractor. The parking lot likely requires total replacement.

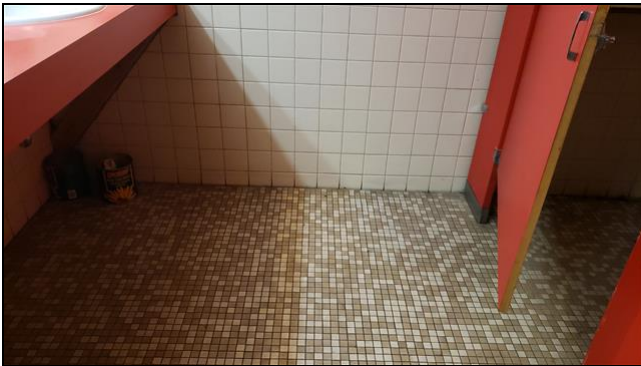
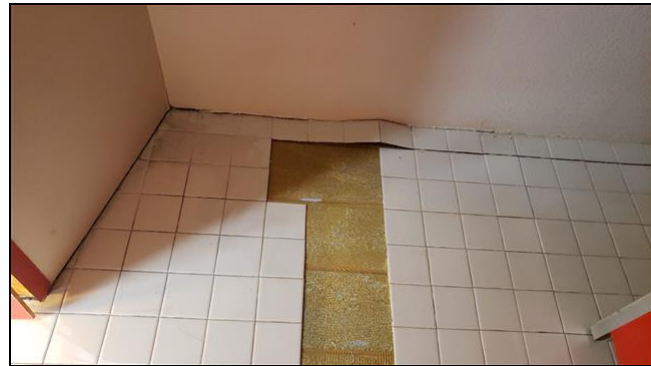
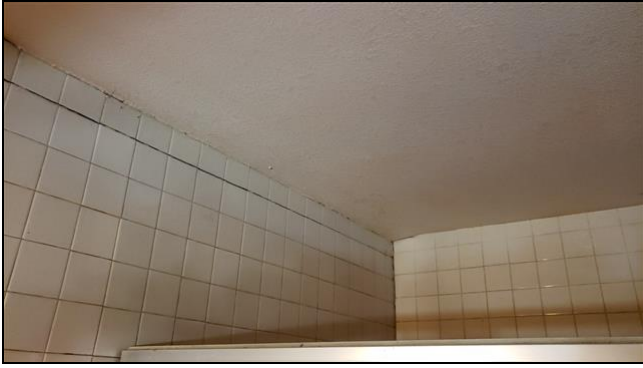
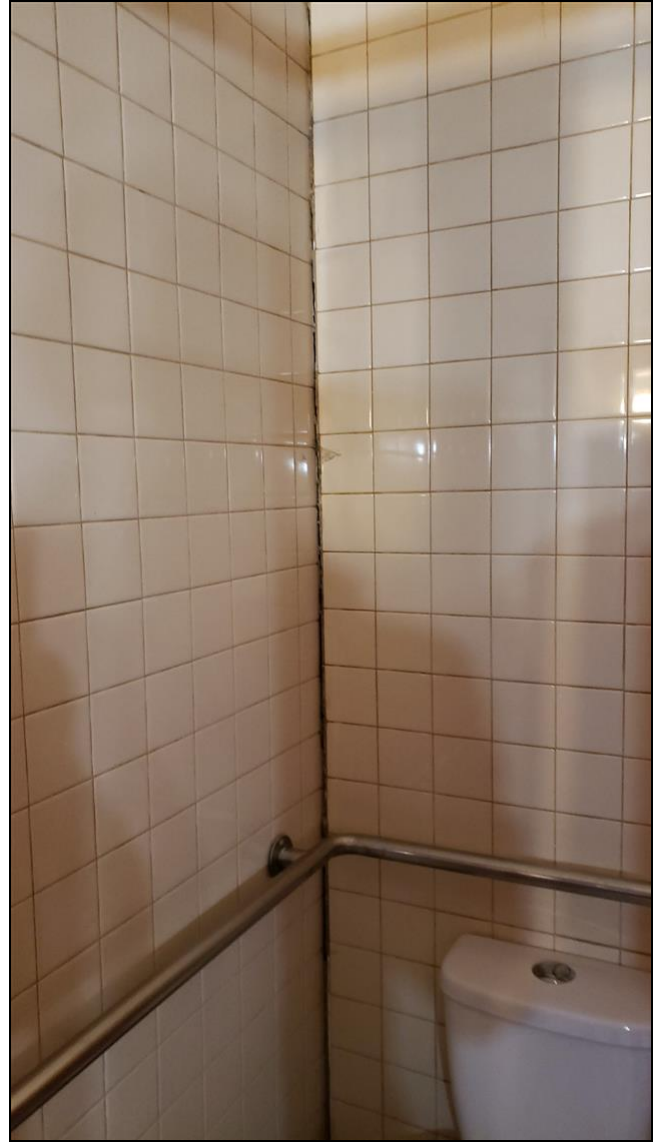
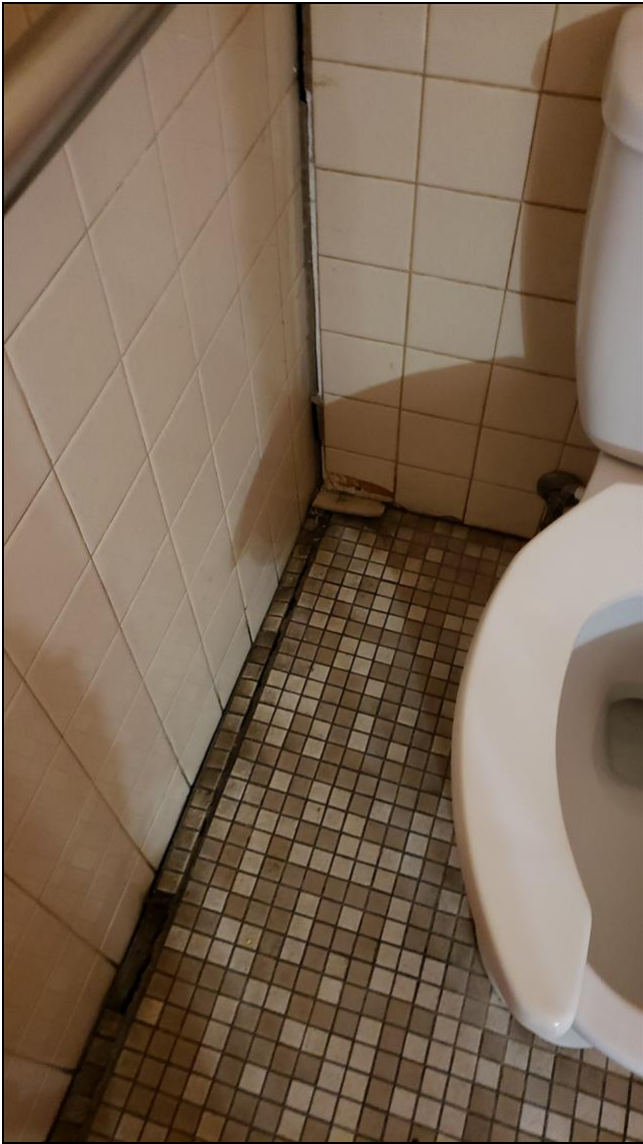
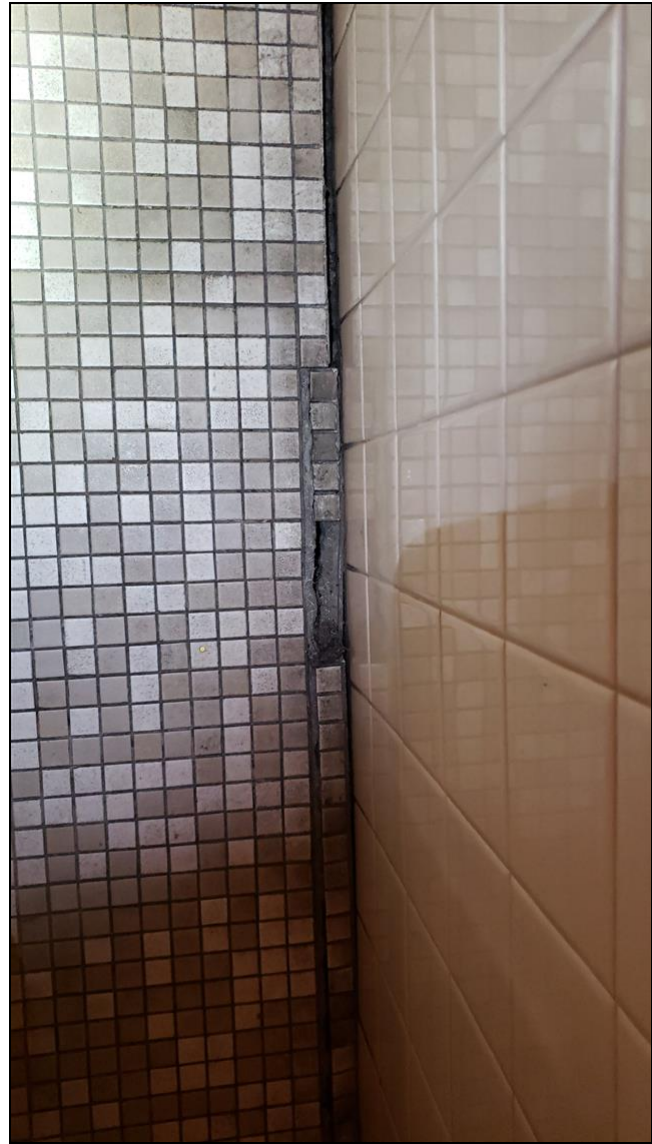
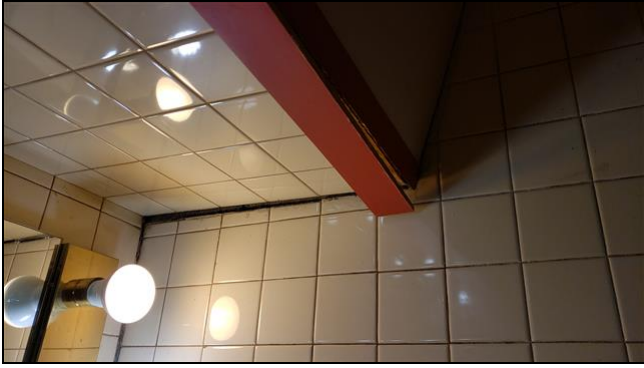
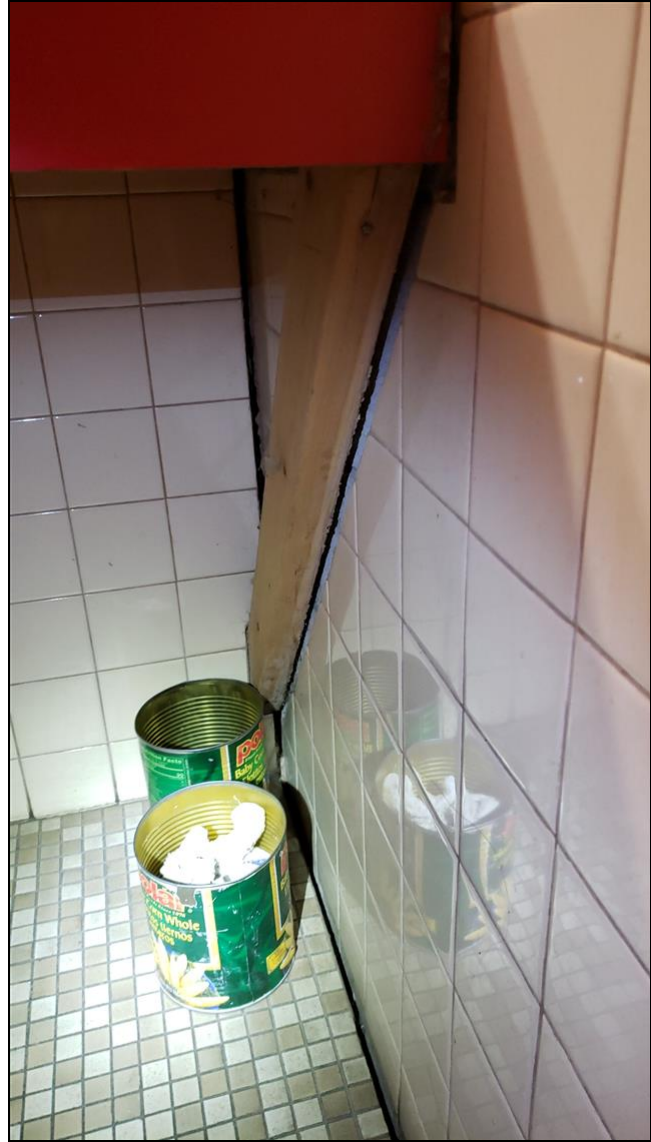
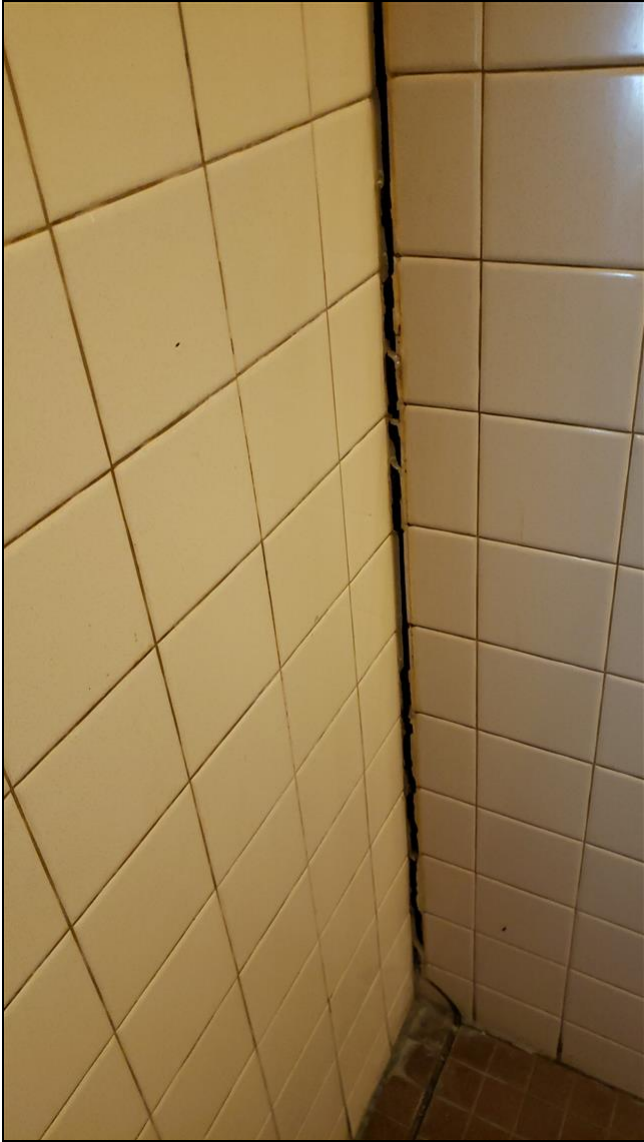
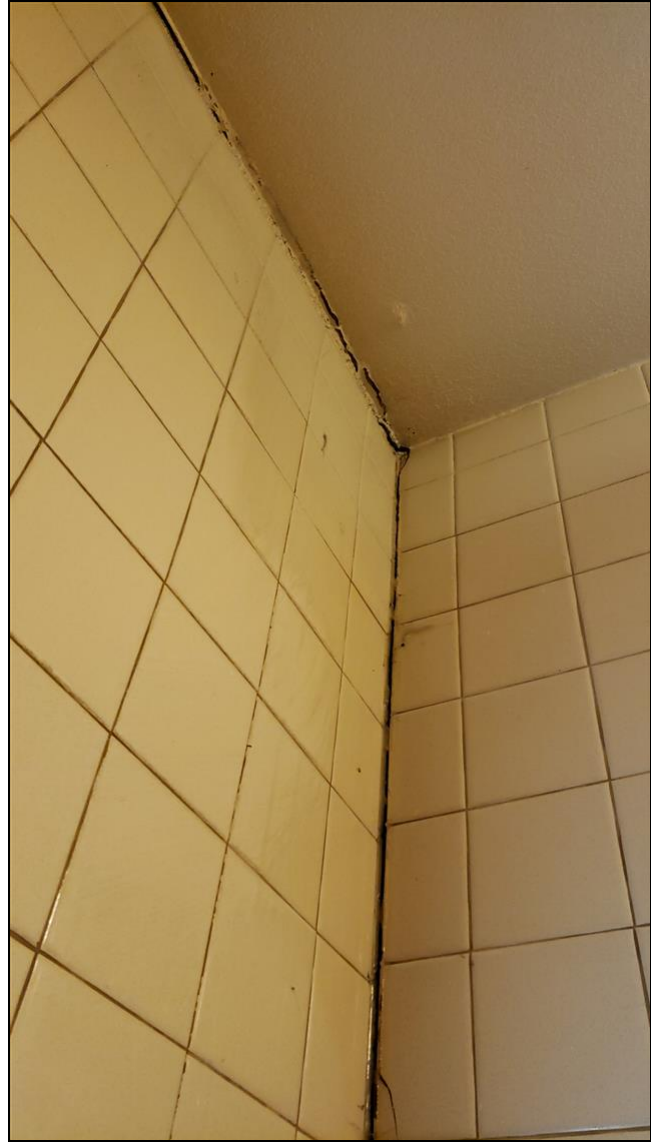
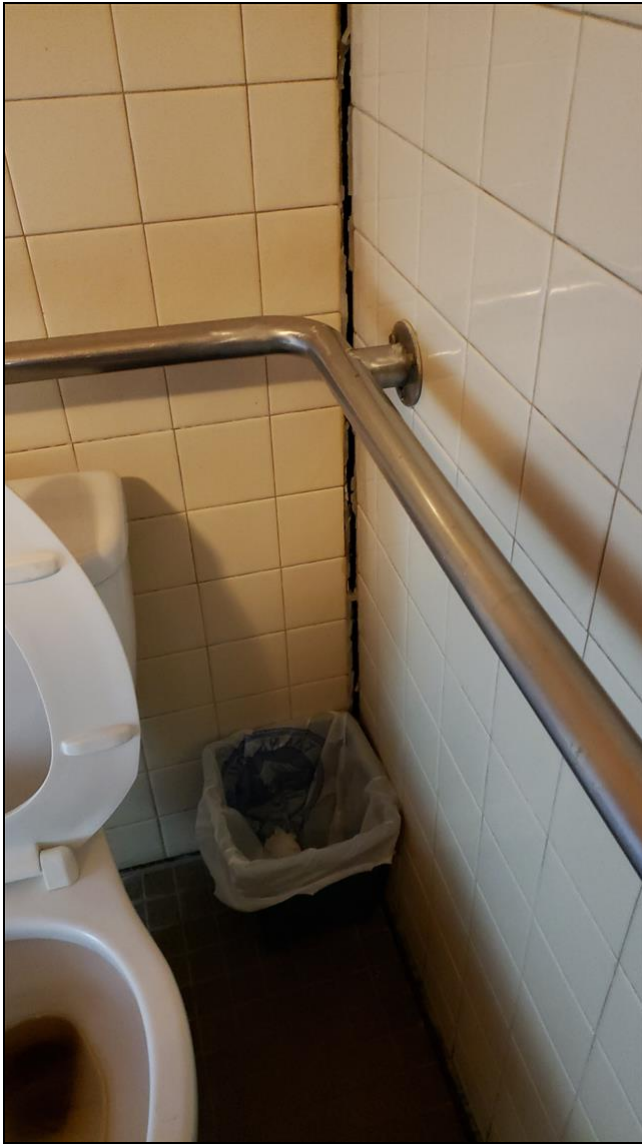
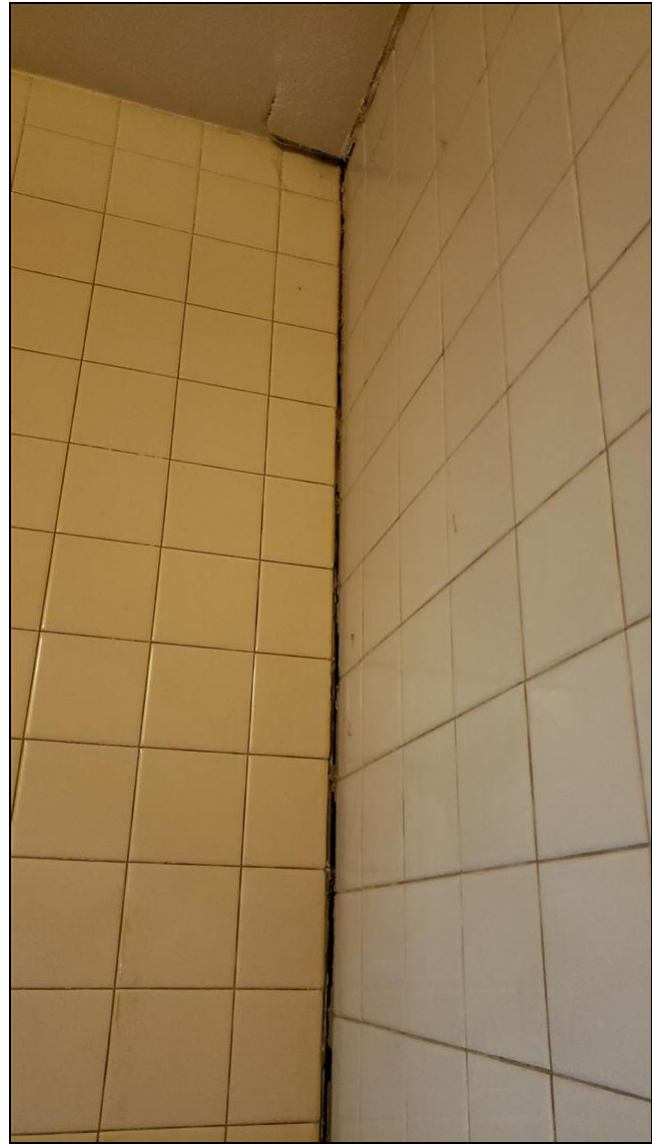
(1) The building frame has sustained significant movement. The source of this movement is suspected to be water below the slab. This is proposed as the exterior blockwork does not have extensive cracking and movement to match the interior. Additionally, the tile floor covering is release in several areas.

The observed movement is occurring along the rear wall. Gaps have appeared at the base of the wall and the floating slab. Wall separations are noted from the exterior wall to the interior walls.

Recommend evaluation by a structural engineer. Locally, Evan Laubach of Reliant Engineering has been very effective in resolving engineering concerns in structures.

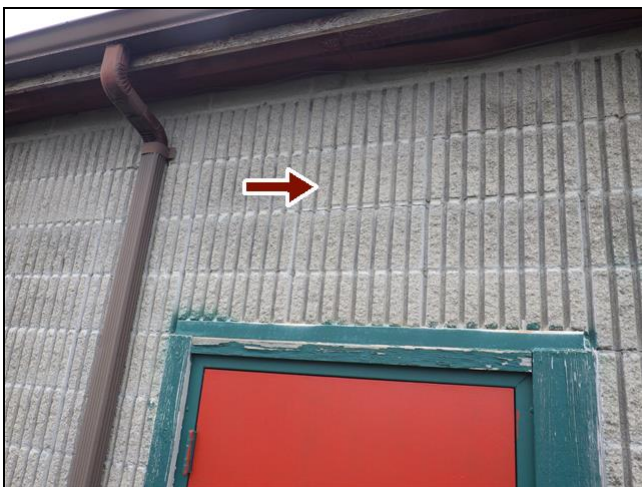
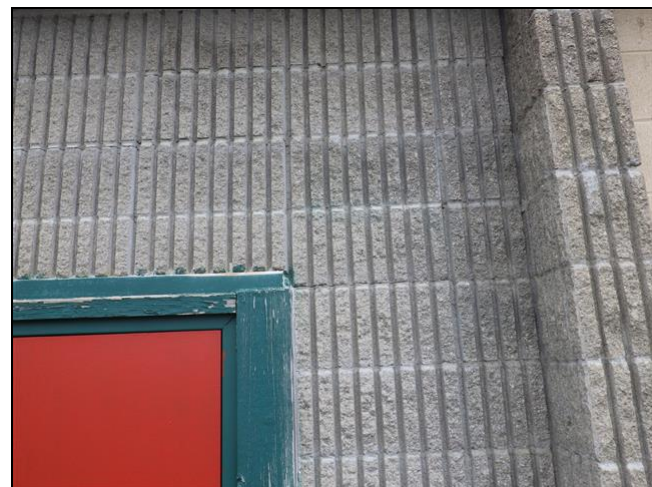
(3) There does not appear to be lintels above the doors to support the masonry. Cracks are evident in the masonry that are consistent with this concern. Recommend repair by a licensed and qualified masonry contractor.

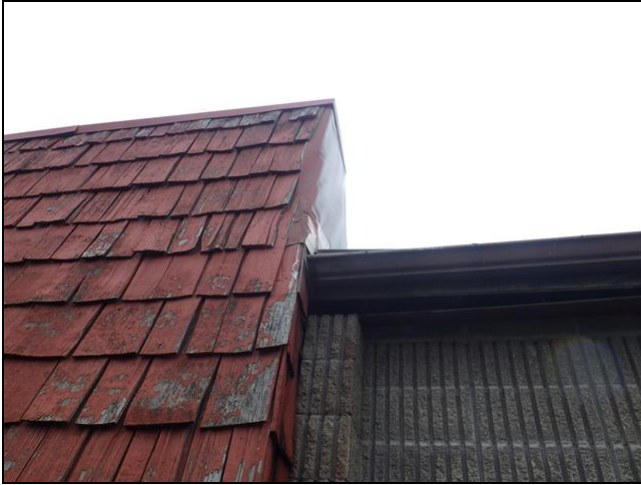
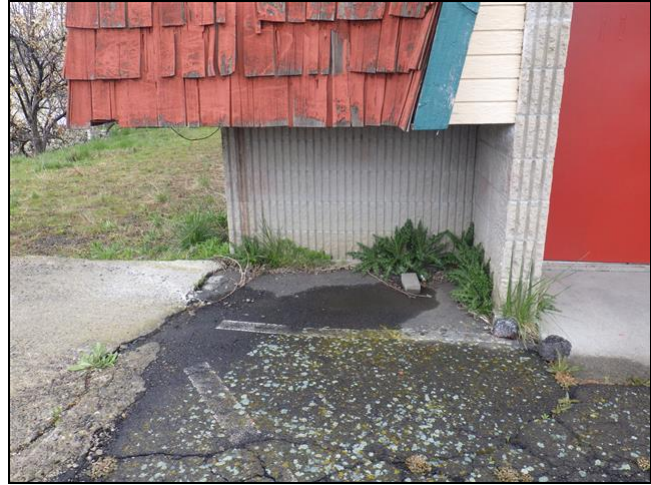
(1) The facades were wood shakes. These are in poor condition due to lack of paint and water intrusion and should be replaced.

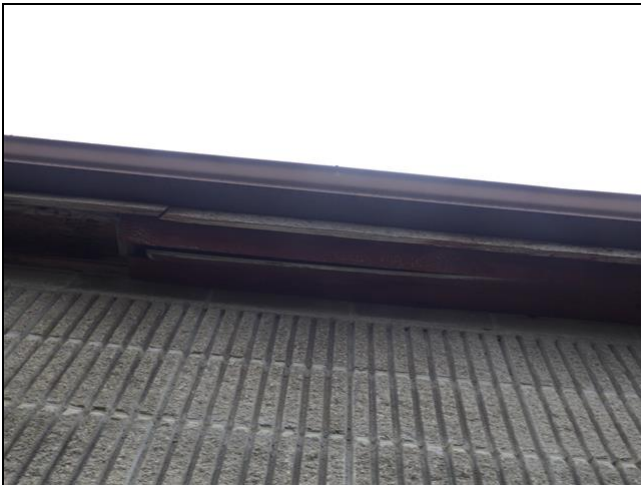
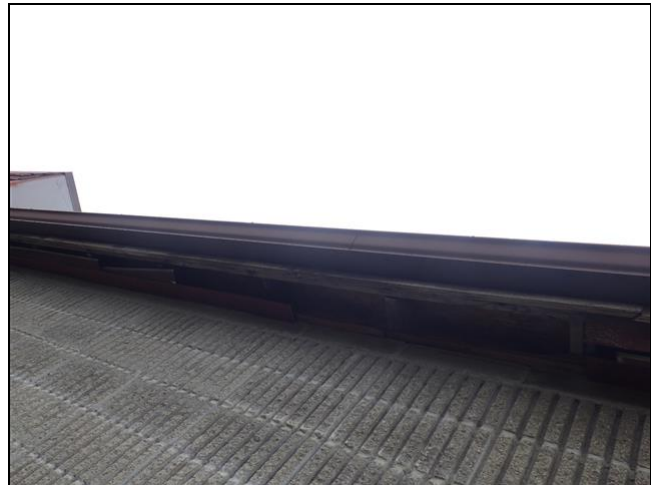
(2) The rear soffits have extensive water damage. Recommend replacement.

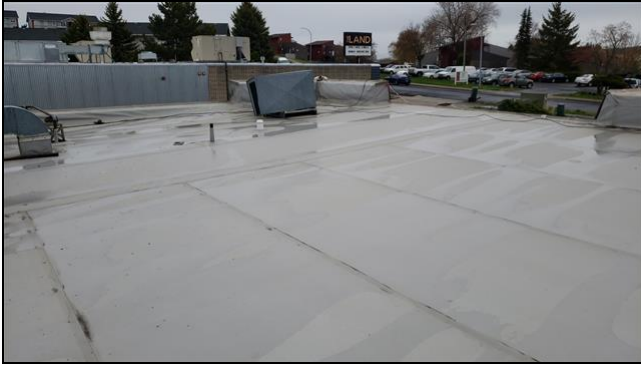
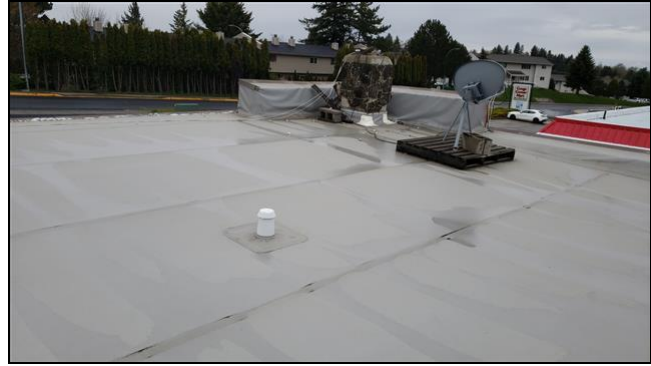
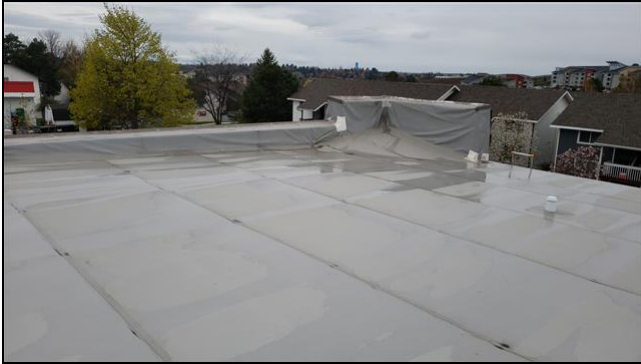
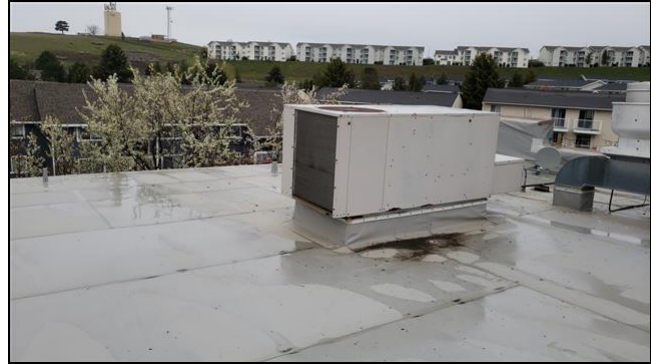
The roof covering was a PVC product that appeared in satisfactory condition. No recommendation.

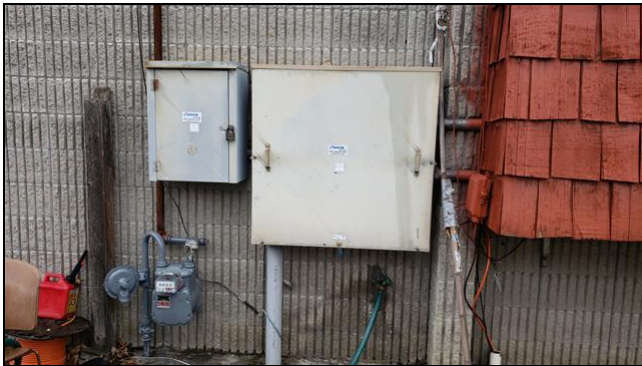
A. Item 1 (Picture)

(1) The electrical service was an underground feeder and connected to the subject property via a riser located on the north side of the structure. No readily observable deficiencies were noted.

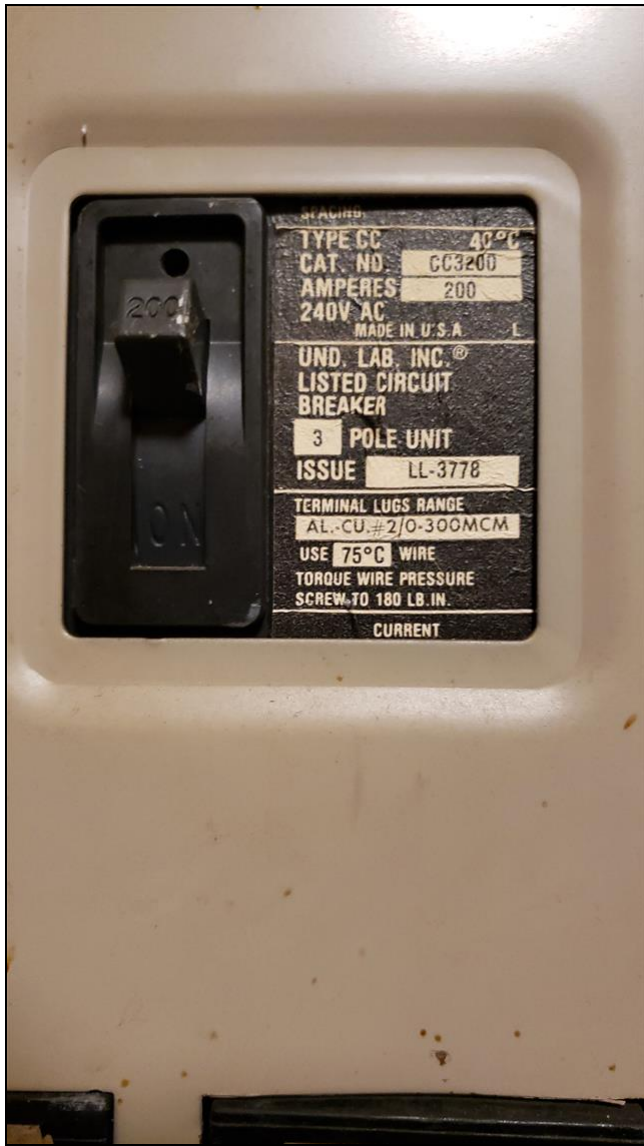
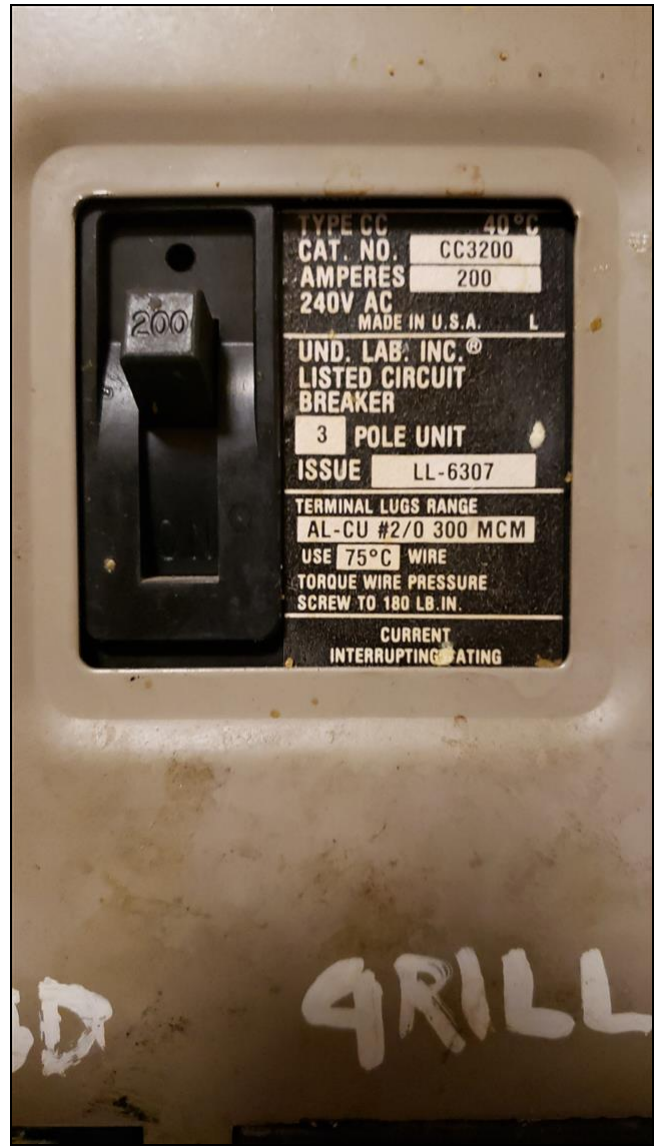
(1) Inadequate access/clearance exists at the main service panel. A panel must be easily accessible. The panel should have: an open area 30- 36" exists in front of the panel; the panel is at a convenient, eye level, height; at least 6'3" of headroom; the wall below the panel is clear to the floor, not used for heavy storage of belongings.

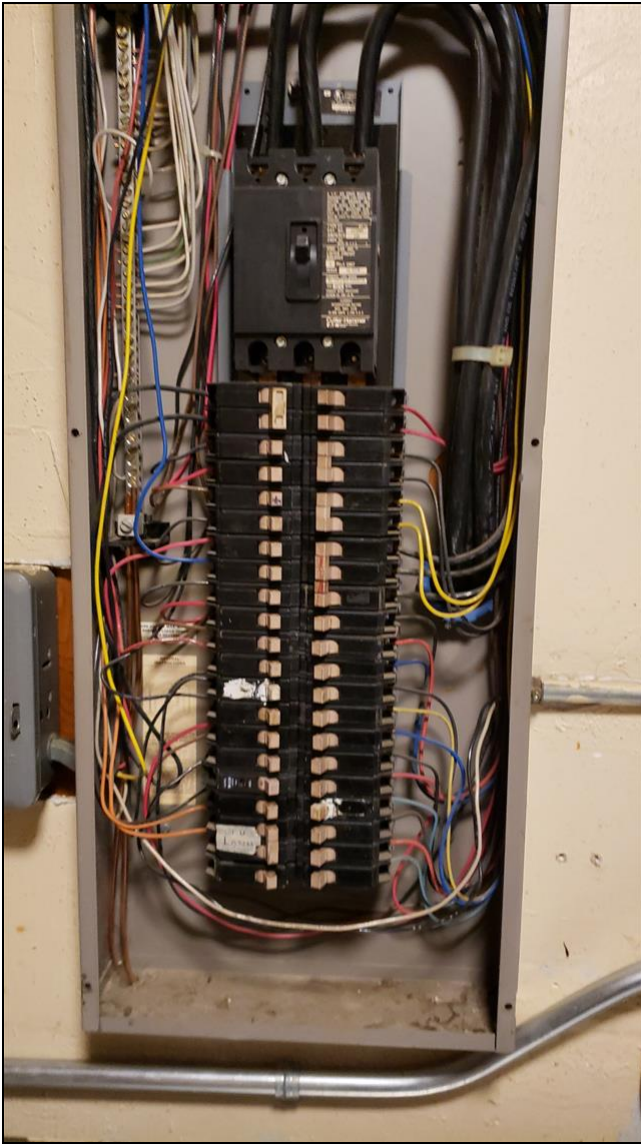
B. Item 1 (Picture)

(1) The panel cover was removed. Observation of the interior of the panel confirmed that the service main and main breaker were correctly sized to each other, the breakers were well-secured to the buss, and that wires and breakers sizes aligned correctly.

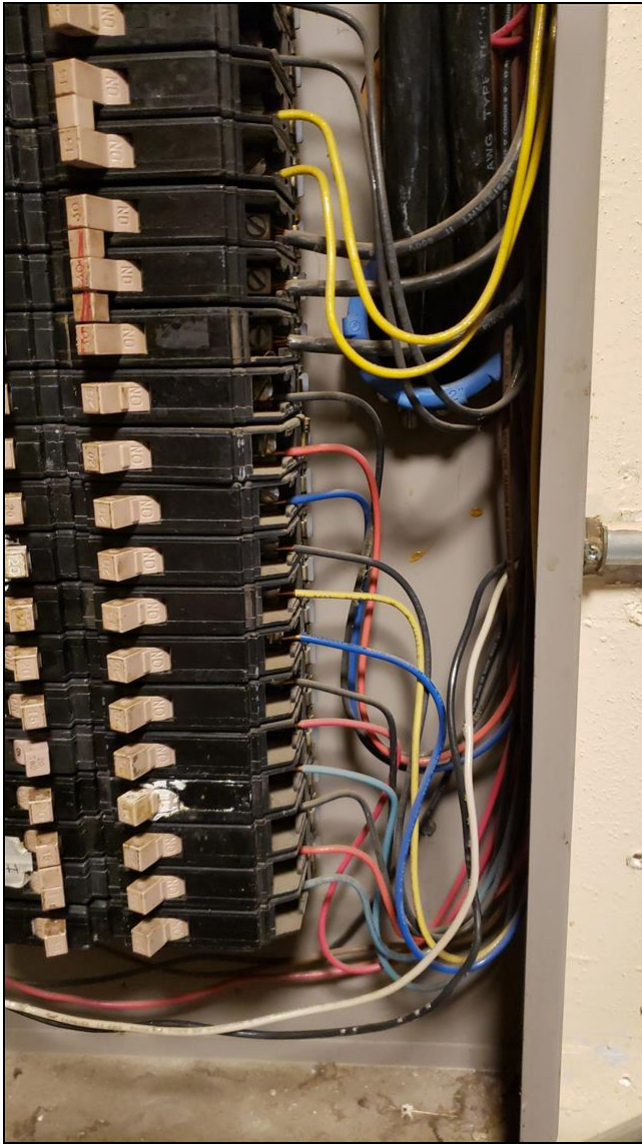
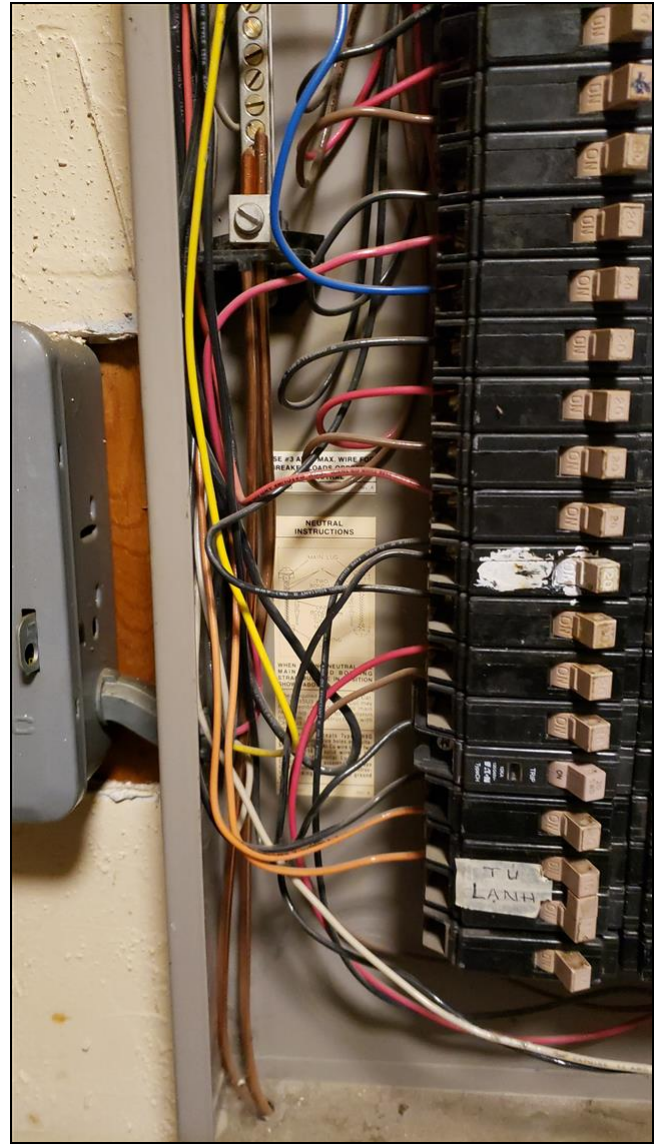
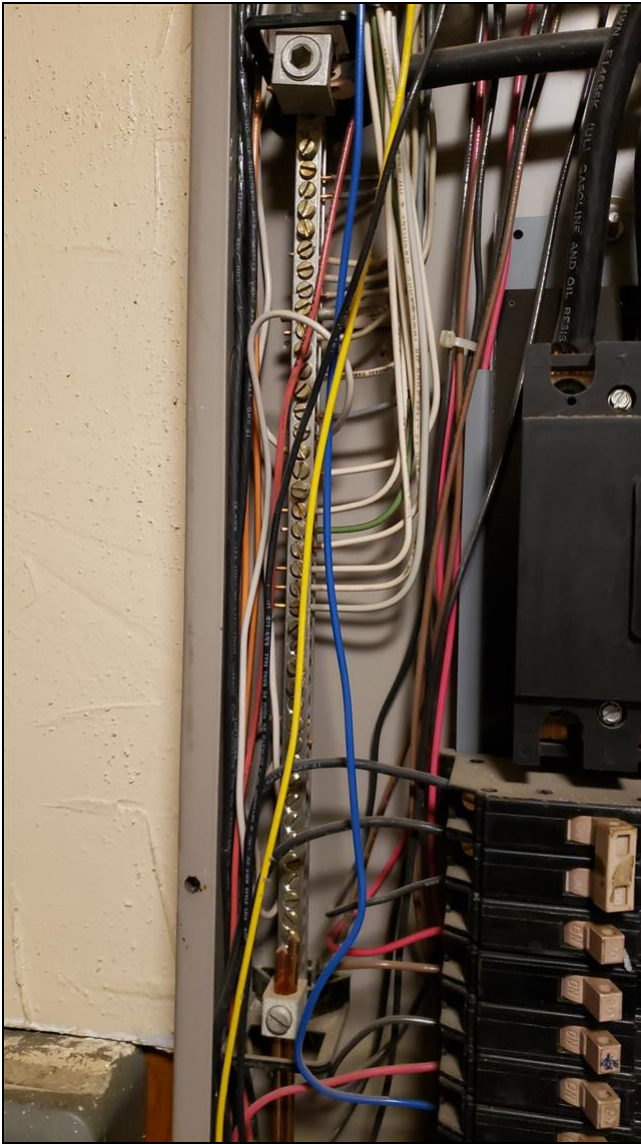
(1) The panel cover was removed. Observation of the interior of the panel confirmed that the service main and main breaker were correctly sized to each other, the breakers were well-secured to the buss, and that wires and breakers sizes aligned correctly.

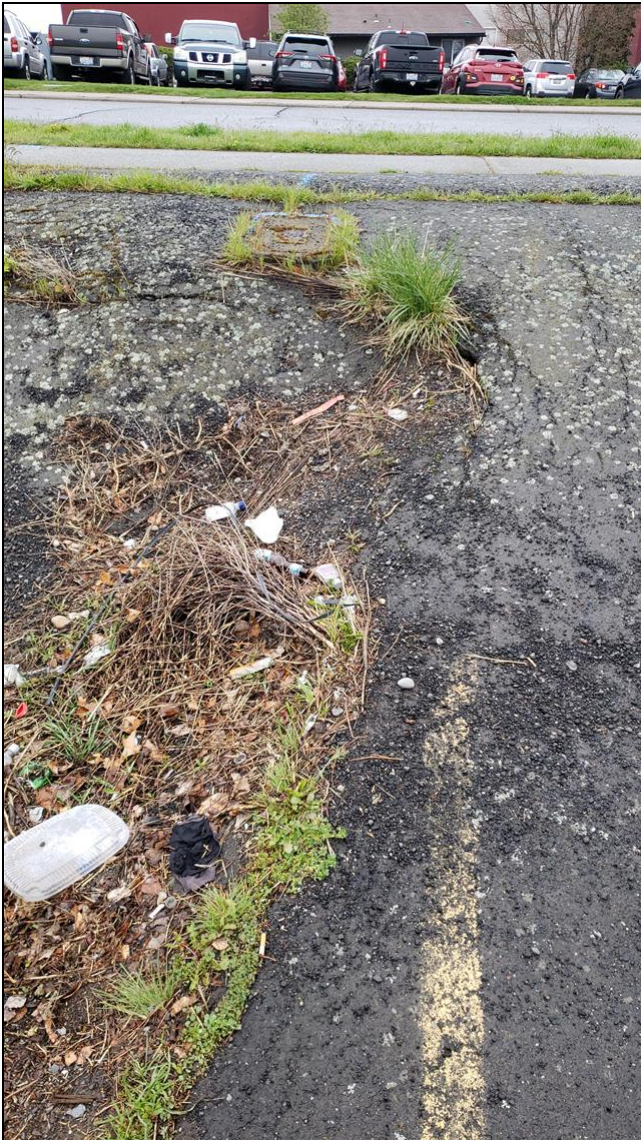
A. Item 1 (Picture)

(1) Although the main water supply shut-off valve was not operated at the time of the inspection it was visually inspected and appeared to be in serviceable condition.

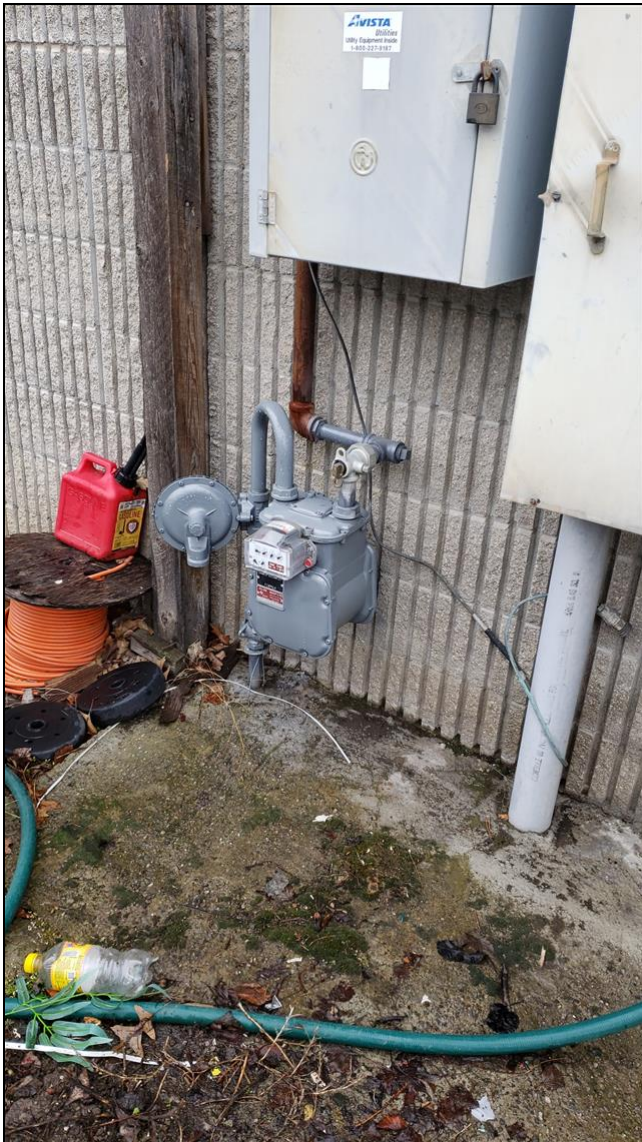
A. Item 1 (Picture)

The gas meter, located on the north, appeared in functional condition. No readily observable deficiencies were noted.

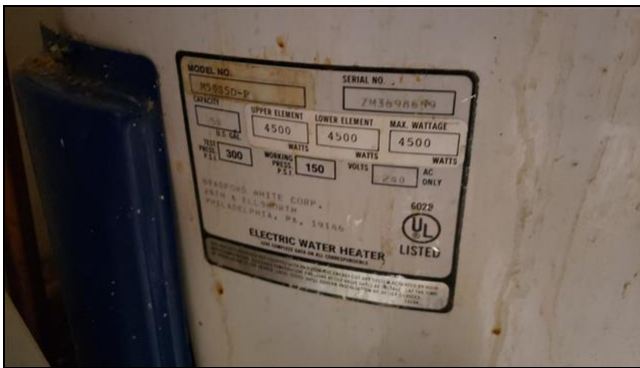
A. Item 1 (Picture)

(1) The water heater is electric and uses elements to heat the water. There are typically two elements, one at the top of the heater and one at the base.

(2) The water heater is more than 20 years old and well beyond the end of a normal service life. Recommend replacement.

(3) The water heater is missing the insulative pad under the tank. All electric water heaters in unheated spaces or on concrete floors shall be placed on an incompressible, insulated surface with a minimum thermal resistance of R-10. Recommend installing.

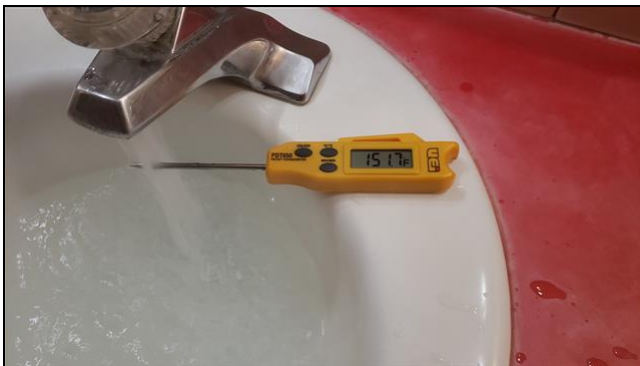
B. Item 1 (Picture)

This water heater was generating water considerably hotter than the generally accepted safe water temperature is 120 degrees Fahrenheit. This poses a scald or burn hazard, especially to the elderly and infants. Scald time for adults is approximately 1.5 seconds at 150 degrees and .5 seconds at 160 degrees. Young children and the elderly scald faster. Recommend turning the water temperature down to the recommended level.

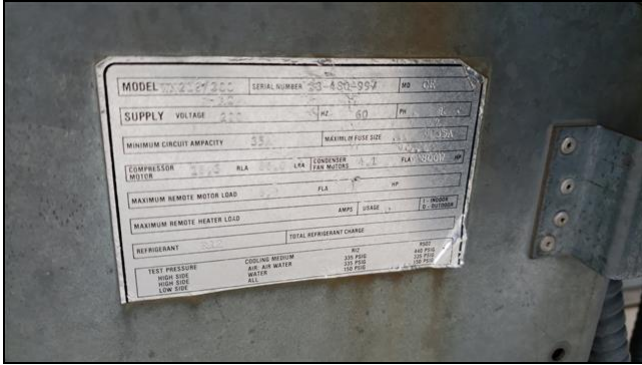
A. Item 1 (Picture)

There was one Hobart walk-in cooler. This is likely original to the structure and is likely due for replacement.

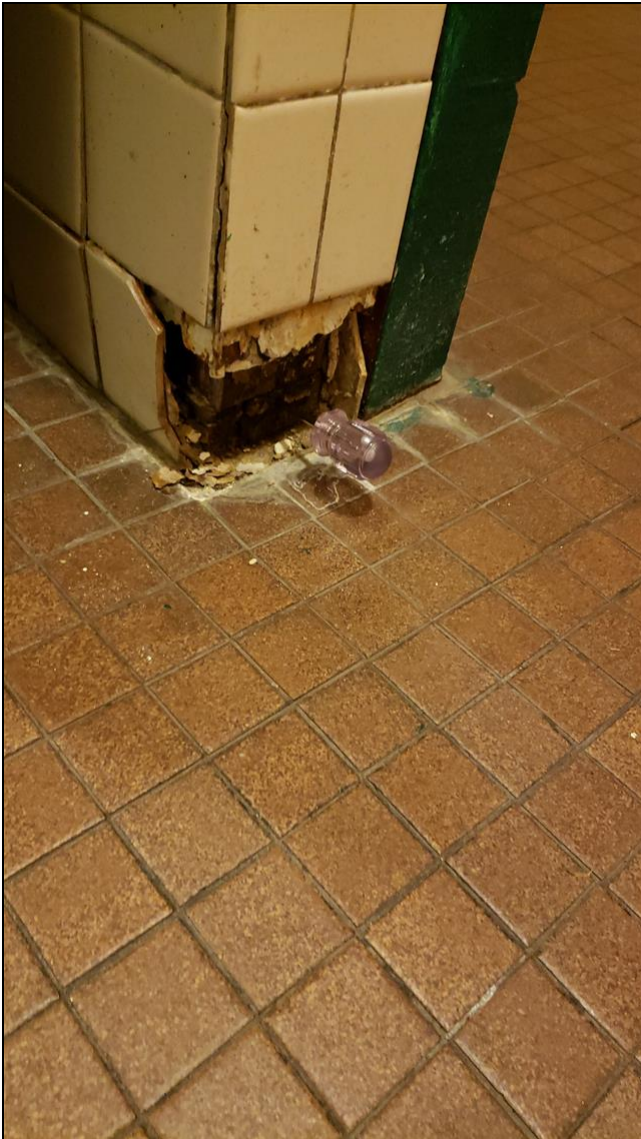
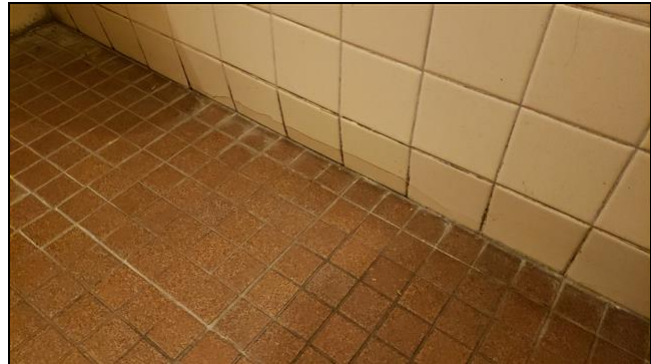
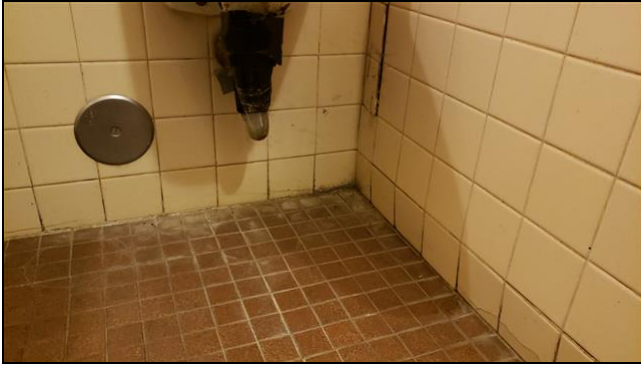
The men's bathroom wall had wood rot in the sill plate with buckling tile. This may be related to the other building frame issues identified. Recommend repair of all wood rot. It is likely that trim will need to be removed and replaced to allow for probing of the sills to ensure their integrity.

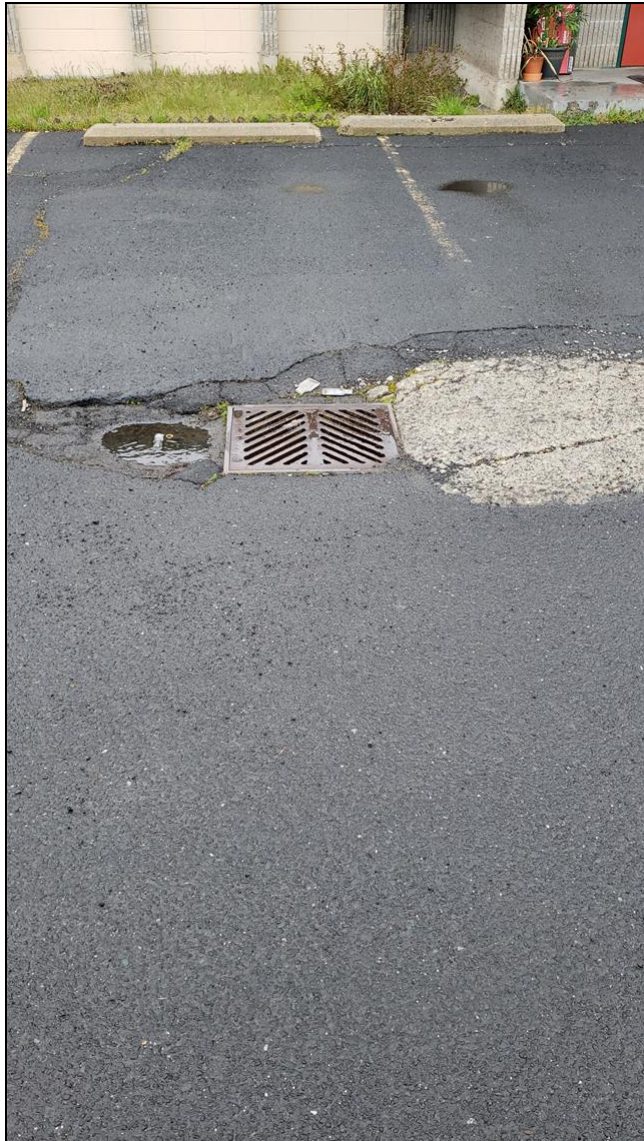
B. Item 1 (Picture)

The area around the storm drain is damaged the water does not properly drain. The roof drains on the rear of the building are damaged and leaking at the rear foundation. Recommend repair of both items.
