Inspection Report

Professional Investor

Safe@Home Inspections, LLC

Executive Summary

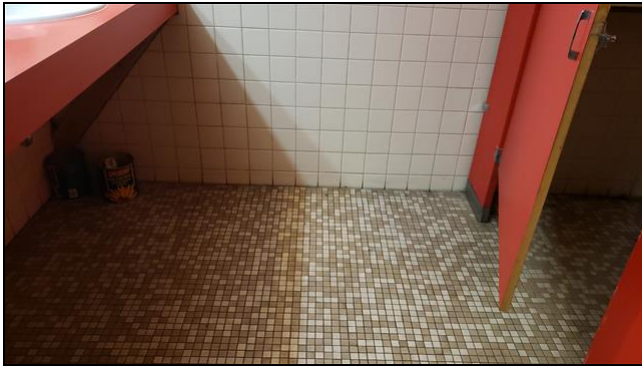
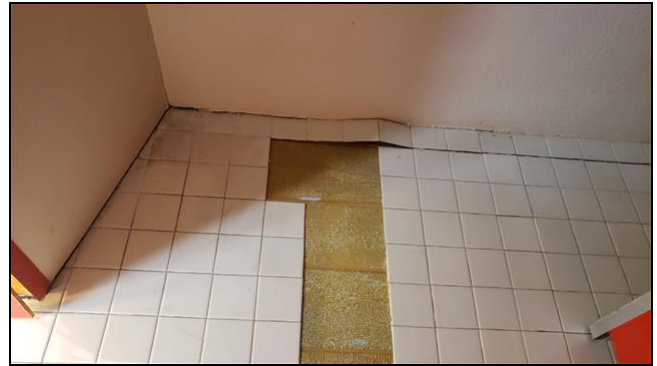
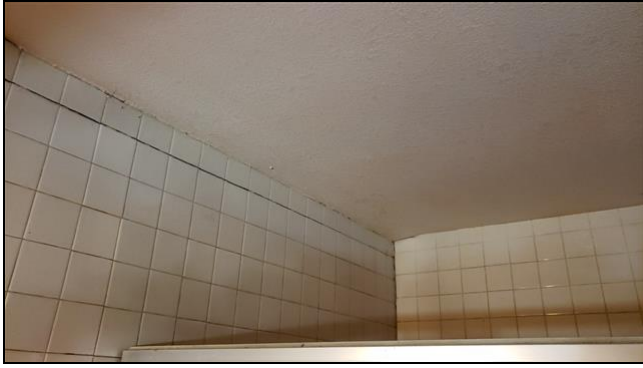
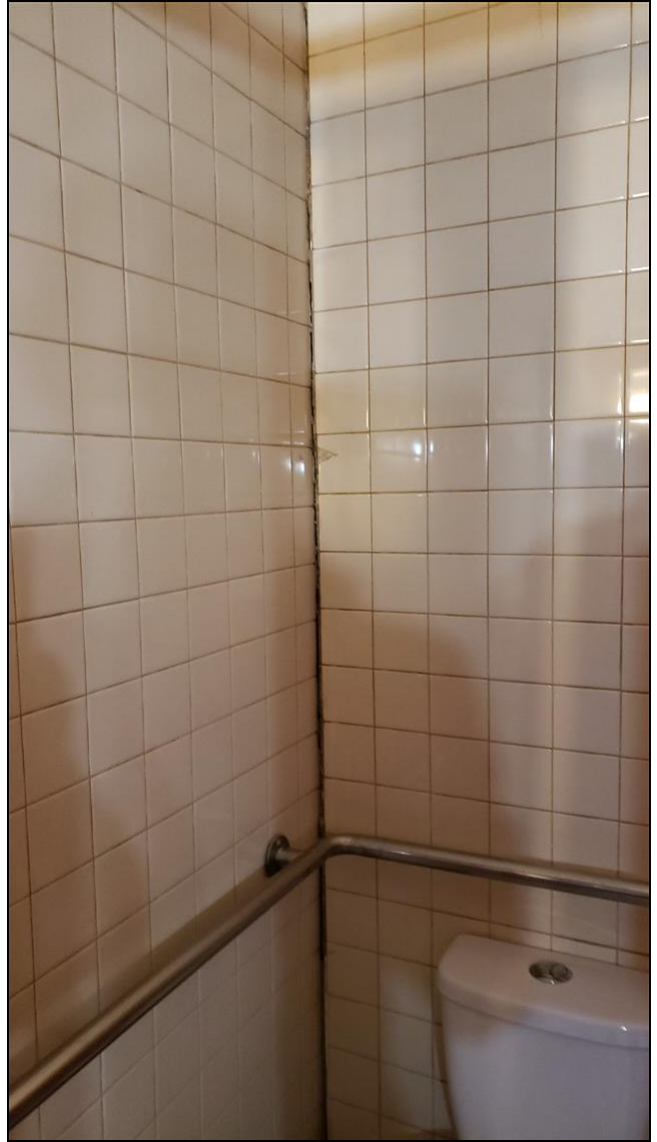
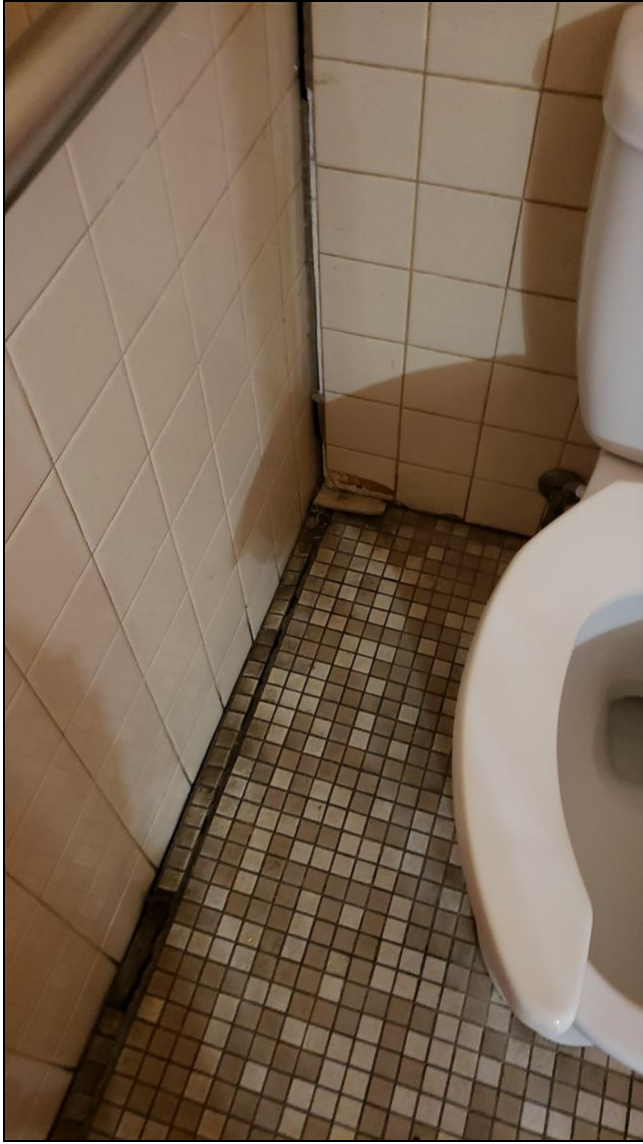
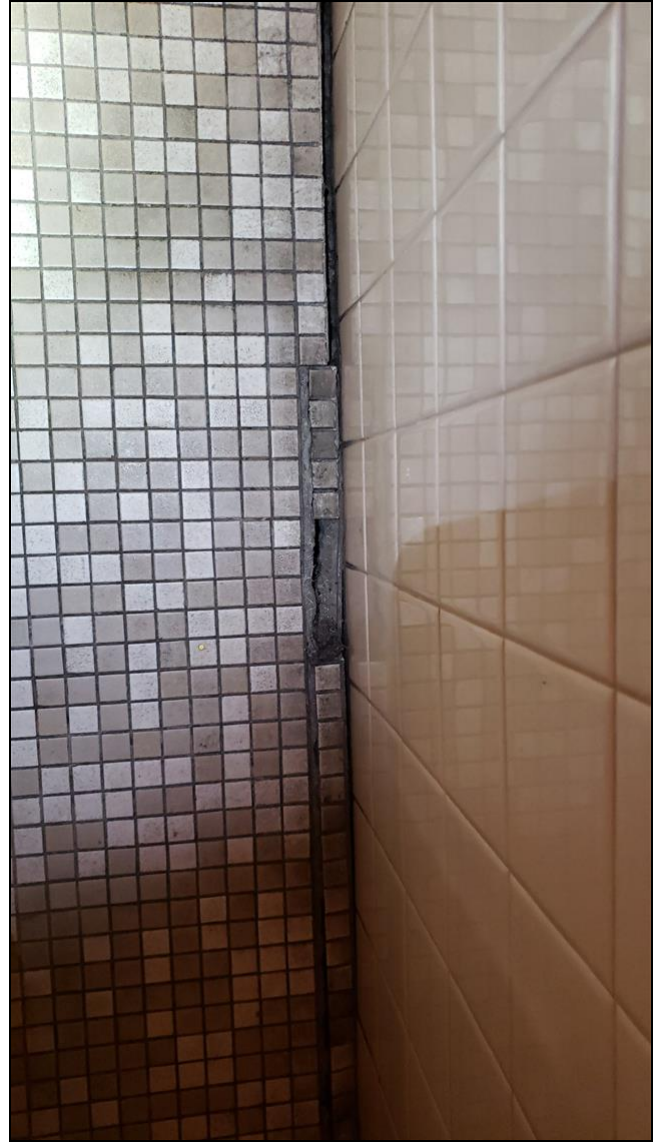
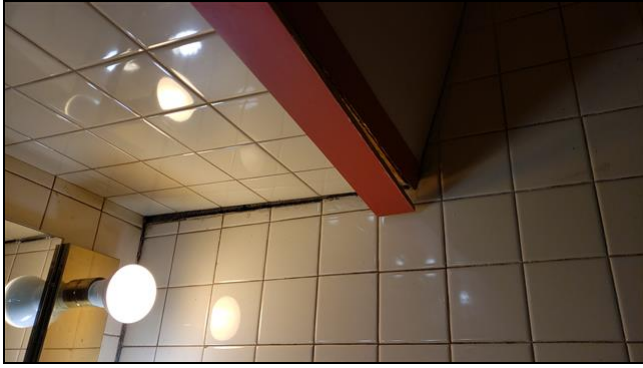
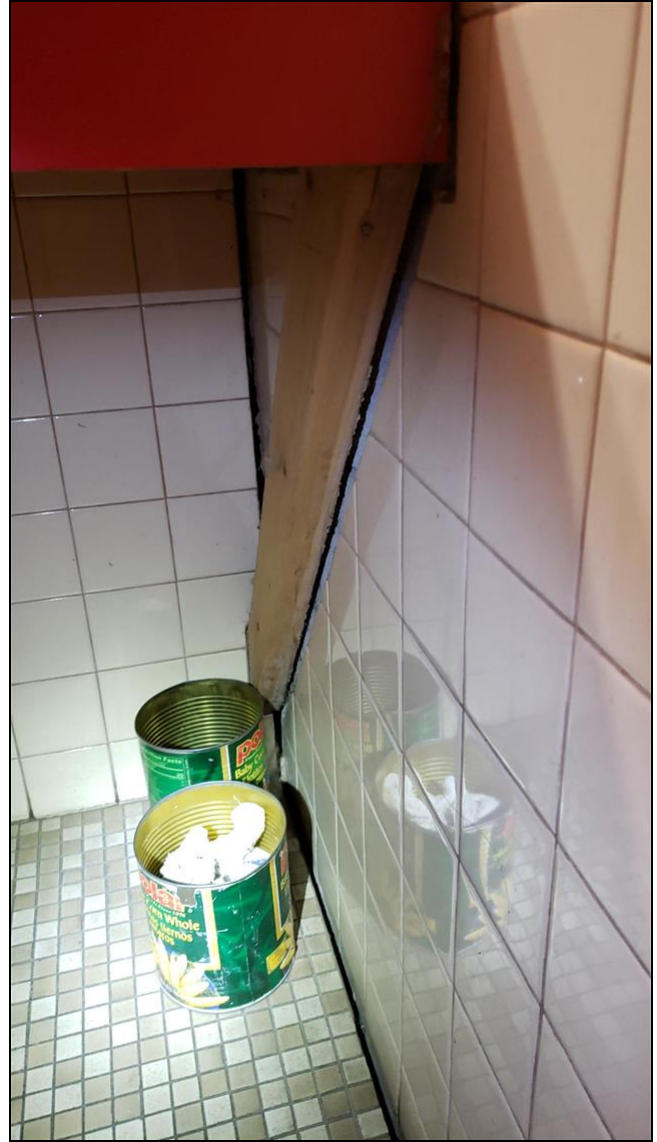
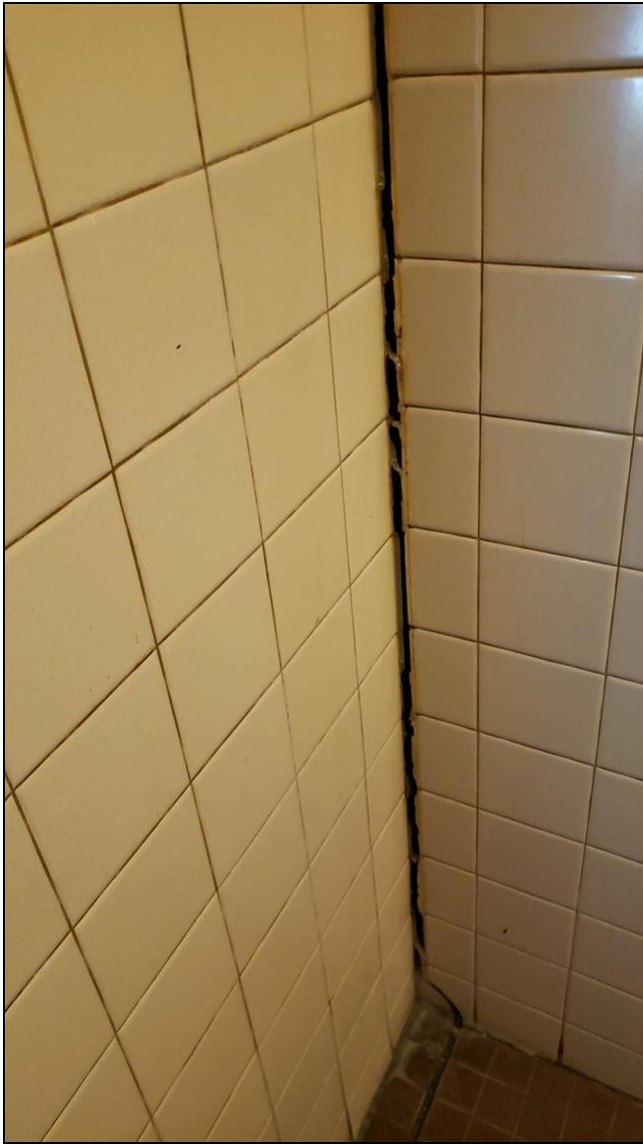
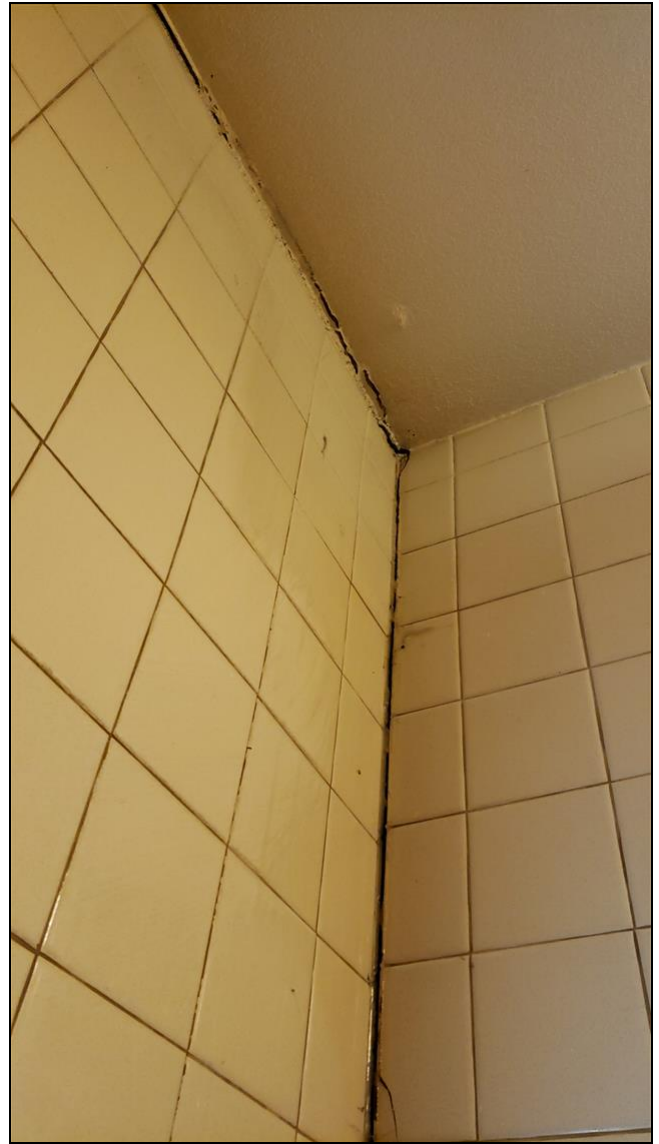
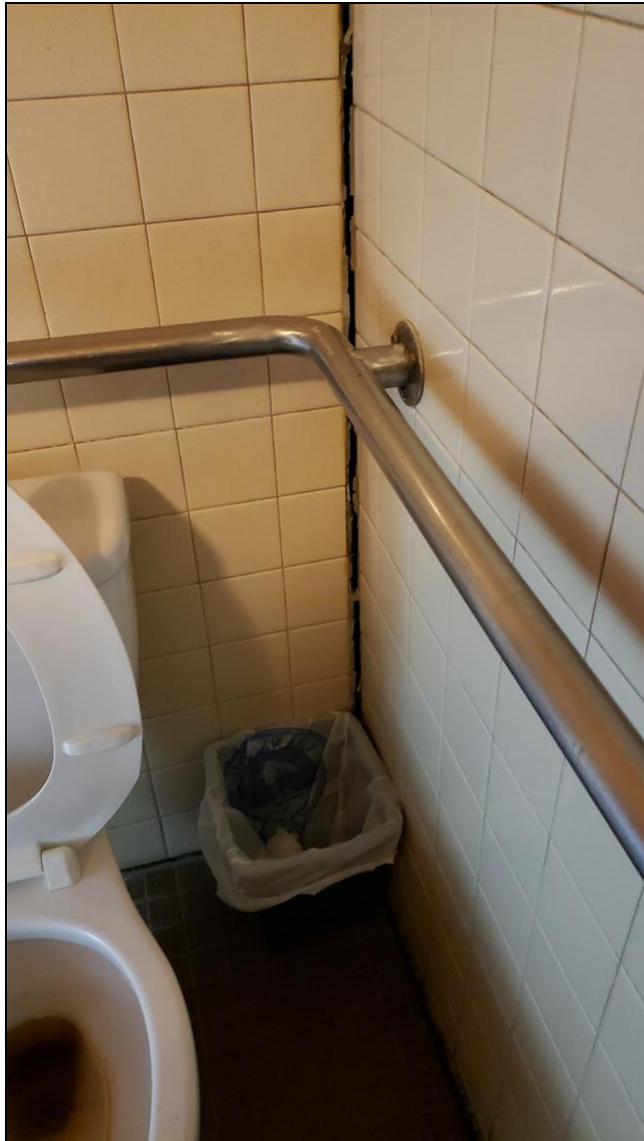
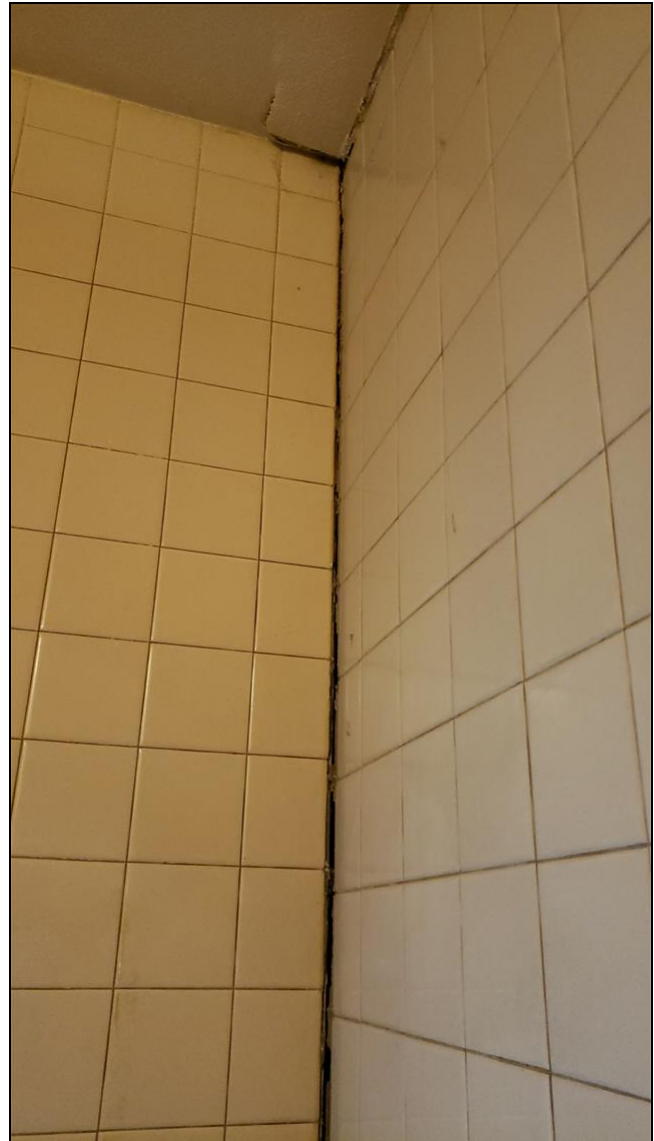
(1) The building frame has sustained significant movement. The source of this movement is suspected to be water below the slab. This is proposed as the exterior blockwork does not have extensive cracking and movement to match the interior. Additionally, the tile floor covering is release in several areas.

The observed movement is occurring along the rear wall. Gaps have appeared at the base of the wall and the floating slab. Wall separations are noted from the exterior wall to the interior walls.

Recommend evaluation by a structural engineer. Locally, Evan Laubach of Reliant Engineering has been very effective in resolving engineering concerns in structures.

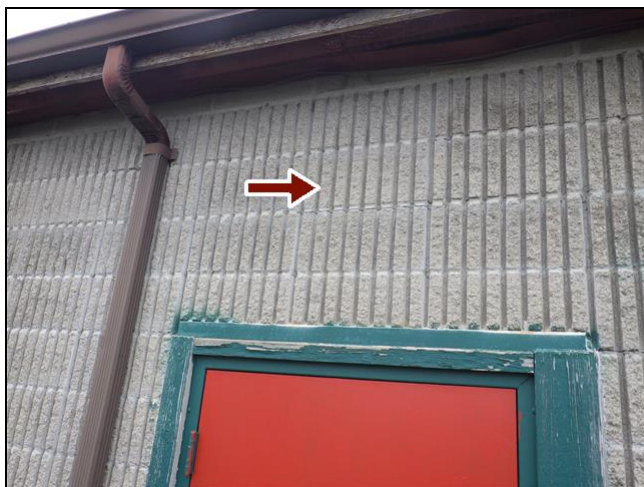
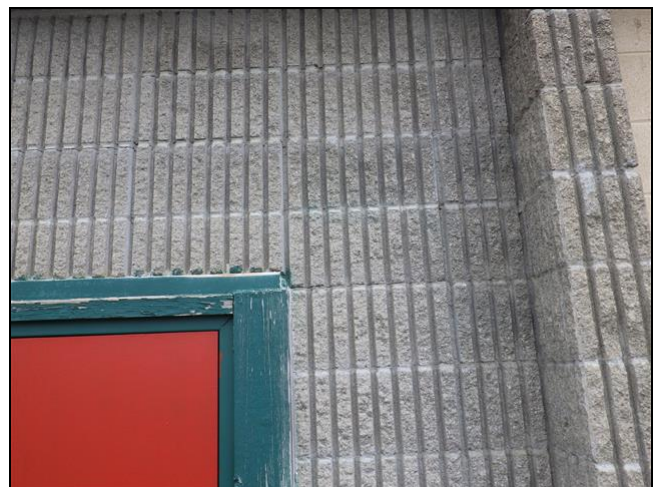
(3) There does not appear to be lintels above the doors to support the masonry. Cracks are evident in the masonry that are consistent with this concern. Recommend repair by a licensed and qualified masonry contractor.

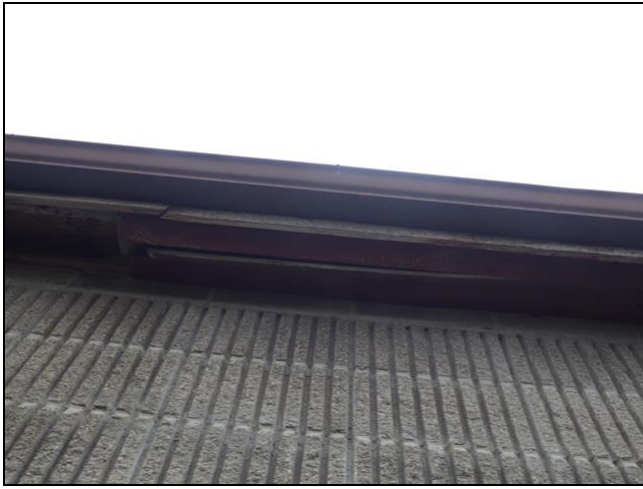
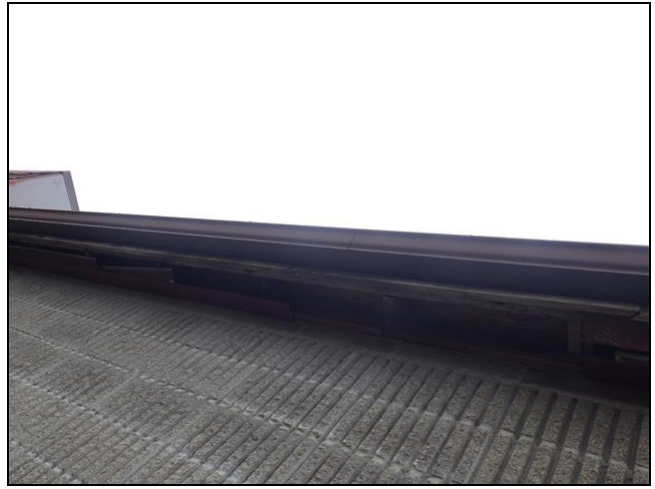
(2) The rear soffits have extensive water damage. Recommend replacement.

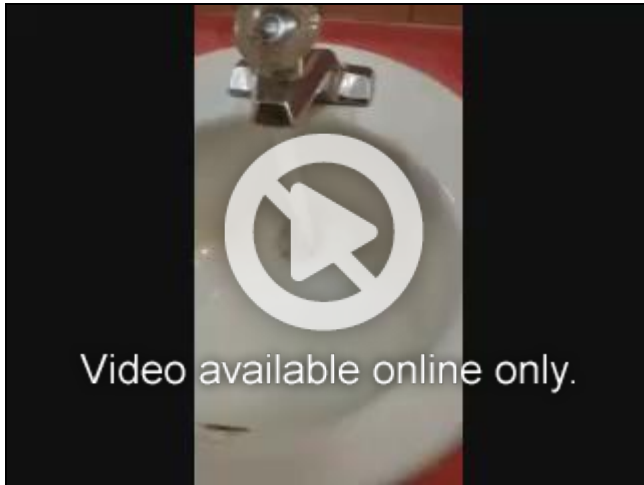
B. Item 1 (Video)

(2) Water hammer noted. Water hammer is a pressure change caused when a fluid is forced to stop suddenly. This pressure wave can cause damage to the piping. Recommend further evaluation of the water hammer along with all necessary repairs be completed by a licensed and qualified plumbing contractor.

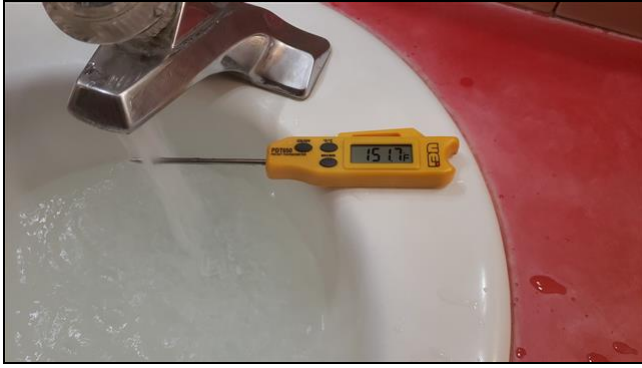
B. Item 1 (Picture)

This water heater was generating water considerably hotter than the generally accepted safe water temperature is 120 degrees Fahrenheit. This poses a scald or burn hazard, especially to the elderly and infants. Scald time for adults is approximately 1.5 seconds at 150 degrees and .5 seconds at 160 degrees. Young children and the elderly scald faster. Recommend turning the water temperature down to the recommended level.

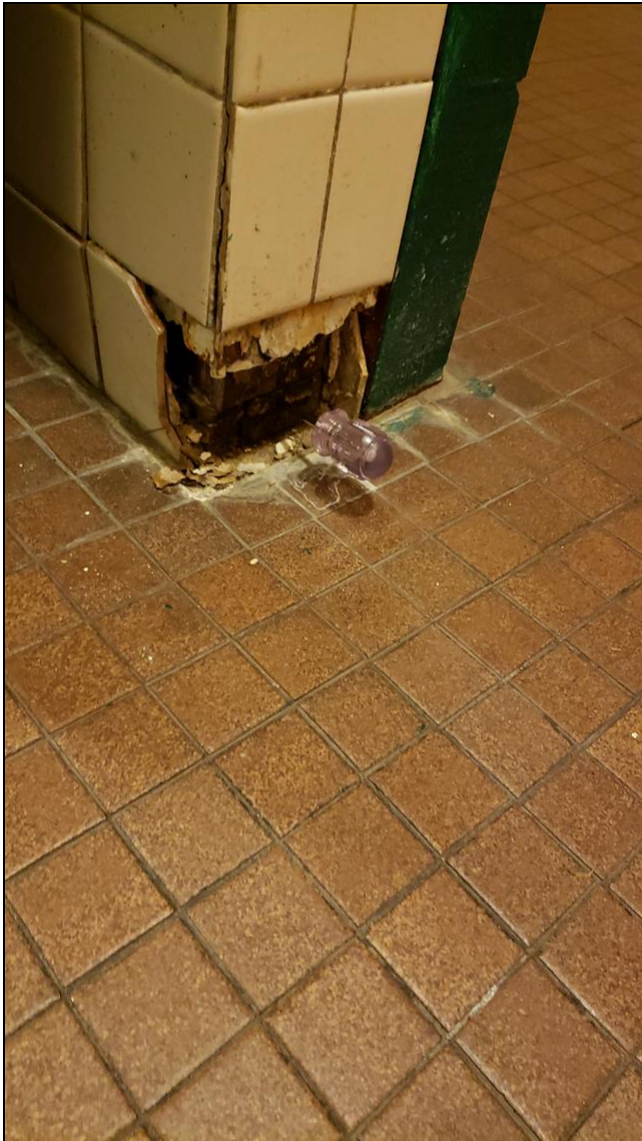
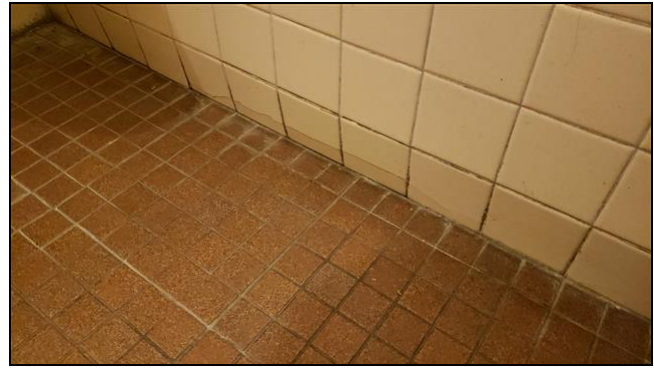
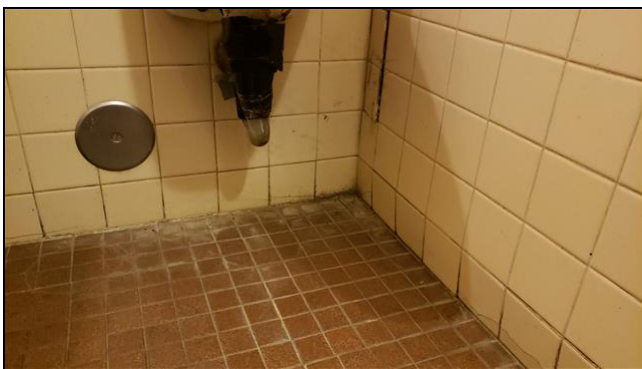
The men's bathroom wall had wood rot in the sill plate with buckling tile. This may be related to the other building frame issues identified. Recommend repair of all wood rot. It is likely that trim will need to be removed and replaced to allow for probing of the sills to ensure their integrity.

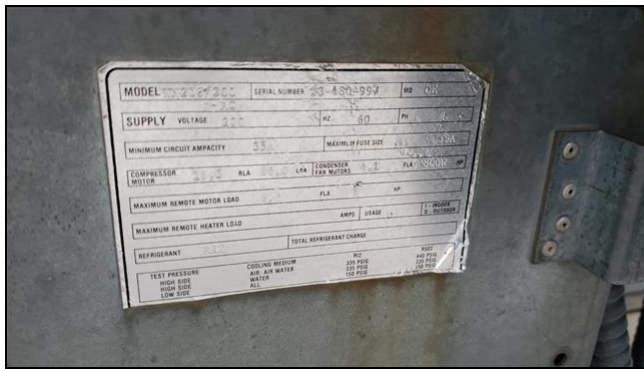
A. Item 1 (Picture)

There was one Hobart walk-in cooler. This is likely original to the structure and is likely due for replacement.
