Inspection Report

Property Address:
1234 Airport Rd
ID

Calibre Commercial Inspections, LLC

Date: 4/1/2024	Time: 09:00 AM	Report ID:
Property: 1234 Airport Rd ID	Customer: Professional Investor

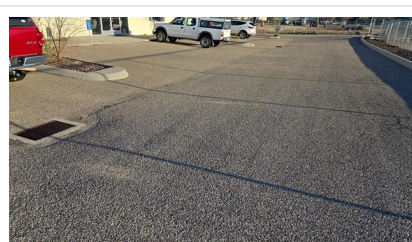
C. Item 1 (Picture)

(1) Stormwater drainage for the plot is handled by sheeting action from the parking lot to storm drains located in the center line to the parking lot. A total of four storm drains were observed.

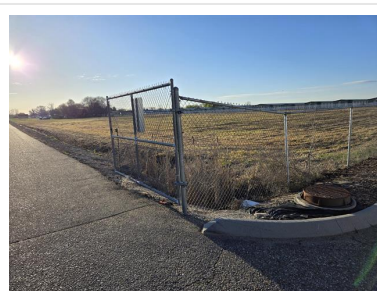
D. Item 1 (Picture)

Public access to the property was through a single gate at the front. Access was also possible on a restricted basis from the direction of the airport runways. Fire lane access was present at both these locations as well.

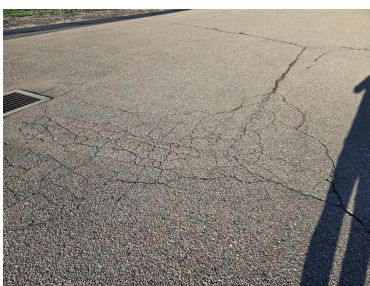
E. Item 2 (Picture)

(2) The asphalt surface was damaged as evident by localized alligator cracking suggesting a localized structural failure of the surface and possibly the subsurface structure. Moderate cracking also observed.. Recommend evaluation by a licensed and qualified paving contractor to determine the full scope of the necessary work.

(3) Striping for the parking lot was in very poor condition. Recommend re-striping the parking lot after repairs and sealant applications are complete.

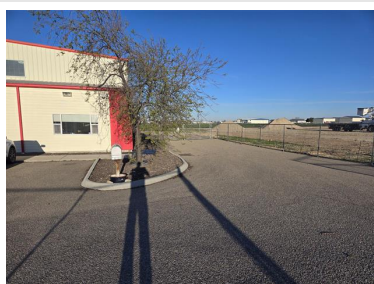
G. Item 1 (Picture)

(1) Landscaping was comprised of low shrubs and trees along the front of the property. A sprinkler system for this was present. The landscaping did not appear well maintained.

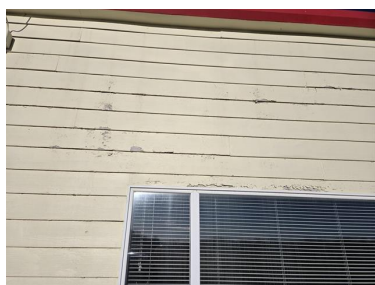
D. Item 3 (Picture)

(3) The cement fiber board siding had considerable water-related damage to the surface. Several of the planks appeared sufficiently compromised as to require replacement. The source of water is likely from the roof edge or gutters. This source of damage should be repaired to prevent reoccurrence. Damaged planking should be replaced. The entirety of the fiber board is overdue for painting. Recommend that all work be completed by a licensed and qualified siding contractor.

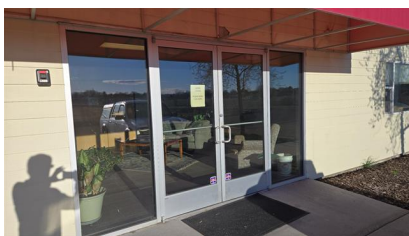
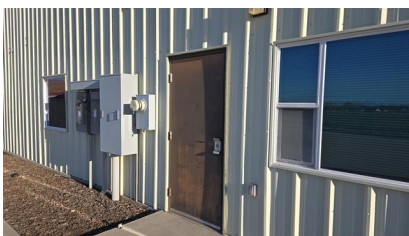
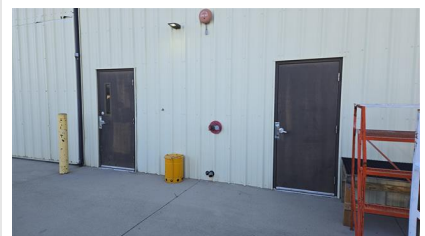
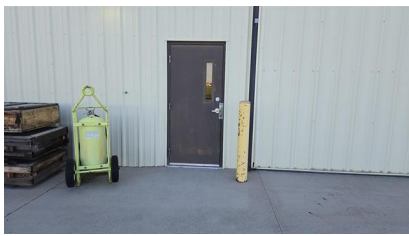
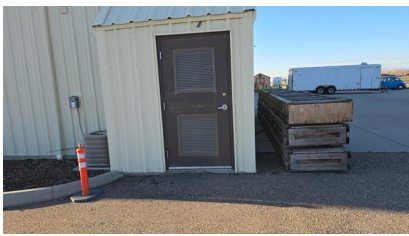
(1) There were a total of five pedestrian doors to the building. The primary entry is an anodized metal-framed pair of doors with thermal glazing. The remaining doors are steel security doors at the rear and side of the property. A steel security door was present at the side of the building for a mechanical space. No readily observable material deficiencies were noted.

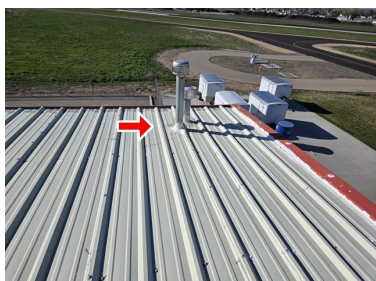
B. Item 1 (Picture)

The flashings used for the various roof penetrations for the mechanical equipment does not conform to good construction practices for metal roofing. Active leaking was noted at the rear left corner of the building where a pair of flues exhaust. Recommend further evaluation of the flashings by a person experienced with metal roofing who can determine the best means of correction and the costs associated with same.

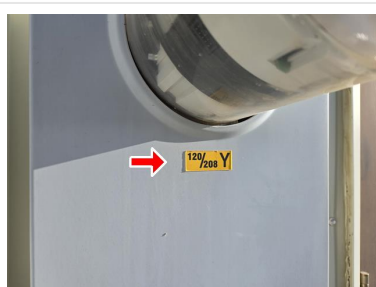
A. Item 2 (Picture)

(2) The cabinet that contain the electrical service did not have a visible data place. It appears that power to the subject property is a three-phase, four wire 120/208v based on the labeling of the electrical meter.

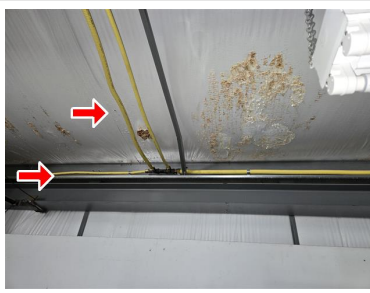
B. Item 2 (Picture)

(1) Corrugated Stainless Steel Tubing (CSST) was observed in the building that did not appear to be correctly bonded. Flexible metal gas piping systems manufacturers generally require bonding methods that are somewhat different from the NEC 250.104(B) requirements. Recommend that a licensed and qualified electrical contractor installed the necessary bond prior to the first incidence of CSST on the gas piping system to the standards established by the CSST manufacturer industry. Additional information can be found at [CSST-Safety](#).

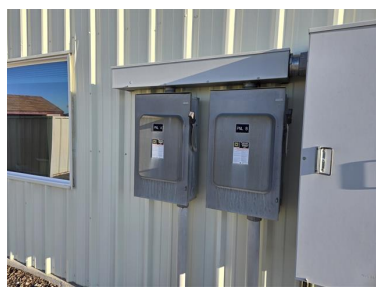
C. Item 1 (Picture)

There are two main electrical shut-offs located on the exterior of the building on the left side. These appear to be fused switches manufactured by Square D and rated for 200amps. No readily observable material deficiencies were noted.

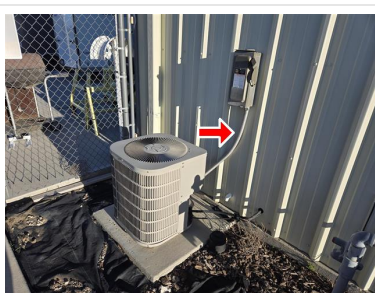
F. Item 1 (Picture)

The electrical service for the air conditioners is protected by conduit that is not weather tight. This can allow water into the service and cause damage to the wiring or create a shock hazard. Recommend repair by a licensed and qualified contractor.

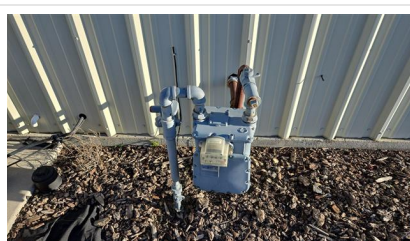
A. Item 1 (Picture)

A natural gas meter was located on the left hand side of the subject property. The meter was an active use at the time of inspection. Meter was checked with a combustible gas detector. No leakage was noted. No readily observable deficiencies were noted.

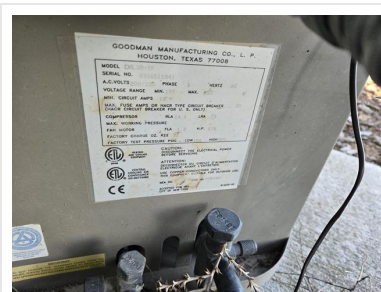
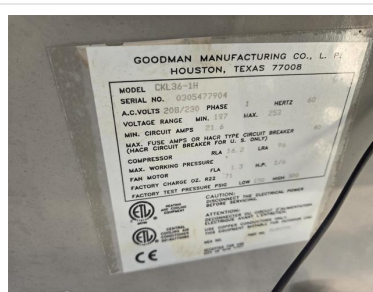
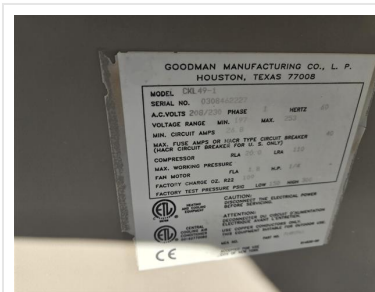
There were three air conditioning systems present. Each was a split system. The manufacturer of all three systems was Goodman Manufacturing. They were rated at 2.5 tons, 3 tons, and 4 tons of cooling capacity, respectively. The evaporator units for two systems were installed with the furnaces while the final one was installed in the interstitial space above the drop ceiling. Maintenance on all three air conditioners appears substandard. All were original to the construction of the building. As such, they are past a normal service life and are due for replacement. Recommend obtaining costs from a licensed and qualified HVAC contractor.

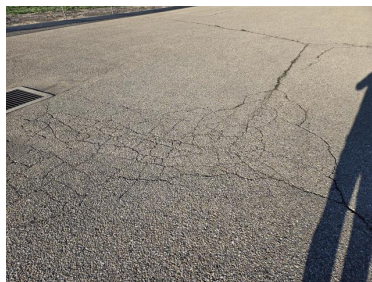
E. Item 2 (Picture)

(2) The asphalt surface was damaged as evident by localized alligator cracking suggesting a localized structural failure of the surface and possibly the subsurface structure. Moderate cracking also observed.. Recommend evaluation by a licensed and qualified paving contractor to determine the full scope of the necessary work.

(3) Striping for the parking lot was in very poor condition. Recommend re-striping the parking lot after repairs and sealant applications are complete.

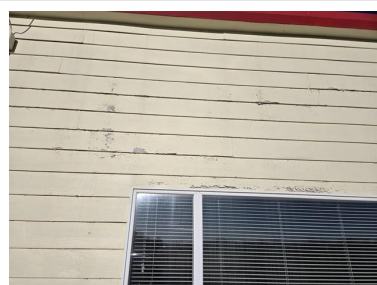
D. Item 3 (Picture)

(3) The cement fiber board siding had considerable water-related damage to the surface. Several of the planks appeared sufficiently compromised as to require replacement. The source of water is likely from the roof edge or gutters. This source of damage should be repaired to prevent reoccurrence. Damaged planking should be replaced. The entirety of the fiber board is overdue for painting. Recommend that all work be completed by a licensed and qualified siding contractor.

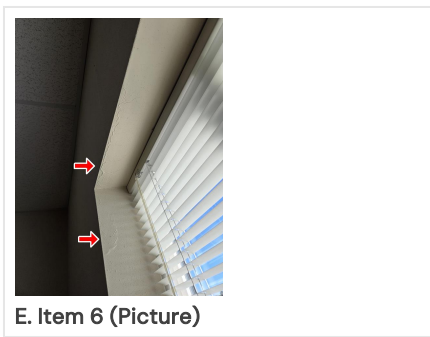
E. Item 6 (Picture)

(3) The windows do not appear to have been properly installed with flashing to prevent water leakage. Indications of leakage were noted at five different windows. One window had apparent fogging from a damaged seal. Recommend evaluation and repair by a licensed and qualified window specialist.

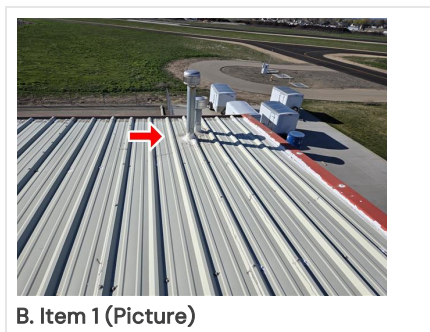
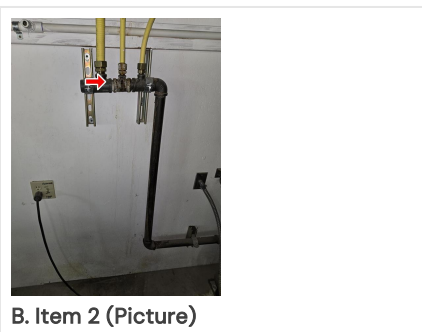
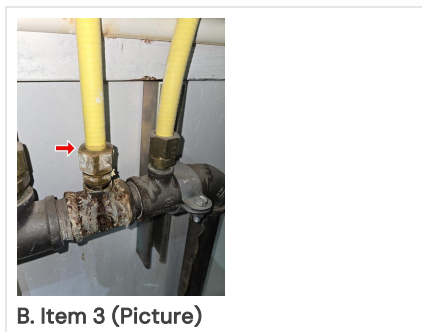
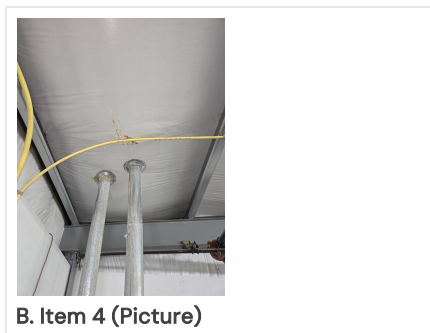
The flashings used for the various roof penetrations for the mechanical equipment does not conform to good construction practices for metal roofing. Active leaking was noted at the rear left corner of the building where a pair of flues exhaust. Recommend further evaluation of the flashings by a person experienced with metal roofing who can determine the best means of correction and the costs associated with same.

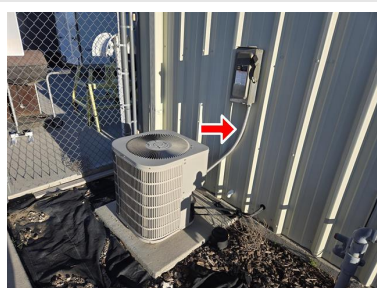
F. Item 1 (Picture)

The electrical service for the air conditioners is protected by conduit that is not weather tight. This can allow water into the service and cause damage to the wiring or create a shock hazard. Recommend repair by a licensed and qualified contractor.

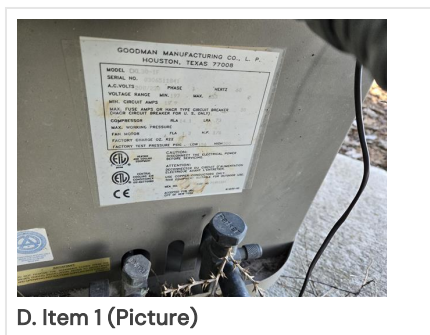
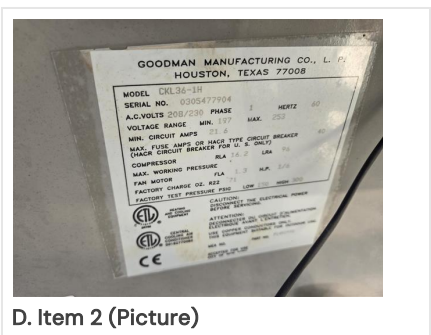
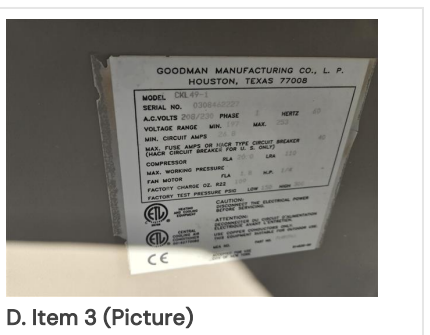
There were three air conditioning systems present. Each was a split system. The manufacturer of all three systems was Goodman Manufacturing. They were rated at 2.5 tons, 3 tons, and 4 tons of cooling capacity, respectively. The evaporator units for two systems were installed with the furnaces while the final one was installed in the interstitial space above the drop ceiling. Maintenance on all three air conditioners appears substandard. All were original to the construction of the building. As such, they are past a normal service life and are due for replacement. Recommend obtaining costs from a licensed and qualified HVAC contractor.
