Inspection Report

Safe@Home Inspections, LLC

Date: 1/1/2024	Time:	Report ID: 20190801-Sample-Office
Property:	Customer: Professional Investor

Executive Summary

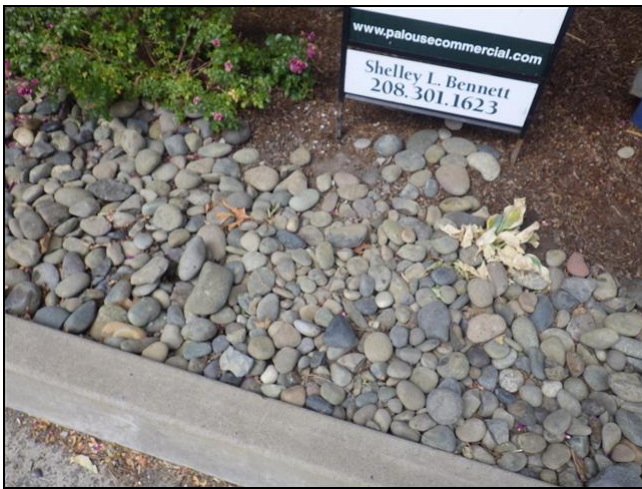
G. Item 1 (Picture)

There is a landscaped border at the sidewalk along Third Street. It appeared well-maintained.

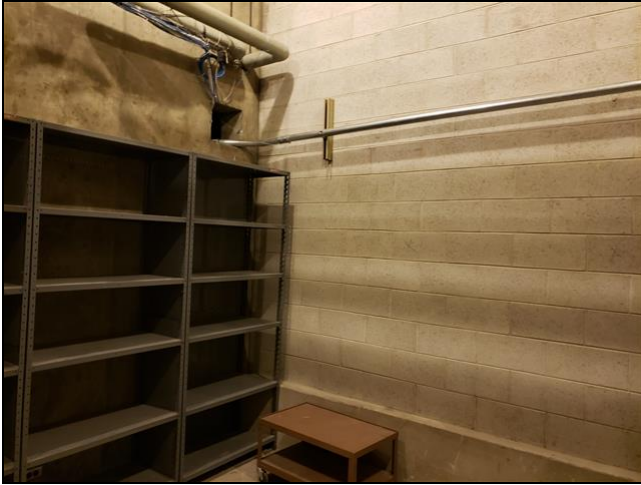
B. Item 1 (Picture)

(1) The foundation is a combination of slab on grade concrete with concrete column support for the elevated sections. While the footing were not visible, they are presumed to be reinforced concrete.

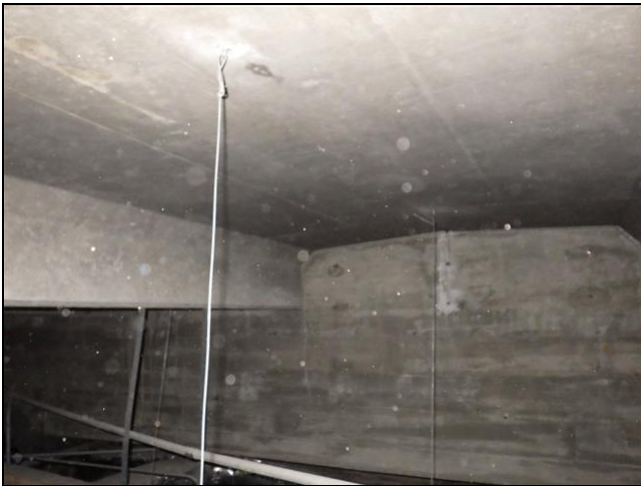
B. Item 3 (Picture)

(2) The floor and roof systems appear to be precast reinforced concrete spans that bear to concrete beams.

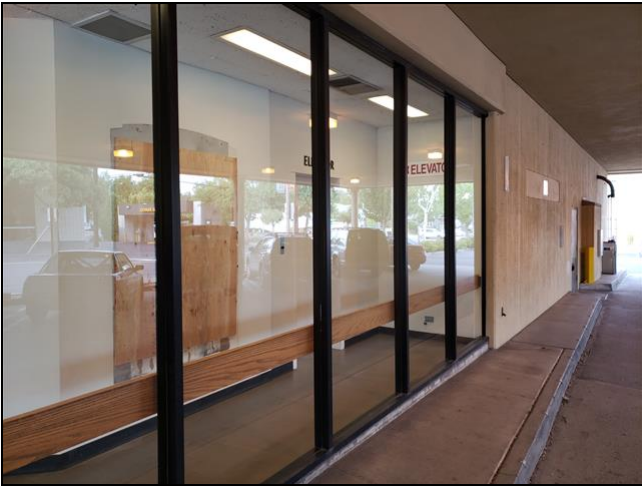
E. Item 1 (Picture)

(1) The windows are anodized metal framed thermally paned systems that appear to have been installed in 1996. No deficiencies were noted.

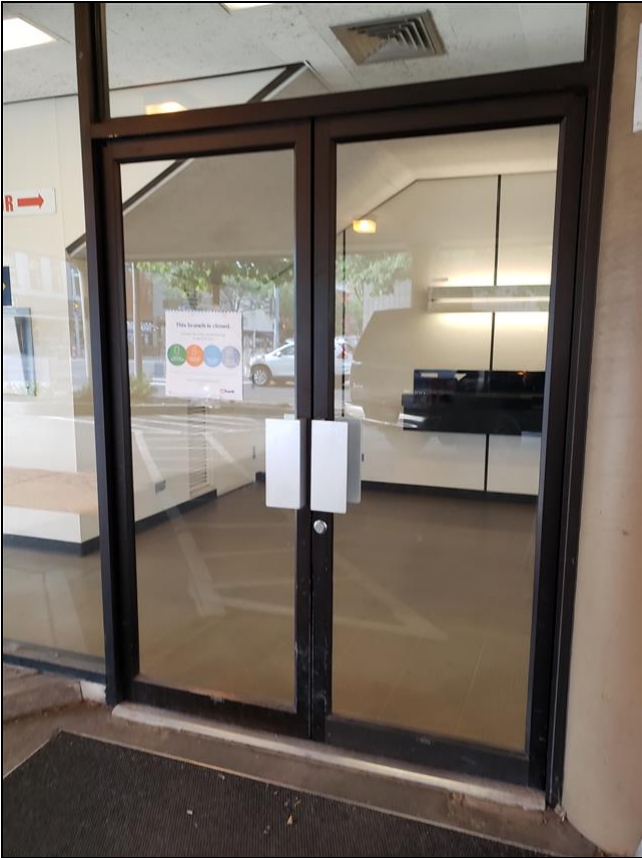
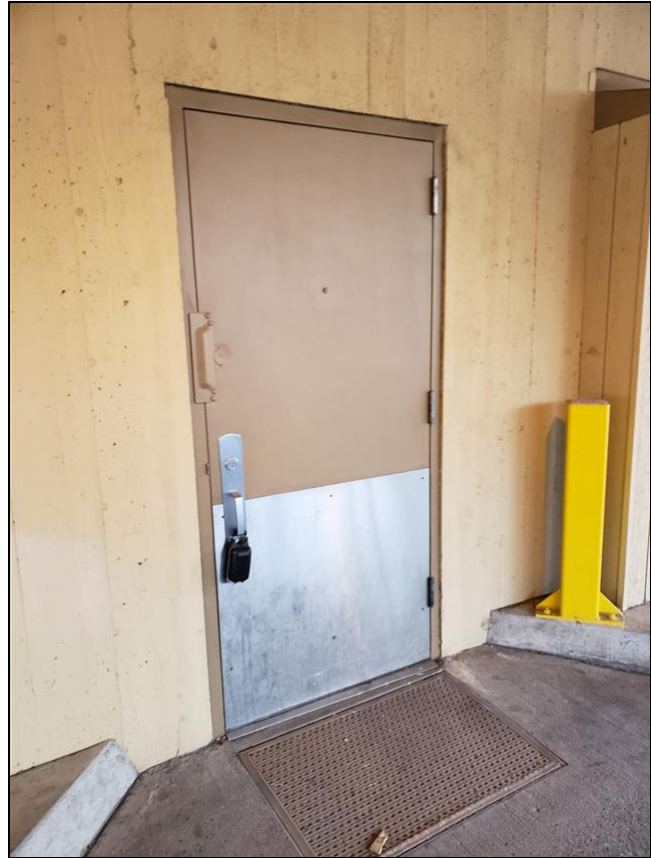
(2) Three doors were present at ground level. The two primary entrances are anodized metal framed doors with thermally paned glazing. These faced east and north. Also on the north side was a steel security door. No deficiencies were noted.

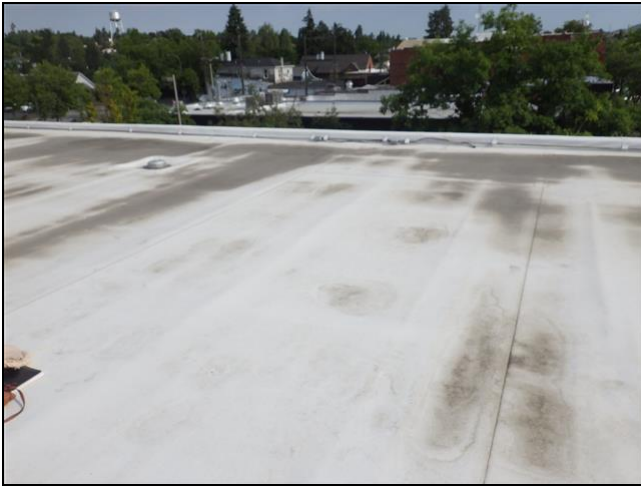
G. Item 1 (Picture)

(1) The roofing material appeared to be TPO (Thermoplastic Polyolefin) membrane roofing. It appears to be approximately 10 years old. In our region, TPO roofing frequently last for 20 years.

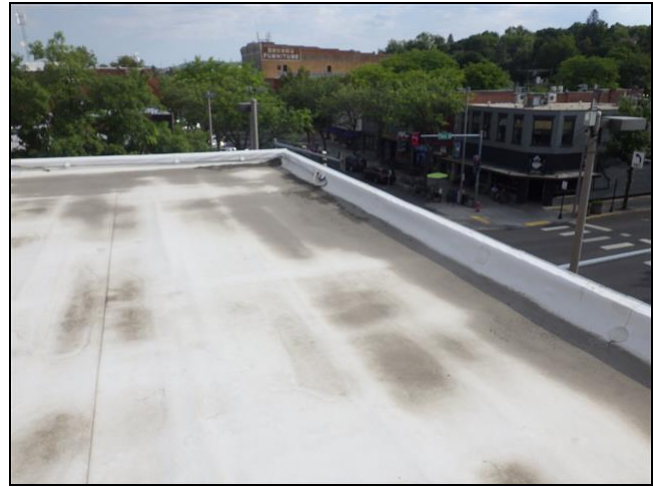
G. Item 2 (Picture)

(2) The roof does not appear to be properly sloped for drainage as is evident from the residual pooling marks. This is not feasible for correction until the roof is replaced.

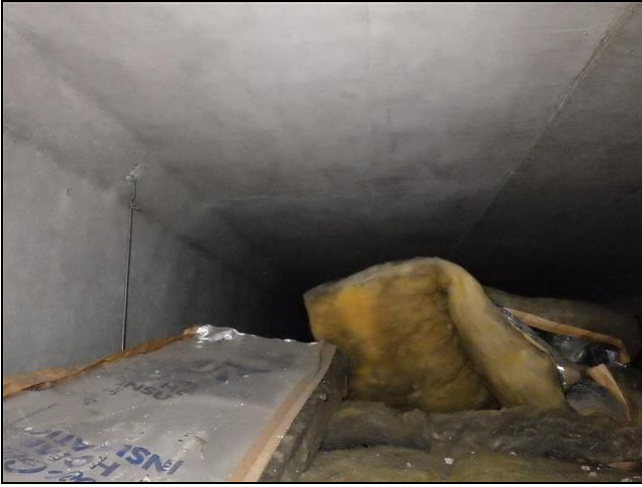
I. Item 1 (Picture)

There is little insulation present. The upper roof deck appears to have rigid foam below the membrane and the upper story walls appear to have insulation.

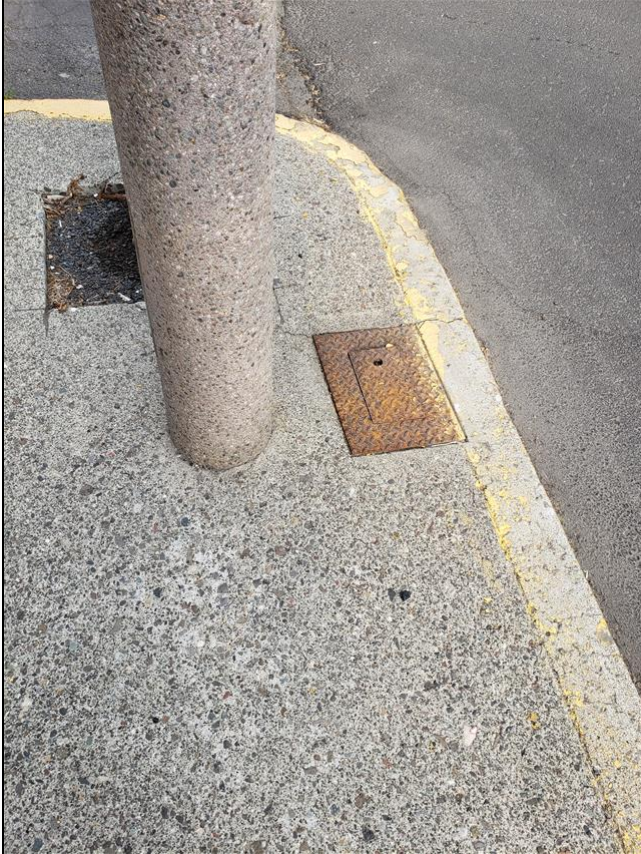
A. Item 1 (Picture)

Domestic potable water is supplied by the City of Moscow. The municipal main is located on the northwest corner of the property.

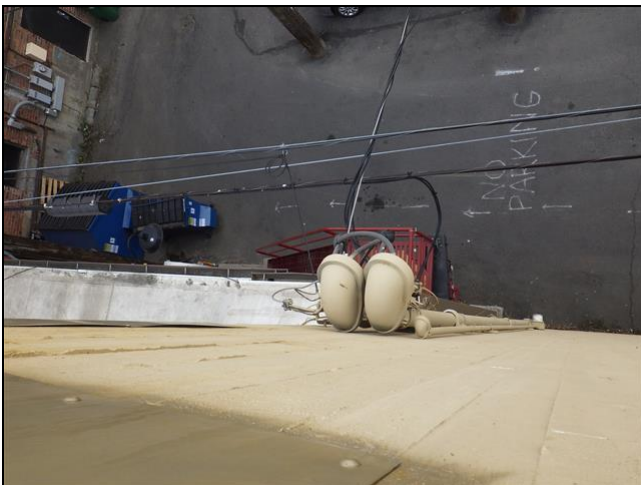
B. Item 1 (Picture)

The source for electricity is Avista Utilities. The electrical service is overhead and attaches to the building on the west side. The service appears to be a 600 amp, 480 volt, three phase system.

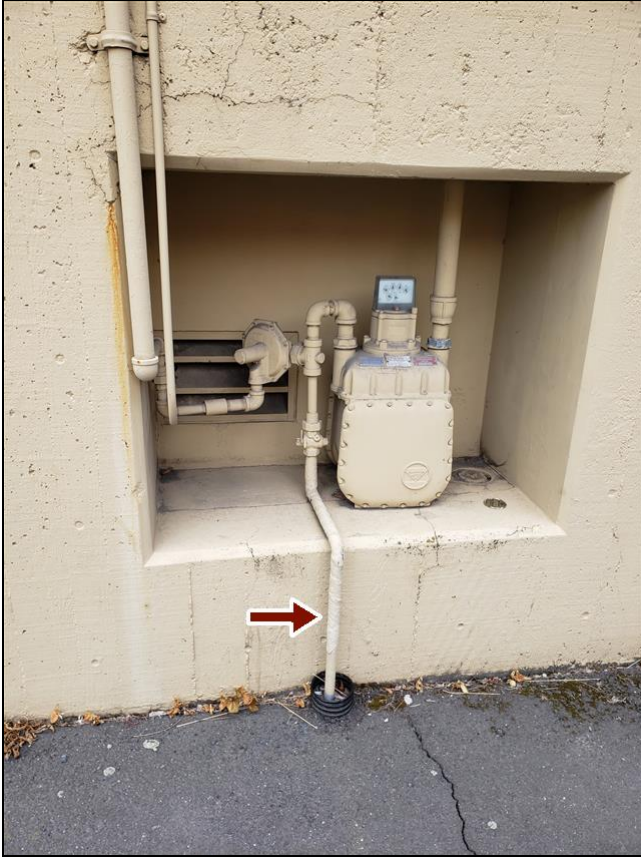
C. Item 1 (Picture)

The fuel source is natural gas and is supplied by Avista Utilities. The meter is located on the west side of the building.

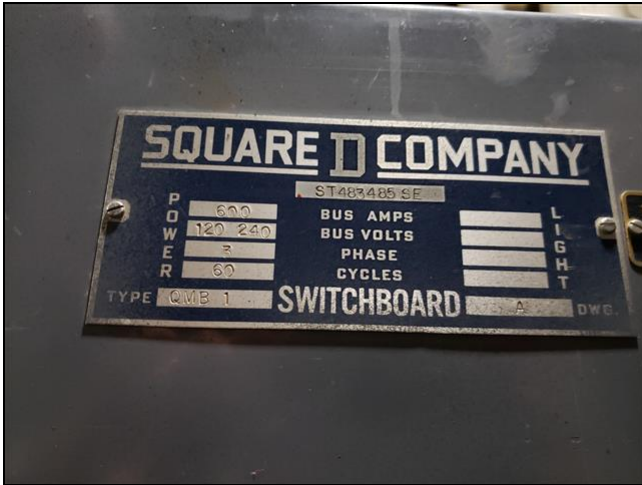
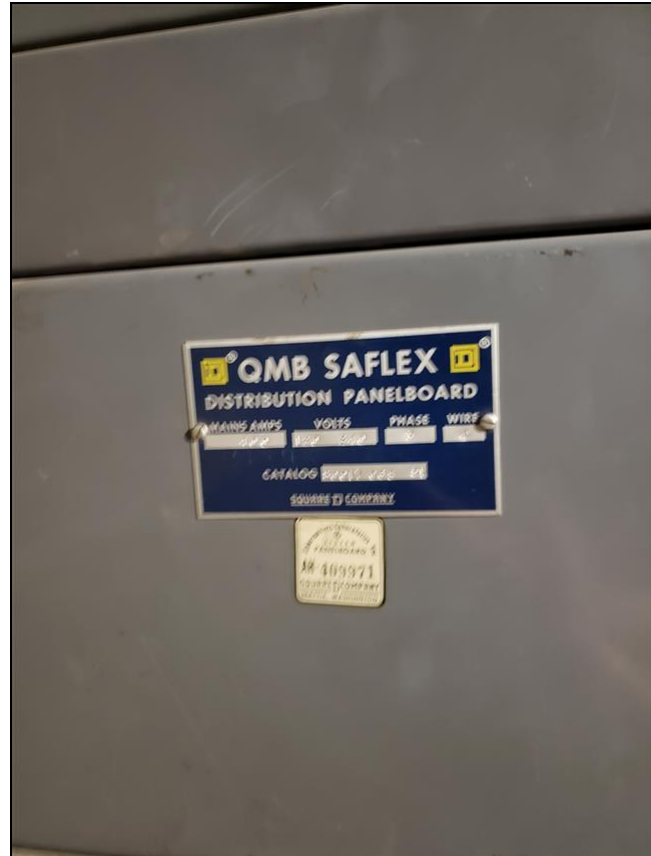
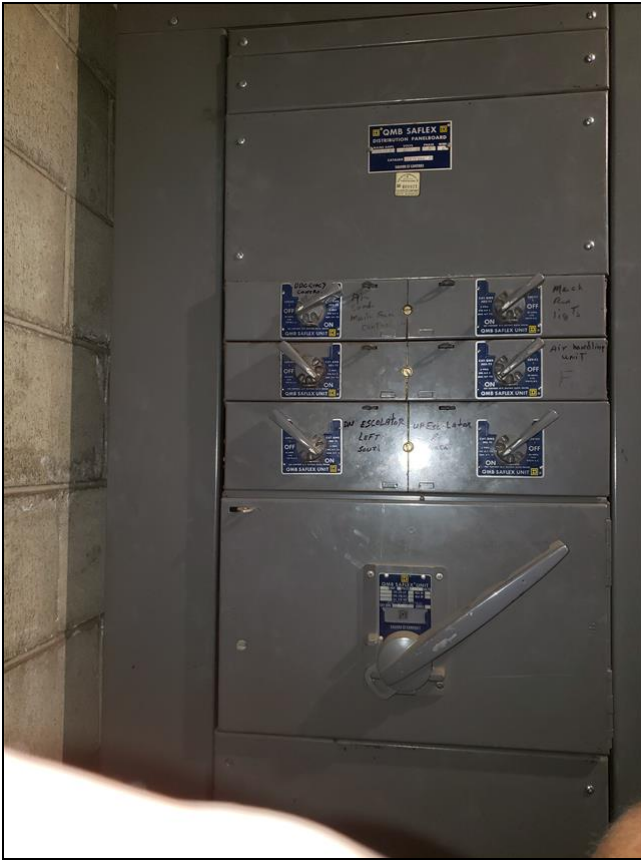
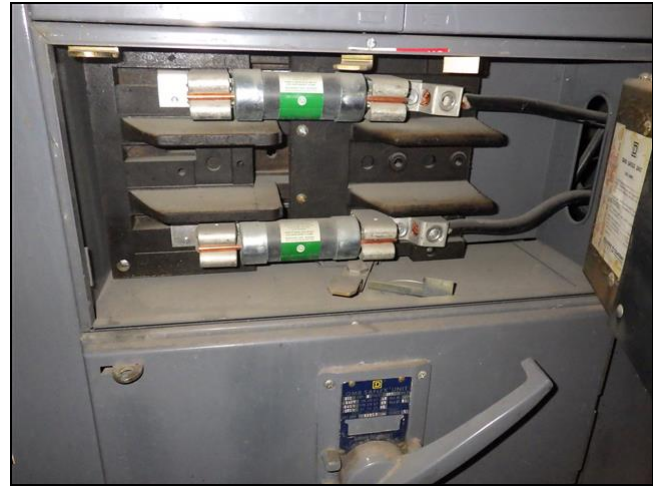
(1) The main panel complex is located at the basement. The system was manufactured by Square D and utilizes cartridge fuses for primary protection. The system is rated for 600 amp with 3-phase distribution.

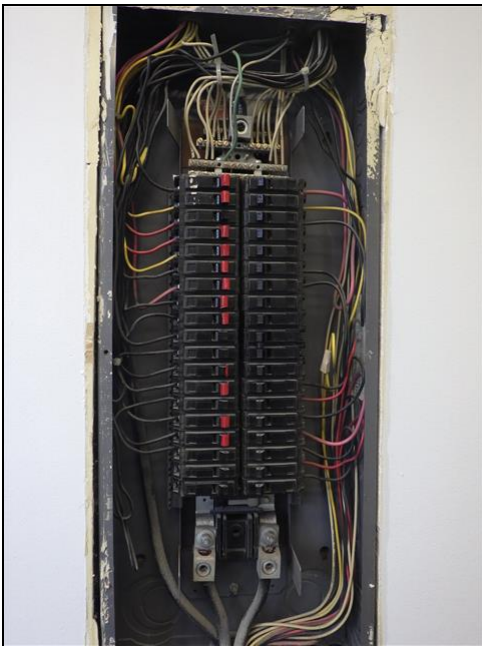
B. Item 5 (Picture)

(3) The sub panel box marked panel B is located at the top of the stairs. This is a 200 amp 120/240 volt Square D circuit breaker panel. Panel B appears to serve the circuits on the second floor. About forty percent of the breakers are unused.

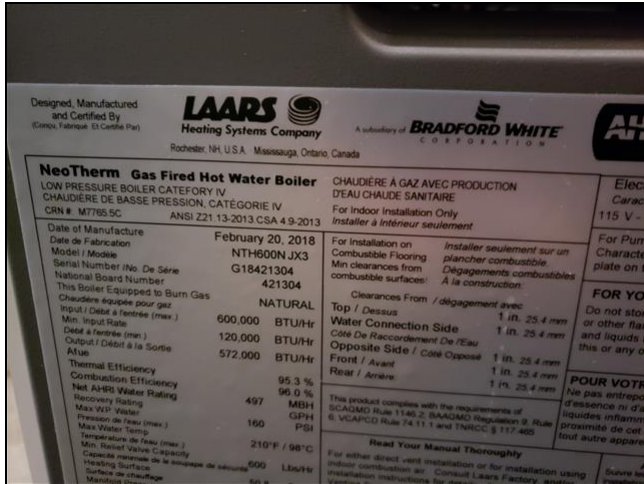
A. Item 1 (Picture)

(1) The boiler was manufactured by LAARS in 2018. It is rated for up to 600,000 BTUs. It is a hot water boiler with two circulator pumps. The controls are electronic. It is rated at 95 percent efficiency.

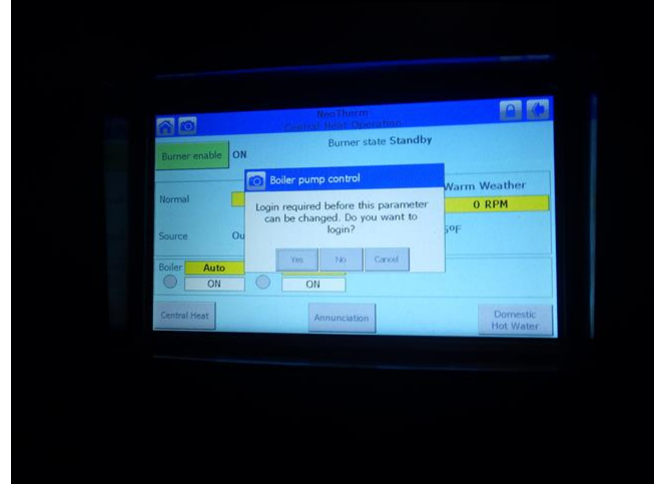
A. Item 2 (Picture)

(2) Heating equipment is due for routine maintenance.

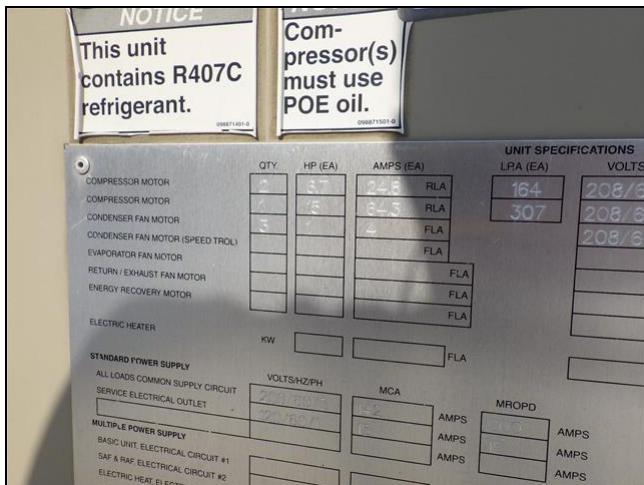
B. Item 1 (Picture)

(1) The air conditioning plant is roof mounted. Manufactured by McQuay, it has a total of three compressors. The total amperage rating of the equipment is 200 amp of 208v power. It appears that the compressors are rated at 3 tons of cooling (2) and 7 tons of cooling (1).

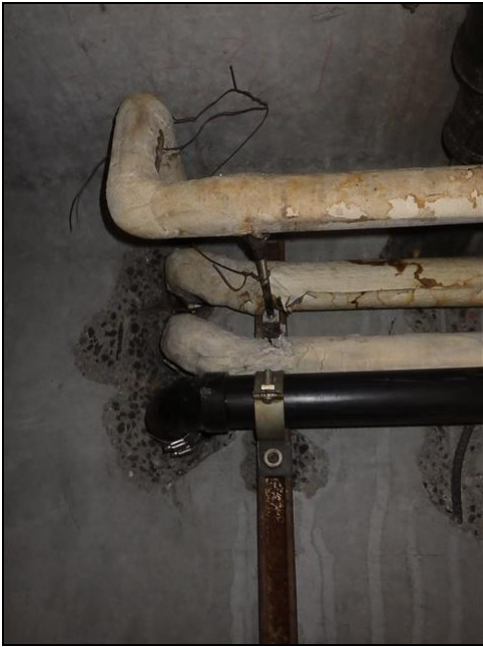
C. Item 1 (Picture)

(1) The boiler distributes heat through a radiant floor system. System not tested.

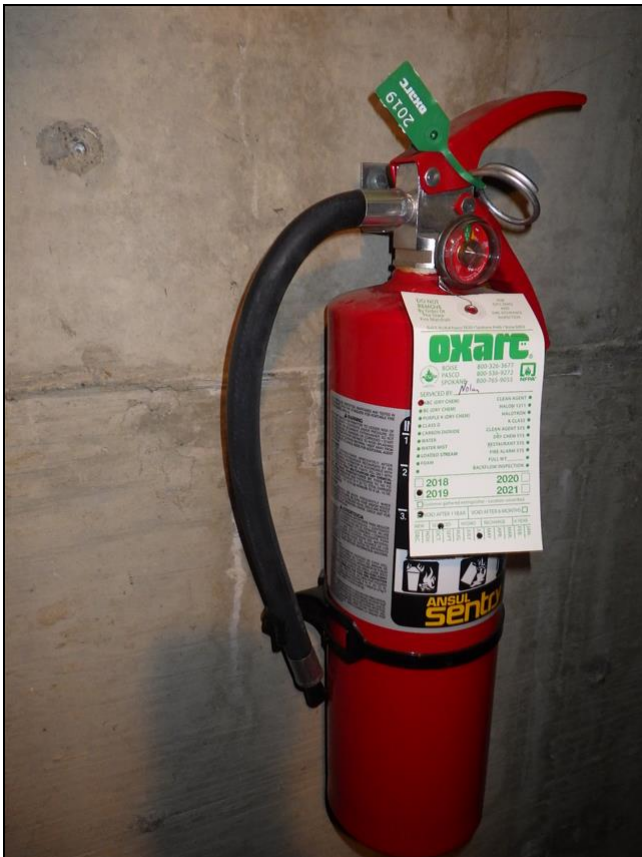
E. Item 1 (Picture)

Fire extinguishers are present on each floor. The tags on the fire extinguishers indicate the service was performed by Oxarc.
