Inspection Report

Professional Investor

Safe@Home Inspections, LLC

**Paul Duffau, WA Lic#215 MT #HI0454
308 2nd Street
Asotin, WA 99402
208-596-1489**

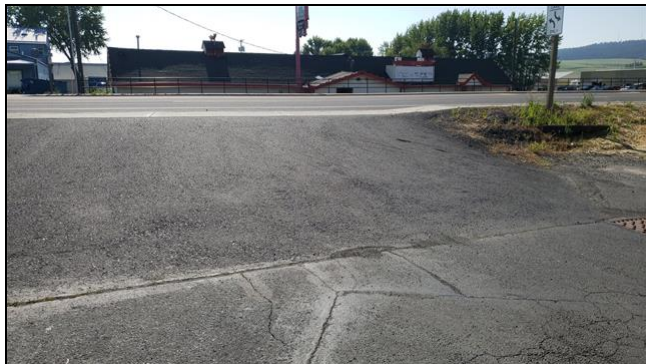
D. Item 1 (Picture)

There are two entrances to the property. The first is from Main Street on the east side. The second is at the north side from Palouse River Drive. There is also a pass through from the neighboring property to the south.

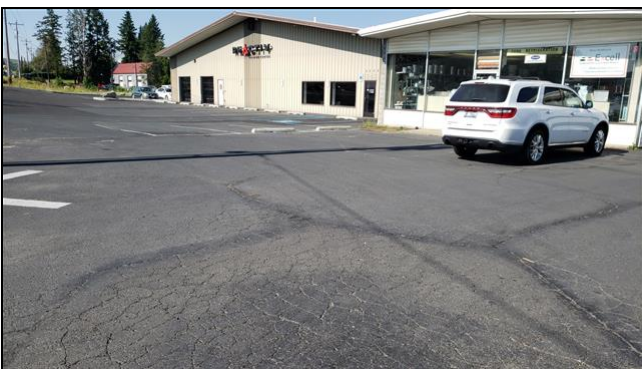
E. Item 3 (Picture)

(2) The parking lots and drives are in very poor condition with extensive surface cracking, evidence of pumping that suggest the subgrade compaction is damaged, and evidence of previous repairs now failing. Striping is nearly non-existent in the front lot. Repairs are necessary on an immediate basis to limit further damage.

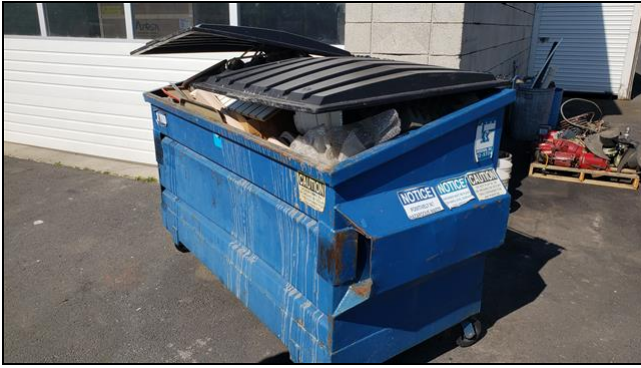
H. Item 1 (Picture)

Landscaping was not present. There was not a dedicated trash enclosure as is now required. A single pole sign at the east side of the property was present.

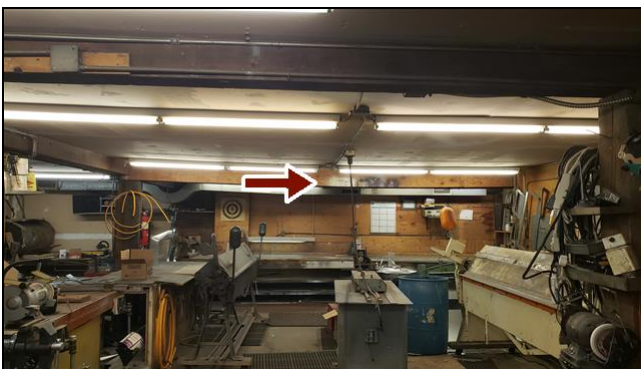
C. Item 4 (Picture)

(2) Beam structures were improperly constructed laminate systems. They lack columns under splices and are significantly sagging. Recommend evaluation

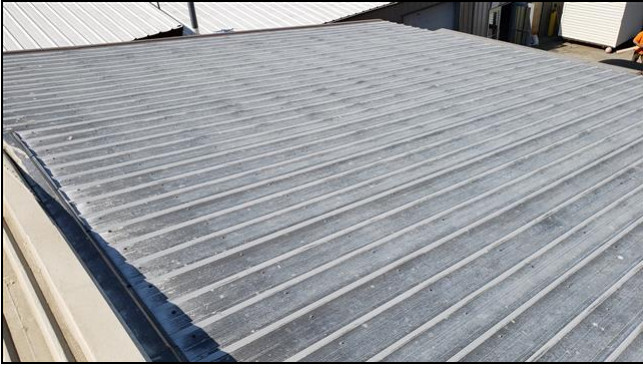
J. Item 12 (Picture)

(6) The roof for the rear addition does not have any coatings.

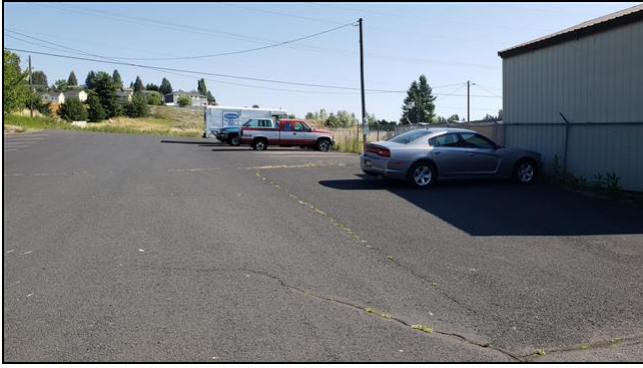
G. Item 1 (Picture)

Overall lighting appears average to poor. Lighting not present in the parking areas.

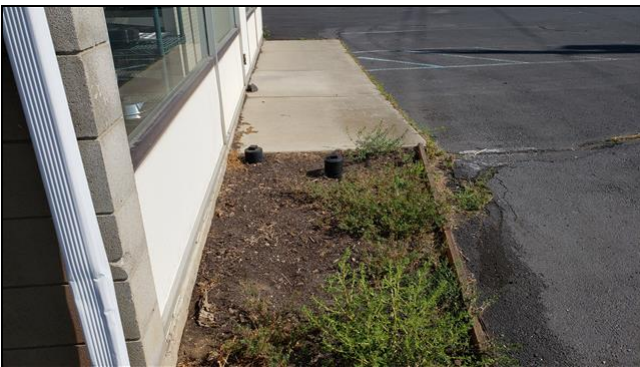
E. Item 1 (Picture)

The cleanout appeared in generally acceptable condition.

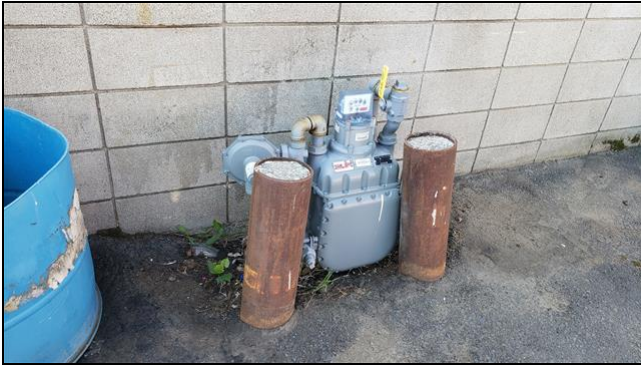
A. Item 1 (Picture)

The gas meter, located on the north, appeared in functional condition. As it was in a drive path, it was protected by bollards. No readily observable deficiencies were noted.

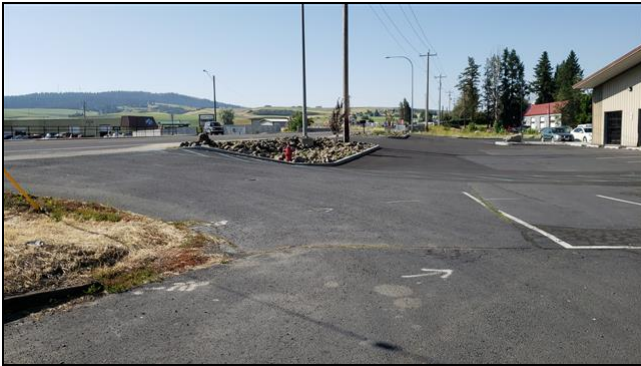
B. Item 1 (Picture)

Located on property.

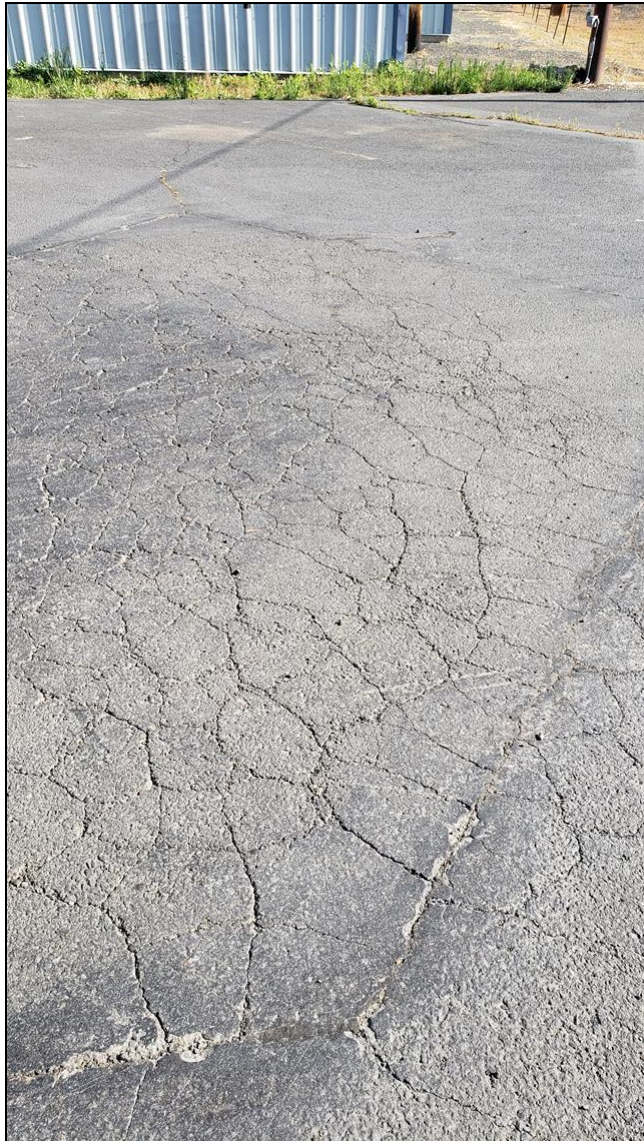
E. Item 1 (Picture)

(2) The parking lots and drives are in very poor condition with extensive surface cracking, evidence of pumping that suggest the subgrade compaction is damaged, and evidence of previous repairs now failing. Striping is nearly non-existent in the front lot. Repairs are necessary on an immediate basis to limit further damage.

Estimate: Cost likely exceeds \$10,000.
