# Inspection Report

**Professional Investor**

**Safe@Home Inspections, LLC**

### Executive Summary

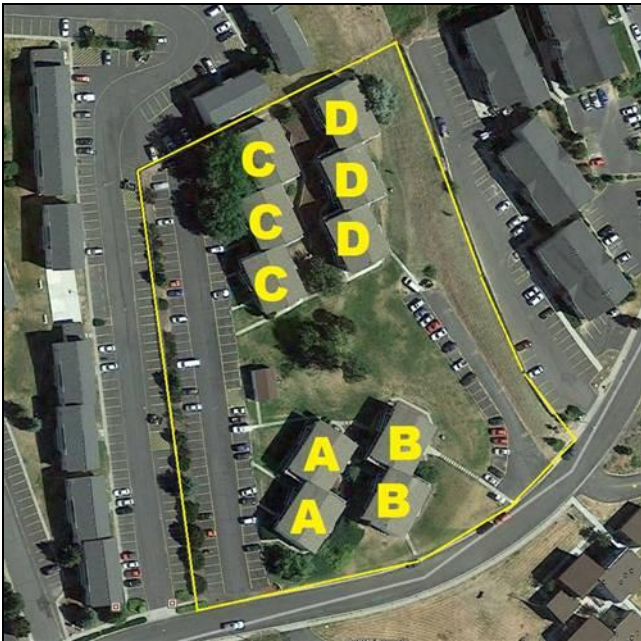
A. Item 1 (Picture)

The lot is irregularly shaped but resembling a rectangle. The east side is adjacent to a condominium association. To the north and west are apartment complexes. The south side fronts to Merman Drive. (Leasing office not in picture.)

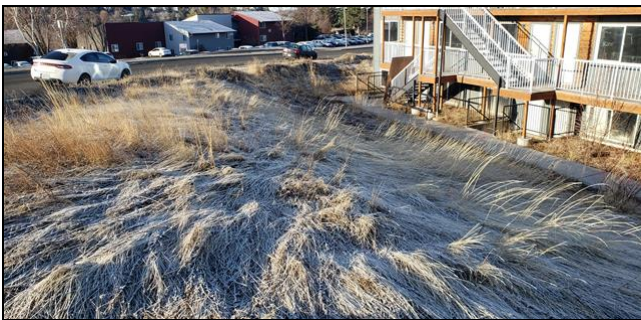
B. Item 1 (Picture)

The lot slopes from east to west with a substantial grade. Individual buildings are built on terraced pads.

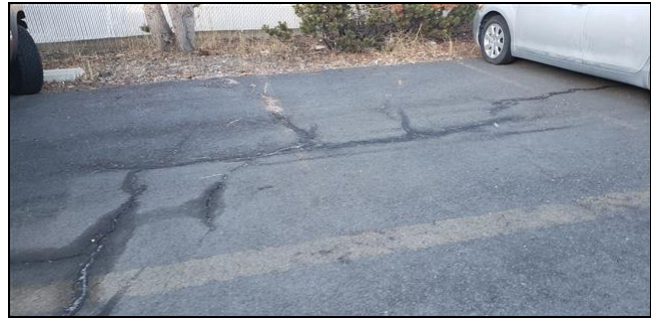
E. Item 2 (Picture)

- (1) The paving is asphalt over a stabilized base with curb stops at Buildings C and D and curbing at west parking lot for the other buildings. The west parking lot appears to have an asphalt overlay on older asphalt.
- (2) The asphalt surface is cracked and is deteriorated in multiple areas. It is recommended to consult further with a paving contractor as to what is necessary to repair and resurface.

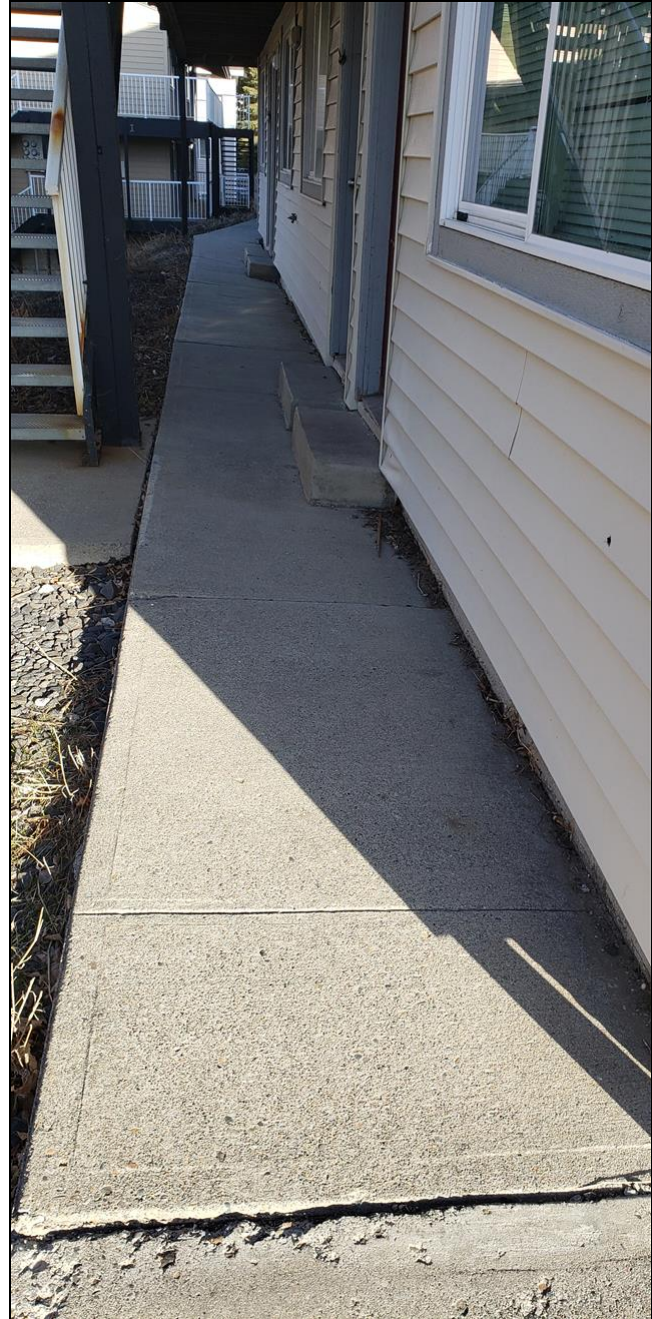
F. Item 4 (Picture)

(3) Walkways show signs of erosion and settlement. In several cases, the walkways have been undermined. All such should be shored up, or where the walkways are too damaged, replaced.

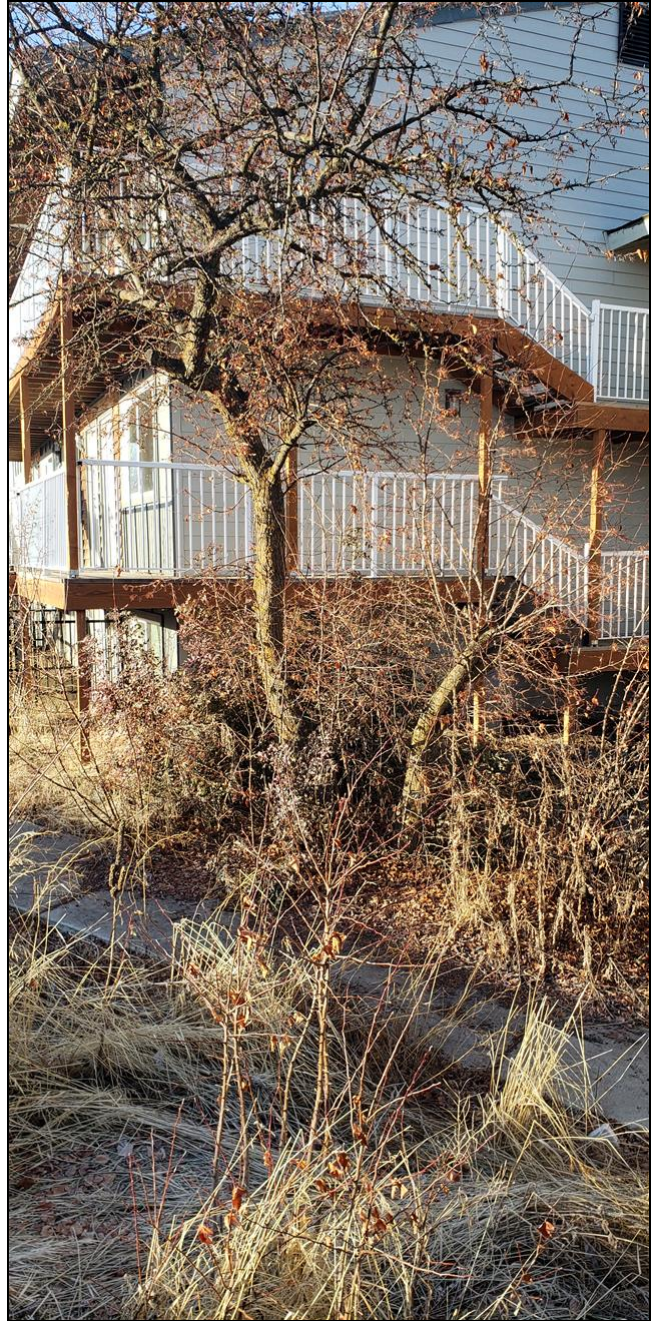
G. Item 2 (Picture)

(1) Significant part of the subject property is devoted to green space. However, this area is very poorly maintained. It appears as overgrown with wild grasses. Trees are in poor condition and in need of attention. And irrigation system appears to be present but probably not functional. Significant improvements are necessary.

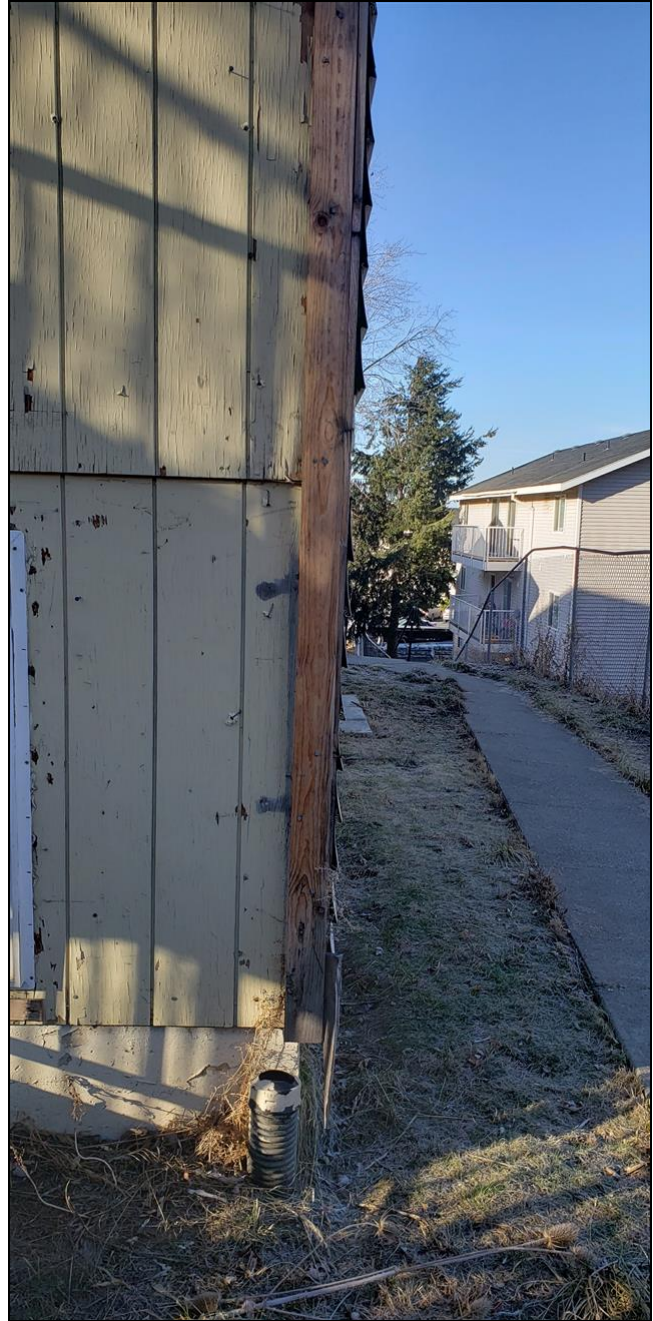
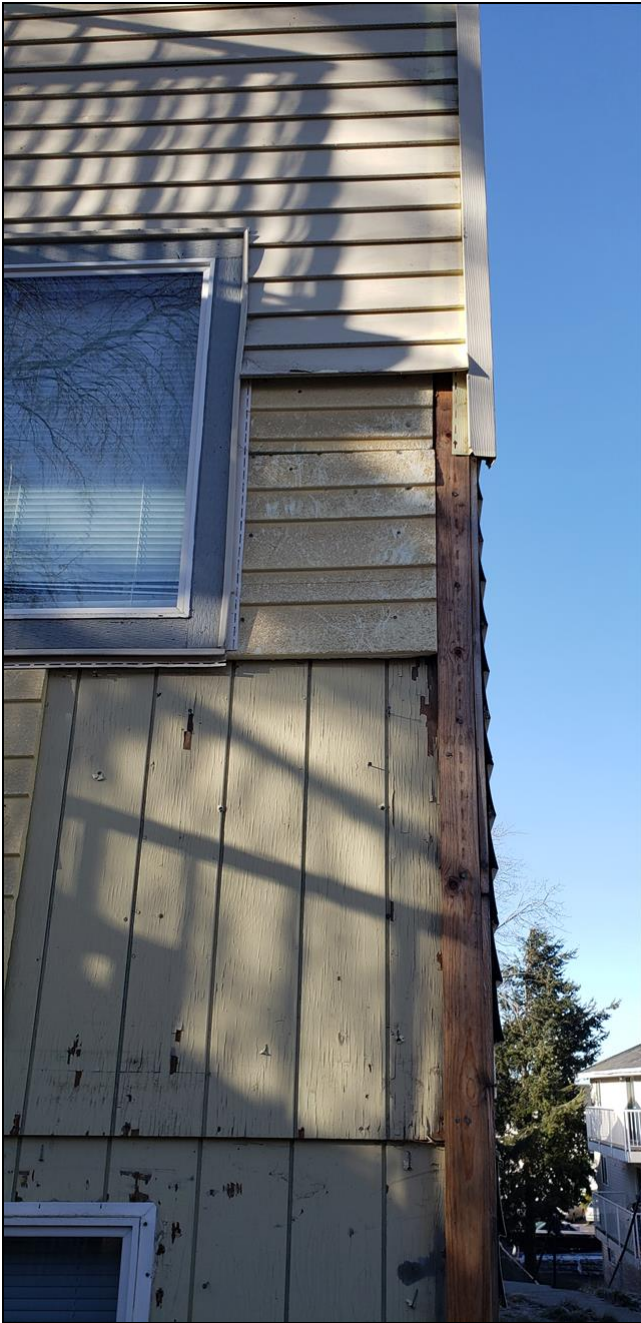
(2) The vinyl siding is failing. It is detaching in wind. Replacement is necessary.

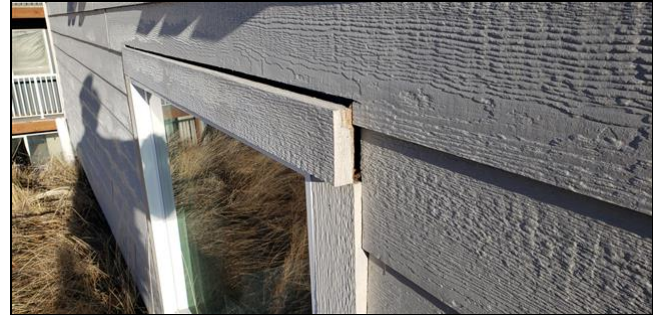
D. Item 6 (Picture)

(5) The fit and finish of the trim work on the hardboard is very poor. Replacement of elements of the trim is likely necessary.

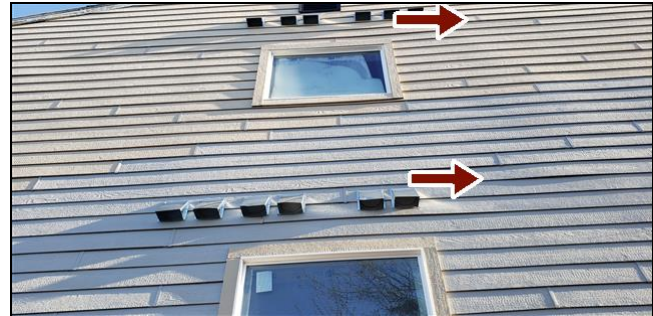
D. Item 8 (Picture)

(6) The hardboard does not appear well-secured. Portions are bulging away from the wall. Recommend evaluation by a licensed and qualified siding contractor.

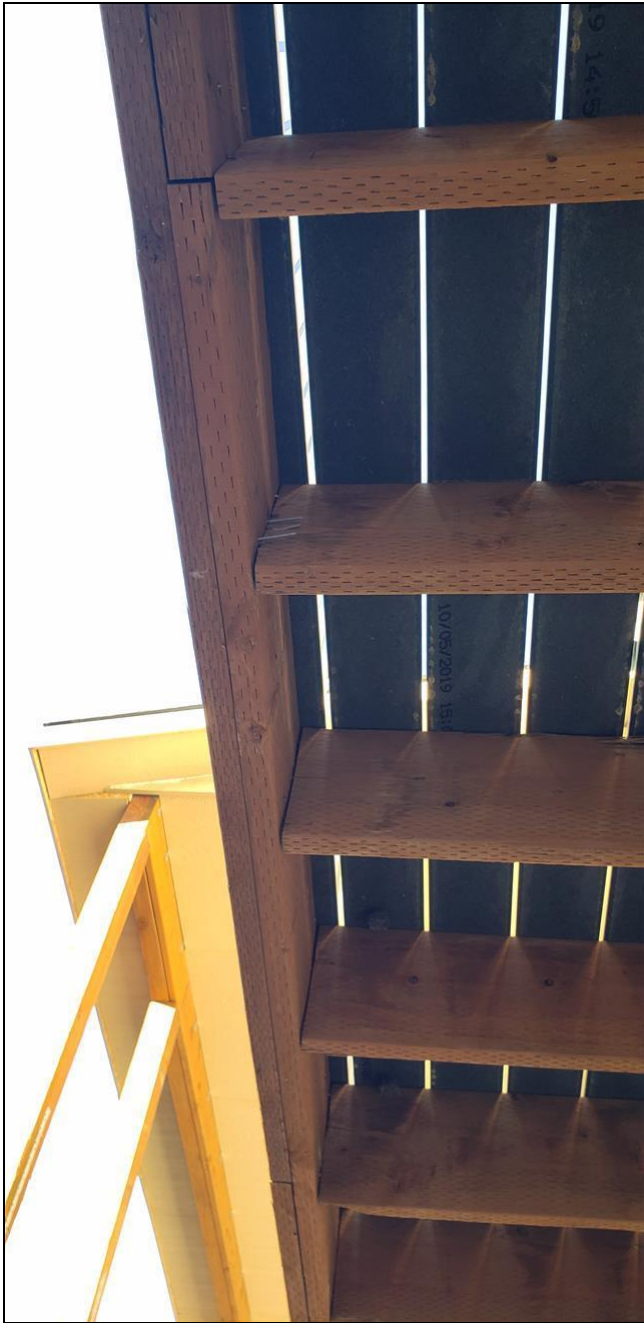
E. Item 5 (Picture)

(9) Splices in beams are not supported.

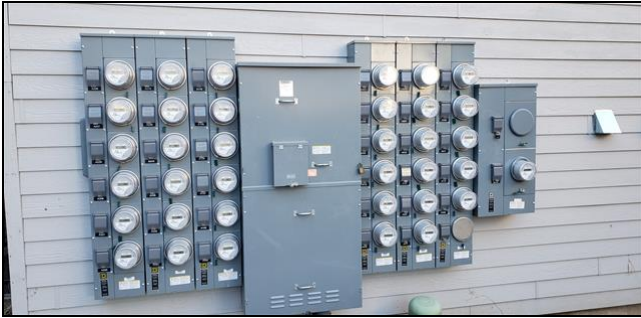
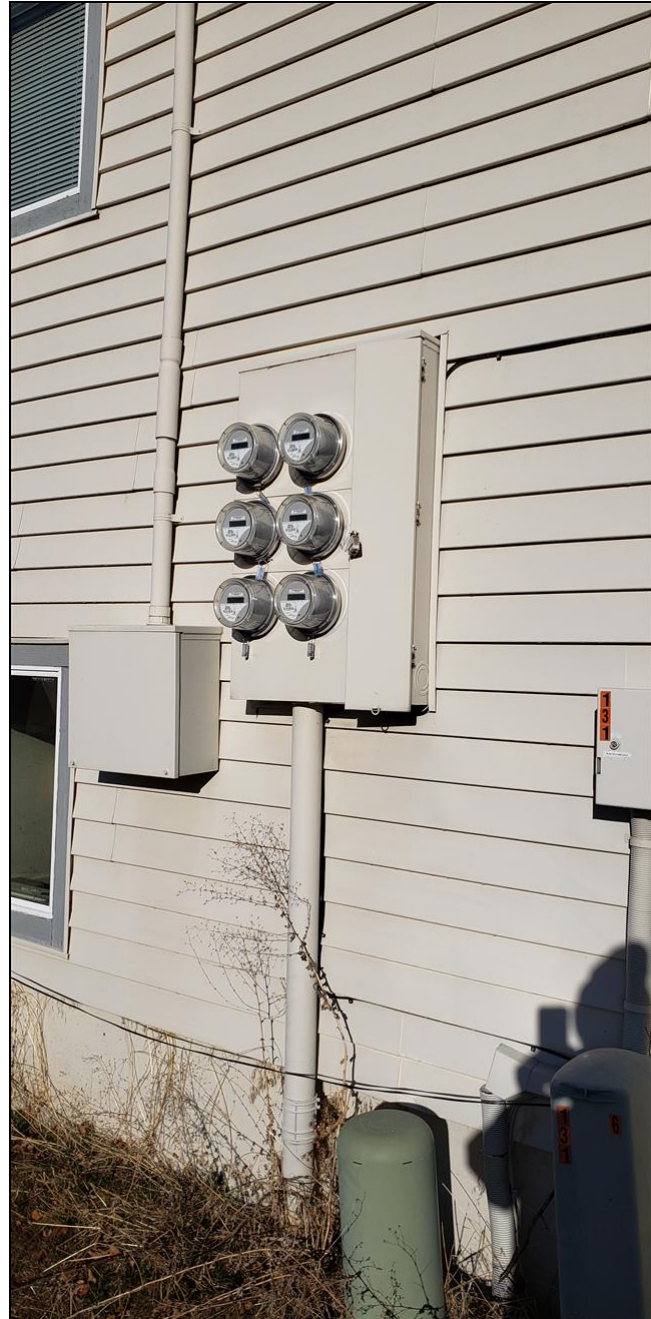
(1) Power is delivered via a series of underground risers from Avista Utilities. It is delivered to exterior mounted meter panels. For Buildings A, B, and C, these are Square D panel systems rated at 120/240v 1000amp for the first two and 120/240v 800amp for the latter. Permit/inspection stickers from the State of Washington were observed.

No significant deficiencies were noted.

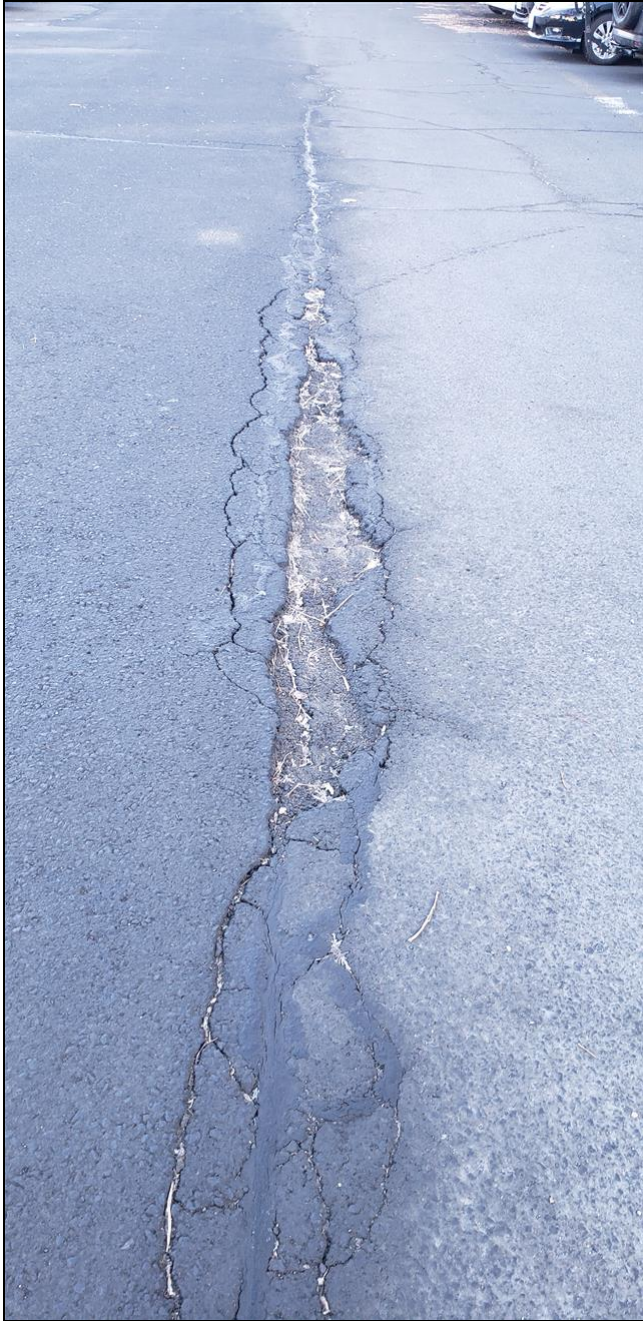
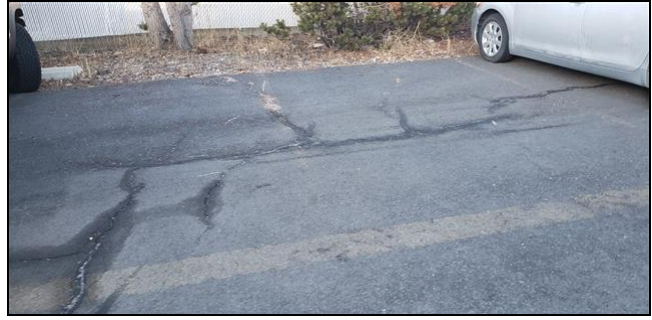
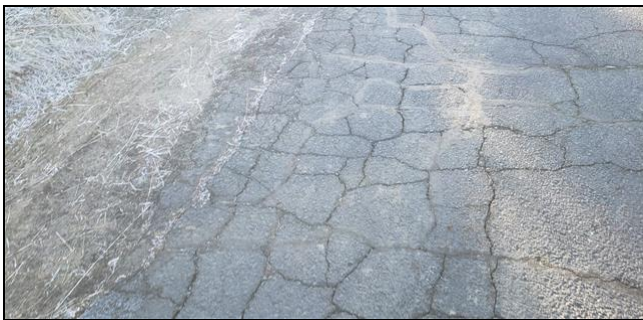
(2) The asphalt surface is cracked and is deteriorated in multiple areas. It is recommended to consult further with a paving contractor as to what is necessary to repair and resurface.

Estimate: \$5,000 - \$10,000

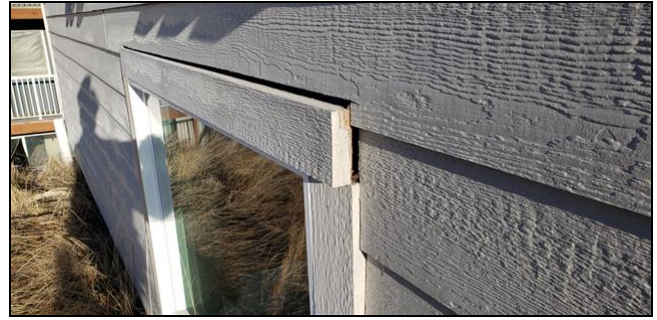
D. Item 6 (Picture)

(4) Head flashing is missing above the doors and windows and at horizontal planes that might accumulate water. This lack of flashing can create water issues within the home. This element is required under the manufacturer's installation specifications and the building codes dating back to 2009. Recommend contacting the contractor to have the flashing installed to the manufacture's installation specifications.

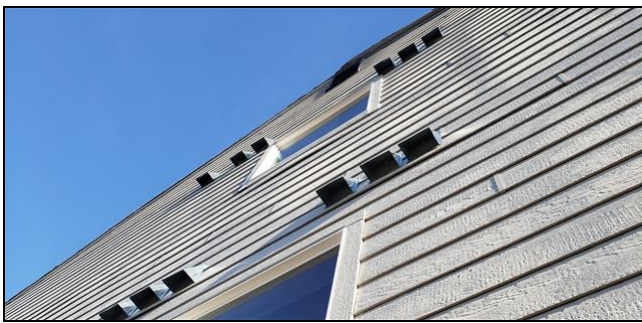
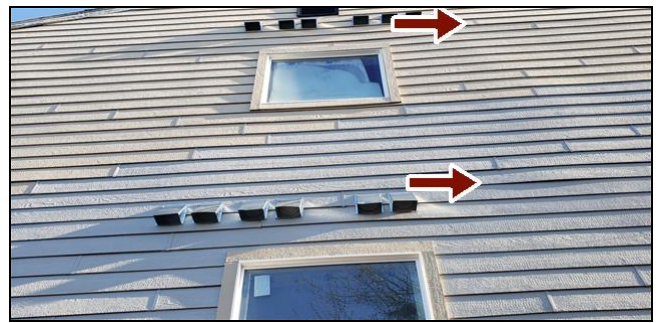
(6) The hardboard does not appear well-secured. Portions are bulging away from the wall. Recommend evaluation by a licensed and qualified siding contractor.

Estimate: Detailed quotation required.

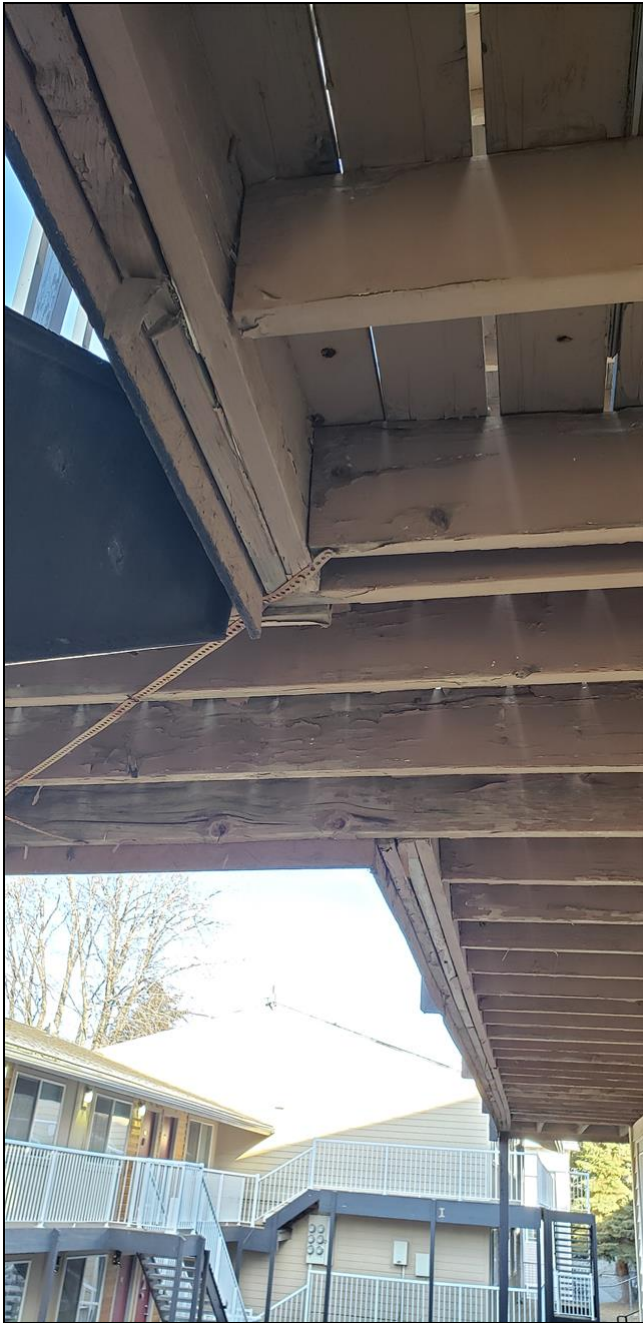
E. Item 1 (Picture)

(4) The joists were not all connected to the framing by use of joist hangers. Recommend installing hangers where missing. Recommend further evaluation and repair by a licensed and qualified contractor.

Estimate: Detailed quotation required.

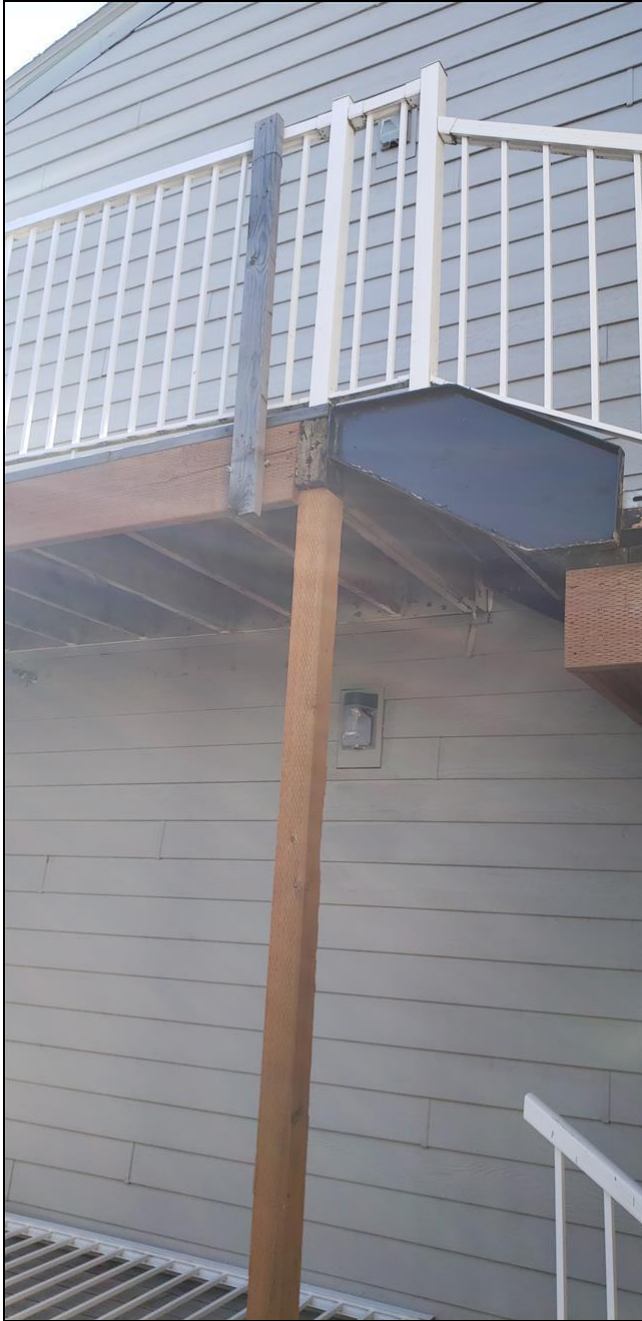
E. Item 2 (Picture)

(5) The maximum allowable height for a 4x4 column is six feet. Most of the columns exceeded this height and should be replaced.

Estimate: Detailed quotation required.

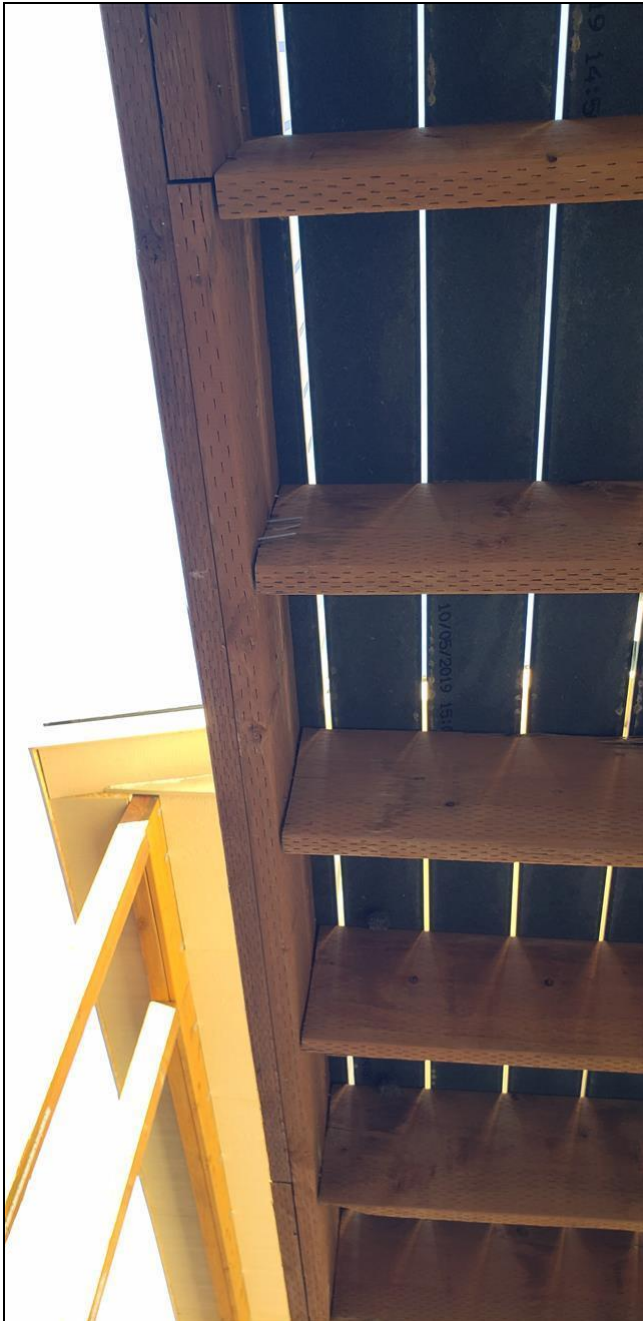
E. Item 5 (Picture)

(9) Splices in beams are not supported.

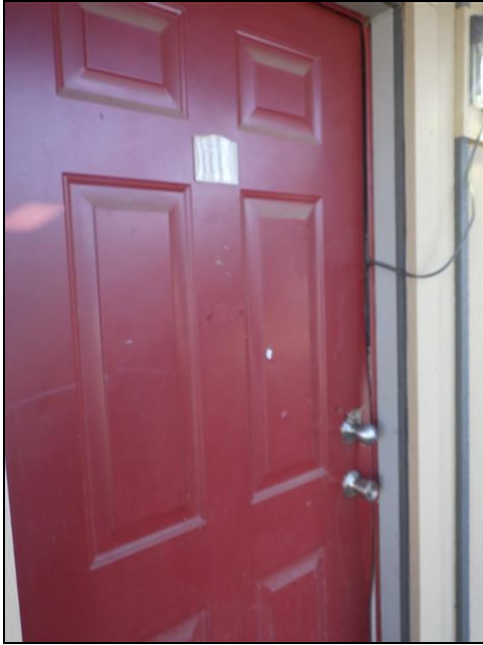
G. Item 1 (Picture)

(2) Each bedroom has an exterior steel door. The doors on Buildings C and D appear original. They are in poor condition and should be replaced.

Estimate: Detailed quotation required.

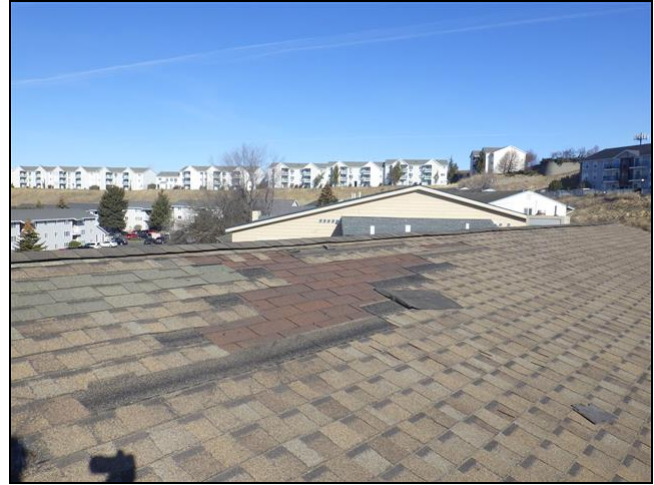
I. Item 3 (Picture)

(2) The roof covering is in very poor condition on the east facing sides of all buildings except the Leasing Office. The roof may not be leaking at time of inspection (this is dependent on weather conditions at the time of the inspection.). The roof is beyond life expectancy. It is unlikely the existing roof covering is or will be water tight. Although some roofing materials in this condition MAY function for a short time, near term replacement of the roofing and flashing should be scheduled. Recommend replacement.  
 Estimate: \$80,000-\$100,000.00

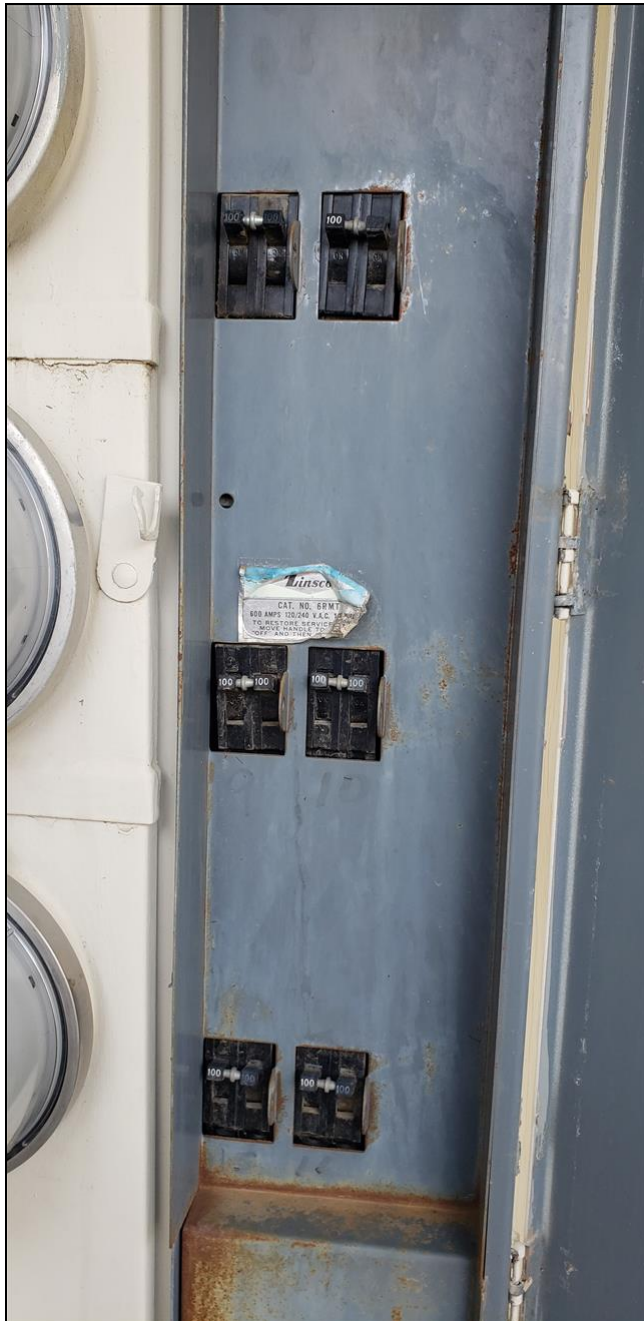
A. Item 3 (Picture)

(2) Buildings C and D were equipped with multiple 120/240 400 amp exterior mounted panels from Zinsco. These panels have long been considered problematical by the industry. The blade type bus bars in these panels were made using an aluminum alloy and tend to corrode, burn, and deteriorate where the breakers attach with a clip. The

breakers fail to lock securely onto the bus bar and this allows the breaker to move and slide around. This increased resistance causes heat, and sometimes fire. Recommend replacement.

Estimate: \$15,000-\$20,000

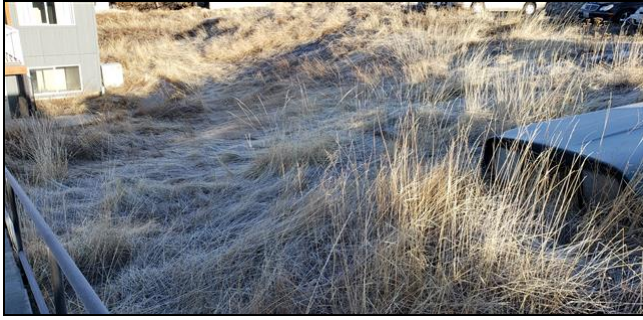
G. Item 1 (Picture)

(1) Significant part of the subject property is devoted to green space. However, this area is very poorly maintained. It appears as overgrown with wild grasses. Trees are in poor condition and in need of attention. And irrigation system appears to be present but probably not functional. Significant improvements are necessary.

Estimate: Detailed quotation required.

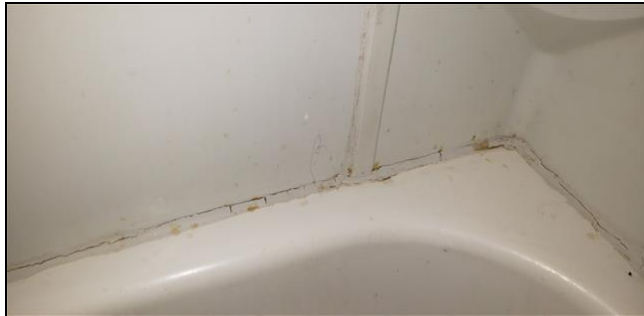
C. Item 1 (Picture)

(2) In Buildings C and D, the shower tubs are generally older and deteriorated. Where repairs have been made, the workmanship has been generally sub-standard. Substantial upgrades for these will be necessary in the next five years.

Estimate: Detailed quotation required.

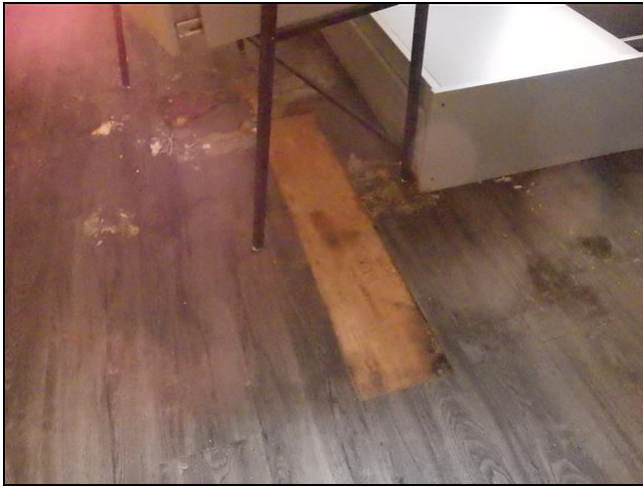
A. Item 1 (Picture)

(3) Flooring in Buildings C and D was uniformly poorly installed. Given the quality of workmanship, replacement is likely the best alternative.

Estimate: Detailed quotation required.
