Inspection Report

Property Address:
1234 Airport Rd
ID

Calibre Commercial Inspections, LLC

Date: 4/1/2024	Time: 09:00 AM	Report ID:
Property: 1234 Airport Rd ID	Customer: Professional Investor

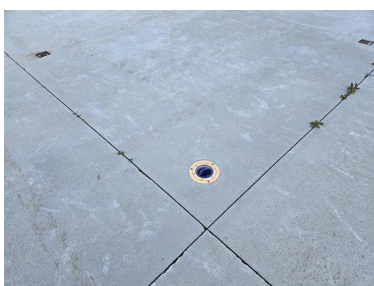
F. Item 1 (Picture)

The walkways are poured in place concrete and located at the front and left hand side of the building. There is also a concrete apron located to the rear of the building. The concrete apron has lighting and

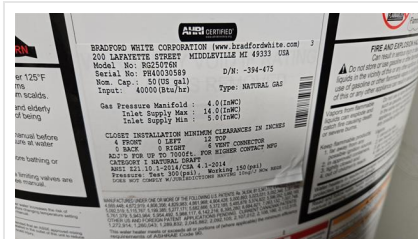
A. Item 1 (Picture)

The water heater is gas-fired using natural gas from the local utility provider.
